SUMMARY REPORT  
MECHANICAL OPERATION OF HORIZONTAL  
TRAVELING SCREEN MODEL VII

By  
Winston E. Farr  
and  
Earl F. Prentice

Research performed under contract between  
Eugene Water and Electric Board, Bureau of  
Reclamation and the National Marine Fisheries  
Service

September 1973

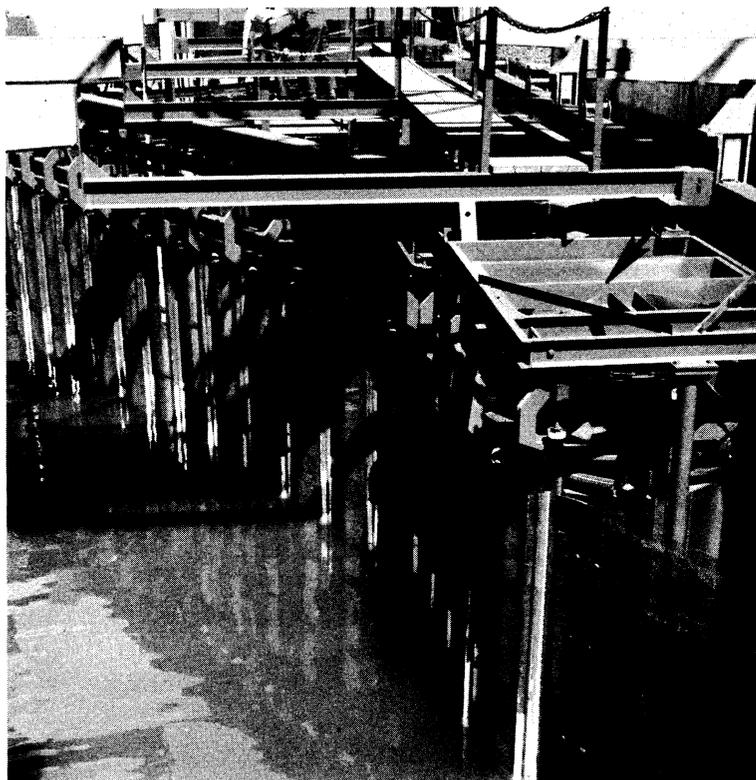
Figure 8. --Upstream view of traveling screen assembly. Black arrow indicates chain adjustment section, white arrow--upper nylon wheel.

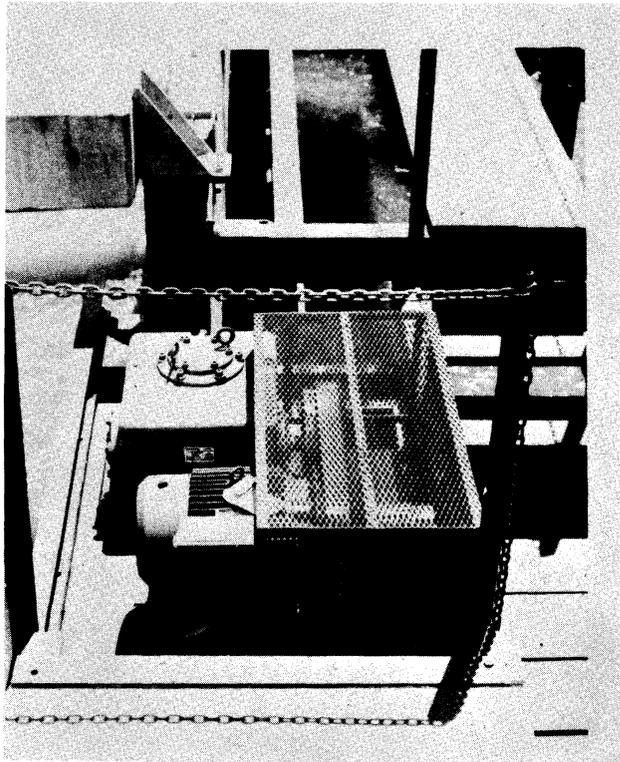
Figure 9.--Screen drive unit.

The drive chain and drive assembly appeared to work satisfactorily with one exception: Because the drive assembly was located at the downstream end of the return leg, the chain would tend to go slack as it left the drive sprocket. This slack chain would sometimes drag on the sprocket teeth.

5. Establish the drive system near or at the upstream turn. Racking of the screen panels may occur with a single drive attachment on larger structures; in this event it may be necessary to place a drive at the bottom as well as at the top.

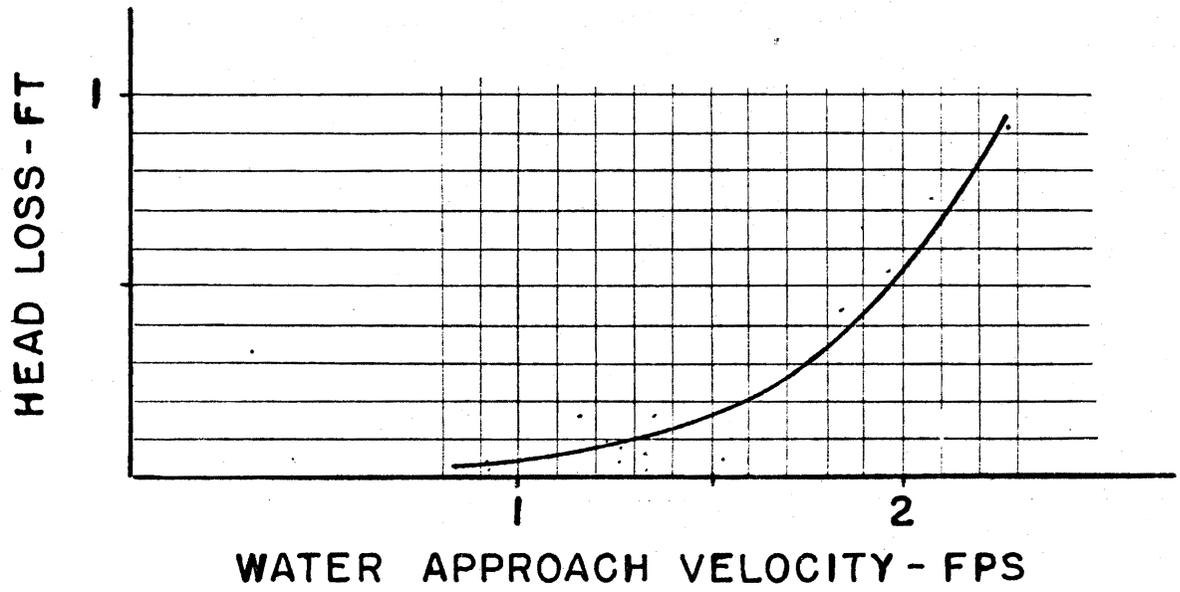
Total head loss (between points 2 and 5) was not significant (less than 0.15 feet) up to about 1.5 fps approach velocity. Above 1.5 fps the total head loss increased rapidly (Figure 11). An example of head loss across the downstream leg appears in Figure 12. Total head loss across the structure was considerable at the higher approach velocities (i.e., 0.55 ft at 2 fps). The majority of this loss occurred across the downstream leg of the facility.

Figure 11.--Relation between approach velocity and total head loss.

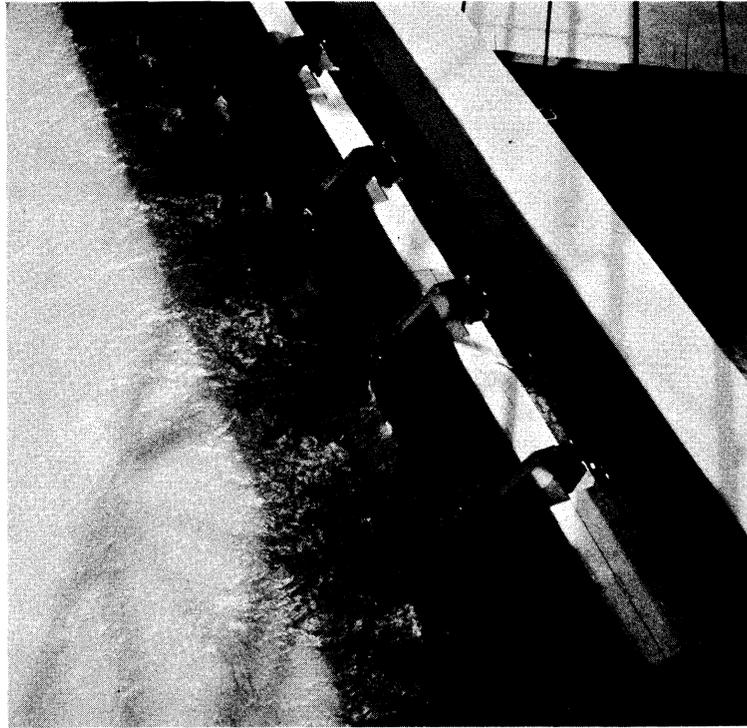
Figure 12.--Head loss at downstream leg of facility. Screen panels closed. (Bureau of Reclamation)

Head loss on the downstream leg can be reduced by hinging the panels on the leading edge and additionally by enlarging the channel on the downstream right bank as shown in Figure 16.

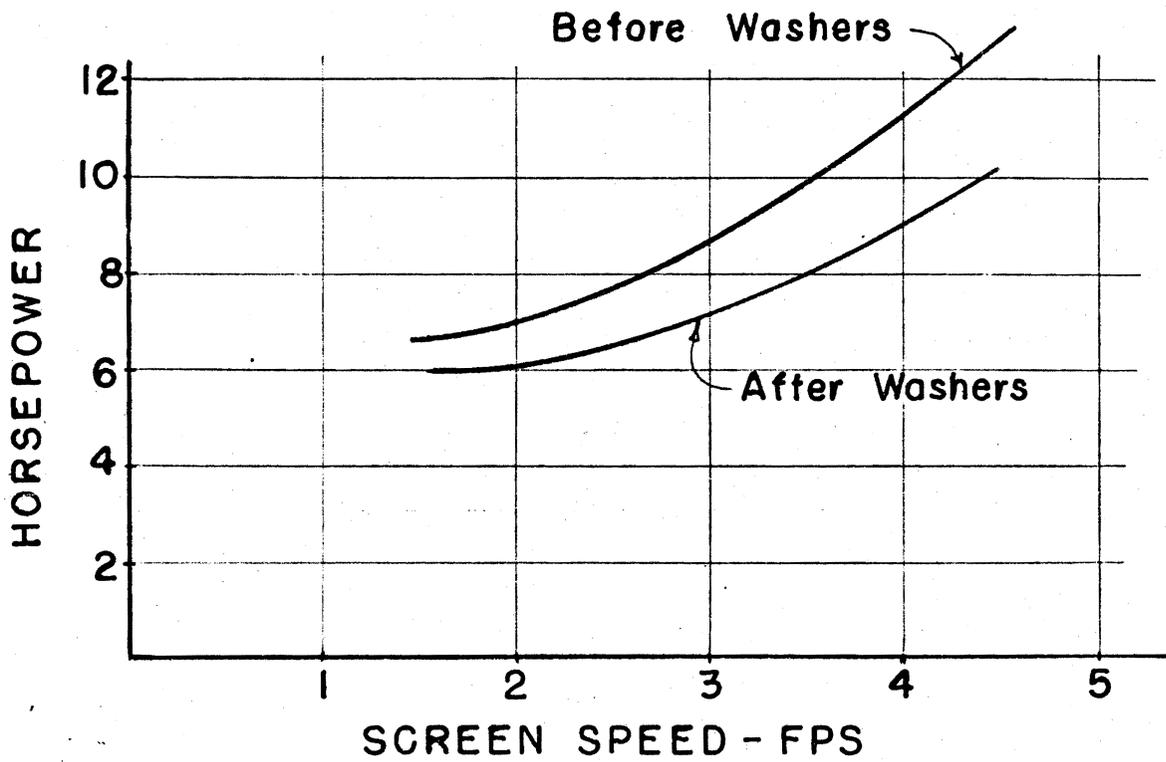
Power requirements were calculated using the theoretical voltage and the measured amperage. Table 2 gives the horsepower required to drive the screen under varying conditions. Design loads were evidently less than the measured loads since the power required was more than the power available for operation at the higher screen speeds with water in the channel. Undoubtedly friction was greater than anticipated, which could account for a good part of the discrepancies between design and measured loads. After washers were installed on the screen panel connections, a significant reduction in power requirements was noted (Table 2 and Figure 14).

Figure 14.--Power required to drive the screen before and after installation of washers at the panel connections.

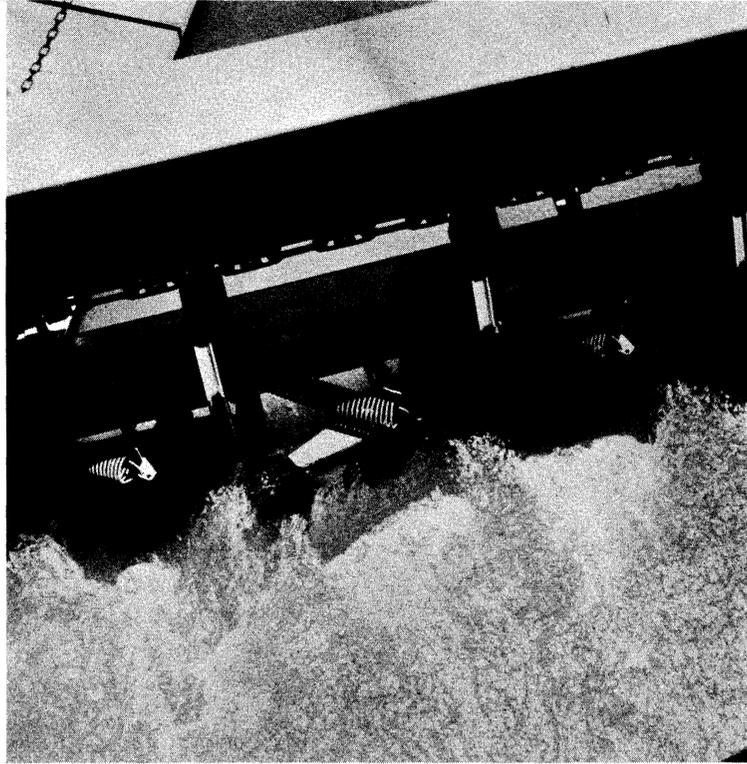
With the screen panels hinged on the trailing edge (Figures 13 and 15), panels opening in the downstream leg pushed water while the screen was moving. Although tension springs were designed to close the screen panels before the panels negotiated the downstream turn, water approach velocities in excess of 2 fps prevented rapid closure of the panels and they subsequently jammed against the adjoining wall.

Figure 15.--Panels open on downstream leg (Bureau of Reclamation).

2. Remove the tension springs on the screen panels for free outward movement on downstream leg. Hinging the panels on the leading edge would eliminate much of the water buildup on the screens as they move across the flume to the downstream turn. Hence, the opening for water passage would be much greater and the head loss across the downstream leg would be appreciably reduced.

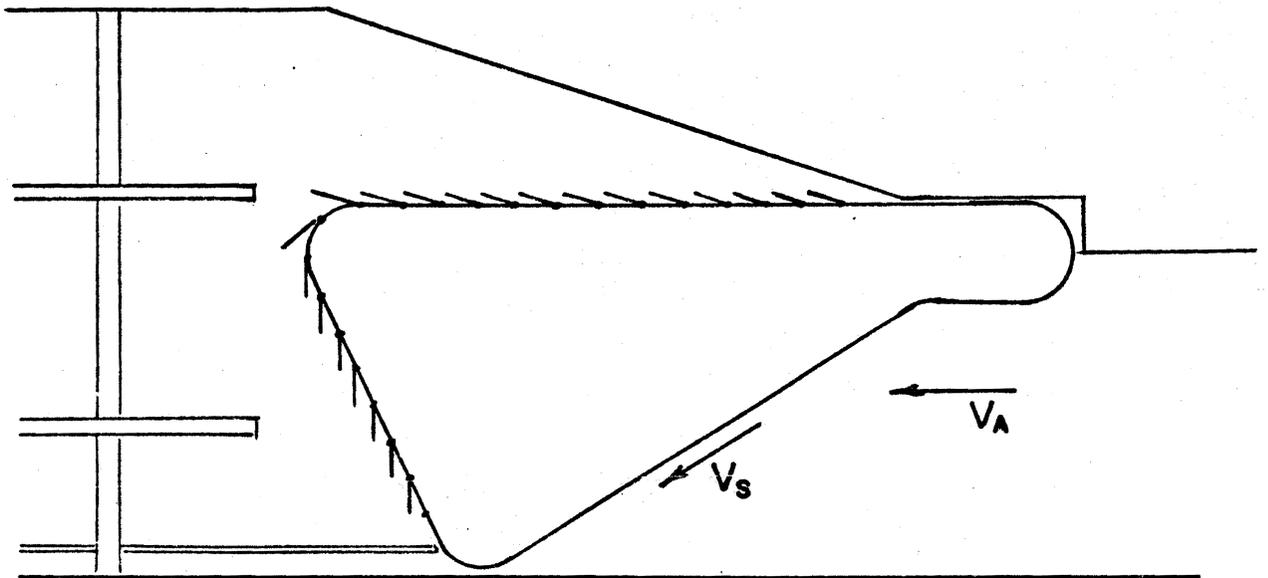
Figure 16.--Suggested installation of traveling screen to increase the water passage area and reduce the head loss.
