Biological Evaluation of the Prototype Gatewell Lift-Tank System at Lower Granite Dam, 1994

December 1994

Annual Report of Research

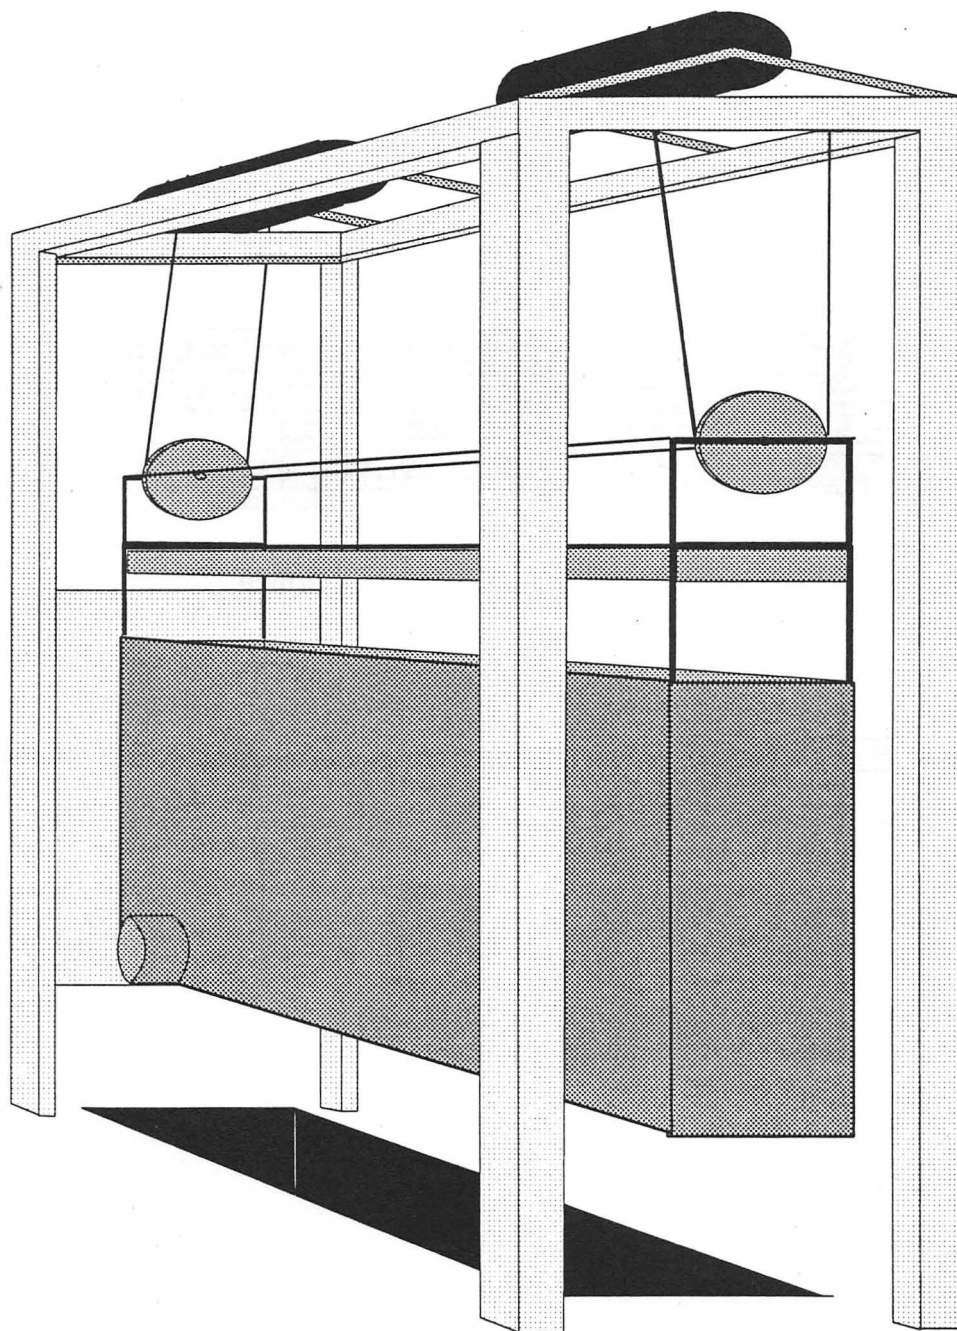
Figure 4.--Lift tank and support structure.

The lift tank consisted of a steel box measuring 7-m long, 1.1-m wide, and 1.8-m deep and held about 11.7 kL of water (Fig. 4). The floor (gate) of the tank was hinged. The gate was opened when the tank was lowered into the gatewell so that fish could swim into the tank. To remove fish from the gatewell, the gate was closed, and the tank was then lifted with fish and water to the bypass orifice. The inner surface of the tank floor was designed to drain water from each end of the tank to the orifice connection (Fig. 5). The support structure for the lift tank was bolted and grouted to the intake deck. The lift tank was designed to be fully automated and during a drawdown scenario would operate 24 h/day with each cycle taking about 1 h.

The lift tank was equipped with a debris screen system to remove large debris from the gatewell when the lift tank was raised. It was mounted inside of the tank and consisted of an array of parallel cables spaced at 15.2 cm intervals, each enclosed in a vertical tube on the downstream side of the tank. The cables were attached to a square steel beam positioned length-wise at the top of the tank. Prior to raising the lift

tank from the fishing position, the steel beam was pulled across the top of the tank by a chain and sprocket system powered by a pneumatic motor. The pneumatic motor failed to operate throughout the evaluation. Therefore, the debris screen system was not tested.

- a. The debris screen was not working at the time of the test. Considering the potential amount and size of debris encountered at Lower Granite Dam, debris separation/removal systems should be tested before implementation of the lift-tank system.
- b. The inner walls of the lift tank were cluttered with debris-screen system hardware. Many sharp edges inside the tank including conduit clips and nuts and bolts may cause descaling when fish are in high numbers. The majority of sharp edges would be eliminated with modifications to the current debris-screen system. The system should be completely covered, mounted on the

outside of the tank, or replaced with a bar grating to handle debris and adult fish.

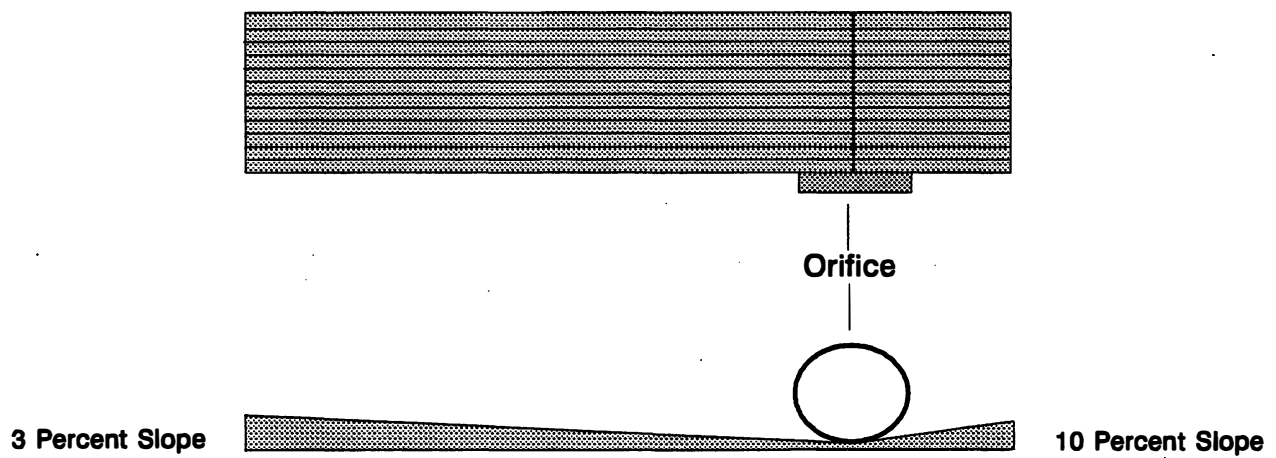
Figure 5.--Plan and side views of lift-tank floor (gate) showing slope to the orifice.

The moderate slope of the floor in the lift tank failed to drain water efficiently. The majority of water did not drain from the lift tank until approximately 3.5 minutes after the orifice slide gate was opened. Review of video tapes indicated that most fish did not begin exiting the lift tank until the water level had decreased to the top of the orifice. At that time, the low water elevation in the lift tank produced a slower flow of water. As a result, fish resisted exiting and remained in the lift tank. About 5 to 10 fish remained in the tank after water had been completely removed, 5 to 5.5 minutes after the orifice slide gate had opened. These last fish either had to be removed by hand or forced to exit with use of additional water from a hose. However, the added water was not effective, and

- d. The floor (inner surface of the bottom gate) of the lift tank did not have an appropriate slope to drain water efficiently from the tank. Therefore, most fish remained in the tank until nearly all water has drained. We recommend increasing the slope on the floor to drain water faster, promote a more efficient fish exit, and eliminate the need for flush water.
