**Development and Evaluation of a Lamprey Passage Structure in the Bradford
Island Auxiliary Water Supply Channel, Bonneville Dam, 2004**

Report of research to

Portland District
U.S. Army Corps of Engineers
P.O. Box 2946
Portland OR 97020
Contract E96950021

September 2006

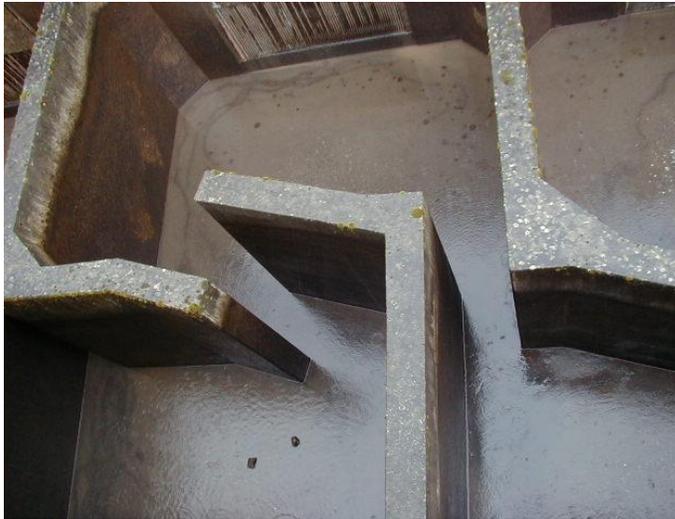
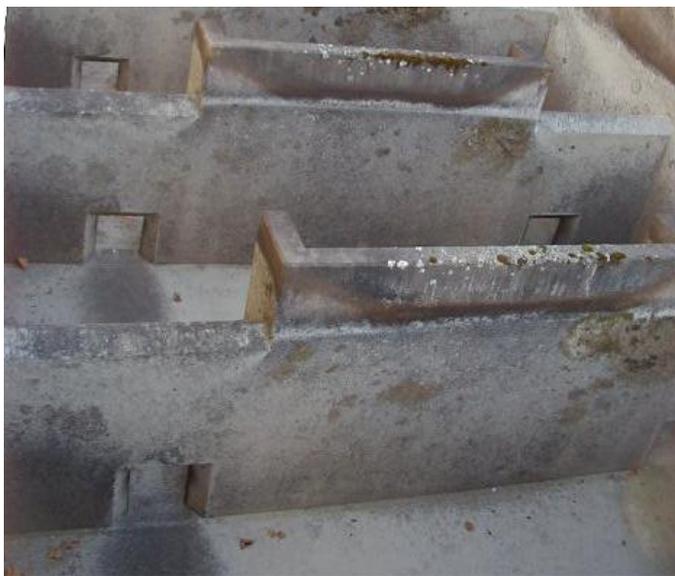
Figure 2. De-watered views of serpentine weirs (upper photo) and overflow weirs (lower photo) used in fishways at lower Columbia River dams.

Construction differs between Bonneville and The Dalles Dams in the flow-control section at the top of the fishways. At Bonneville Dam, this part of the fishway has serpentine weirs (Figure 2, top), whereas at The Dalles Dam there are overflow weirs at the top of fishways. At the top of Bonneville Dam fishways, adult Pacific lamprey are routinely delayed and/or obstructed by the serpentine weirs located immediately upstream from the count stations at both the Bradford Island and Washington-shore fishways (Moser et al. 2002c, 2003b, 2005a). In contrast, at the Dalles Dam from 1997 to 2002, 99% of radio-tagged lamprey that approached the top of fishways passed successfully over the dam (Moser et al. 2005a).

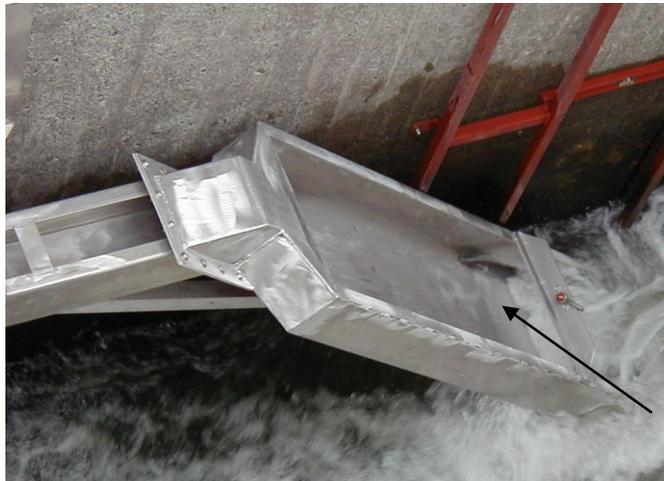
Figure 4. Photo of the Bradford Island LPS collector. Arrow points to a lamprey that is moving up the ramp near the water surface.

The 0.5-m wide collector ramp was made of schedule-40 aluminum and extended from the bottom of the AWS channel to the level of the first rest box (3.3-m elevation, Figure 4). Lamprey could enter the collector ramp at any depth in the water column. A heavy rubber flange was used to create a seal against the wall and floor of the AWS channel and to help guide lamprey onto the ramp (see Moser et al. 2005a).

A series of four half-duplex PIT readers was integrated into the LPS design (Figure 4). A rectangular schedule-40 PVC sleeve was seamlessly inserted into the chutes leading to each rest box and to the exit slide (Figure 7). This was necessary because the aluminum chute itself would attenuate the PIT signal. Each reader was comprised of the following elements: a loop antenna of 10-G, multistrand wire wrapped around the PVC sleeve; an outer aluminum housing that acted as a Faraday cage to shield the antenna; a detector that interrogated the antenna; and a palmtop computer that logged the time and date of each detection to a 256-mB memory card. We synchronized the detectors by wiring them together.

Most PIT-tagged lamprey were released directly into the LPS by carefully lowering them onto the steep ramp, so that they could slide into Rest Box 1 (Figure 4). To avoid crowding in the rest box on a given day, half of the lamprey were released in the morning (0800-1200) and half were released in the evening (1800-2300).

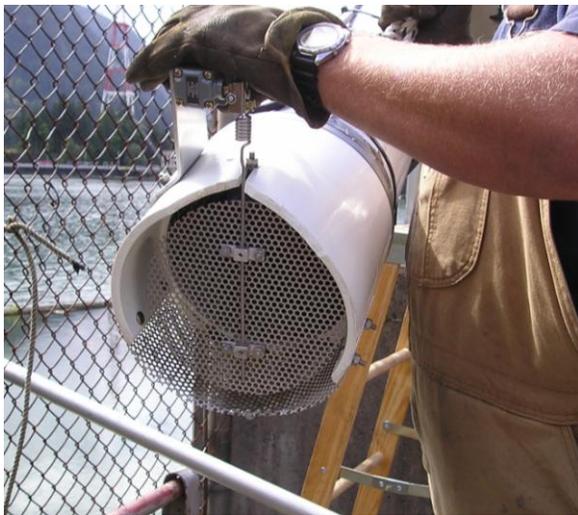
Figure 10. Lamprey activated switch at the terminus of the LPS exit slide.

The first iterations of the lamprey activated switches were installed in the upwelling box located at the top of the exit slide. As the lamprey entered the box, they passed through a plastic mesh funnel that forced them to move through a narrow opening (approximately 5 cm). We tested a variety of limit switch sensitivities and positions near this constriction point. Next, we tested an infrared detector installed in the same location. The lamprey's body interrupted an infrared beam and thereby triggered the switch.

paddle, and the switch was activated. The switch was connected to a digital event recorder that recorded the number of lamprey passing the switch.

In each case, these devices were wired to an event recorder so that the number of lamprey that activated the switch could be recorded. Ultimately, we attached the limit switch to a large paddle, which was fitted into the slide near its terminus (Figure 10). As the lamprey fell through the slide, they contacted the

On 25 August we installed two completely new counters: an infrared beam counter in the upwelling box, and a mechanical limit switch at the distal end of the exit slide. Testing from 26 August to 14 September revealed that the beam counter always over-represented the number of lamprey passing. In contrast, the mechanical counter (Figure 10) produced accurate counts of lamprey falling through the exit slide.

Our development of a lamprey-activated counter for the LPS indicated that the simplest design worked best. A mechanical lamprey-activated limit switch in the LPS upwelling box was not successful because the lamprey were able to either pass under the switch without being detected, or were detected multiple times when the switch sensitivity was increased. Similarly, use of an infrared beam to detect lamprey passage was plagued by multiple counts of the same individual. A mechanical limit switch positioned in the LPS exit slide produced reliable counts of lamprey exiting the LPS.

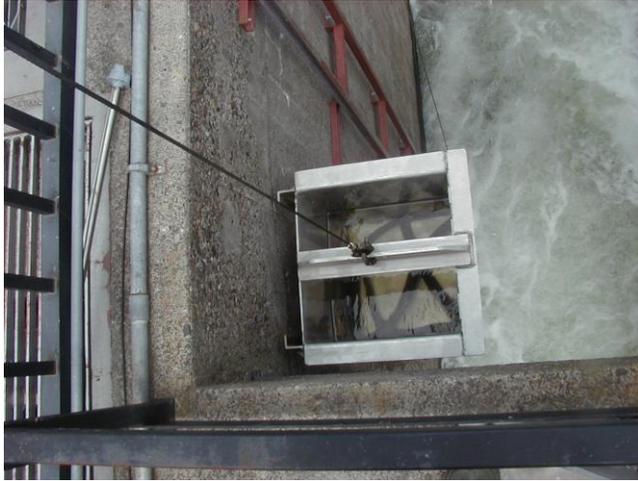
Figure 11. PIT-tagged lamprey being lowered into the Bradford Island AWS.

Some PIT-tagged lamprey were also released directly into the AWS to obtain estimates of LPS efficiency. To help lamprey acclimate upon release, they were lowered into the AWS in an open aluminum release box (Figure 11). Lamprey could voluntarily leave the release box at any time after it was submerged. The LPS efficiency was computed by dividing the number of AWS releases detected in the LPS by the total number of AWS releases.
