**Development of Passage Structures for Adult Pacific Lamprey  
at Bonneville Dam, 2005**

Report of research to

Portland District  
U.S. Army Corps of Engineers  
P.O. Box 2946, Portland OR 97020  
Contract E96950021

September 2008

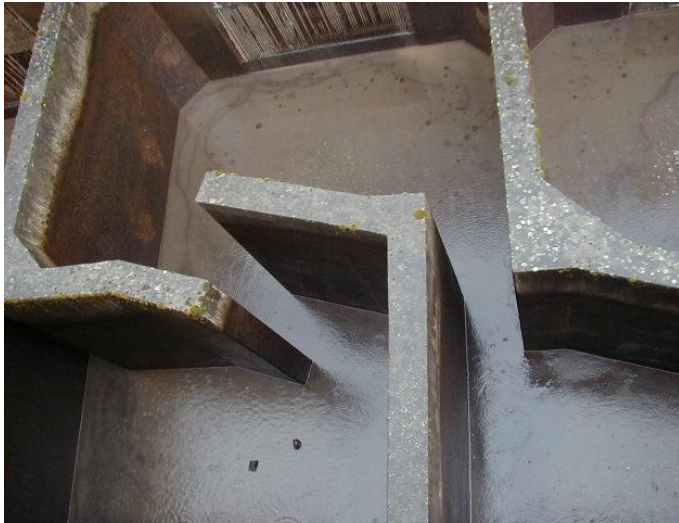
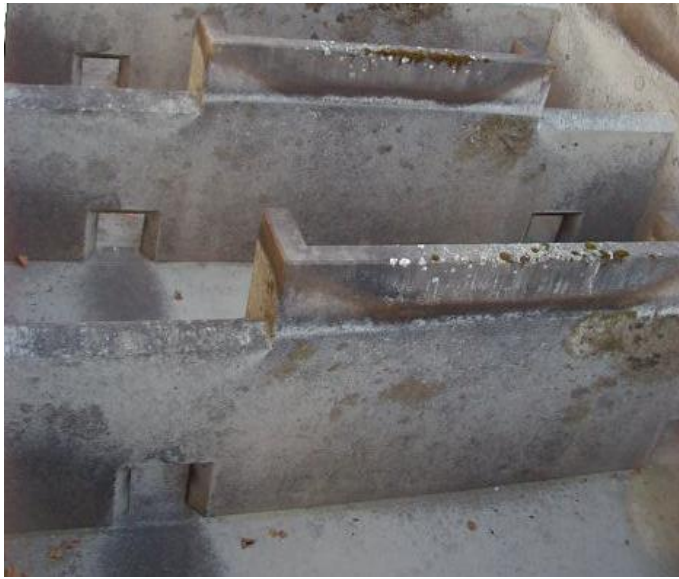
Figure 2. De-watered views of serpentine weirs (upper photo) and overflow weirs (lower photo) used in fishways at lower Columbia River dams.

This difference in passage success may be related to flow-control areas at the top of fishways, which differ between Bonneville and The Dalles Dams. Bonneville has serpentine weirs, while The Dalles Dam has overflow weirs (Figure 2). Adult Pacific lamprey are routinely delayed and/or obstructed by serpentine weirs, which are located immediately upstream from the count stations at both the Bradford Island and Washington-shore fishways (Moser et al. 2002c, 2003, 2005a). Thus, to avoid serpentine weirs at Bonneville Dam, some lamprey move into the adjacent auxiliary water supply channel (AWS) through connecting diffuser gratings or via the picketed lead downstream from the count stations (Figure 3). However, there is no ready access to the forebay of Bonneville Dam from the AWS channel.

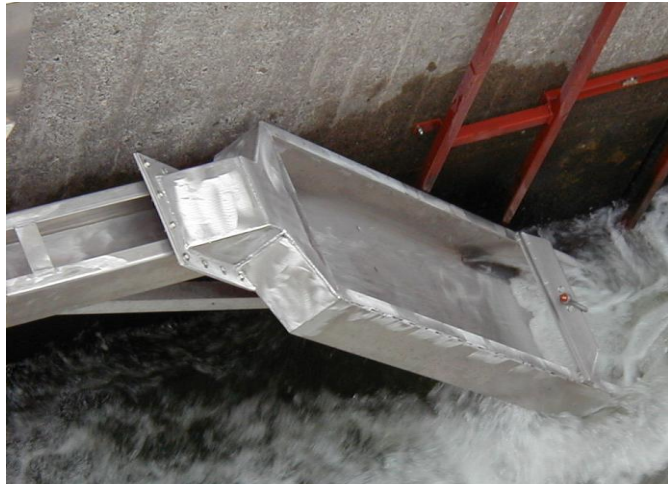
Figure 4. Photo of the Bradford Island LPS collector. Note the lamprey that is moving up the ramp near the water surface.

The LPS collector in the Bradford Island Auxiliary Water Supply (AWS) Channel was positioned on the west wall at the upstream end of the channel (Figure 3). The collector features an open ramp of 0.5-cm-thick sheet aluminum, which extends from the bottom of the channel to the level of the first rest box (3.3-m elevation, Figure 4).

Lamprey may enter the collector ramp at any depth in the water column. The lower 1.3-m section of the ramp was fitted with a heavy rubber flange, which creates a seal against the wall and floor of the channel to help guide lamprey onto the ramp (Moser et al. 2005a). After ascending the 4.4-m-long ramp (at a slope of 1:1), lamprey enter a 1.2-m-long, open, rectangular chute that empties into a rest box (Rest Box 1; Moser et al. 2006). The end of the chute is fitted with a funnel made of 1.2-cm plastic mesh to prevent lamprey from passing back down the ramp after entering the rest box. This "one-way valve" design was incorporated into each LPS rest box.

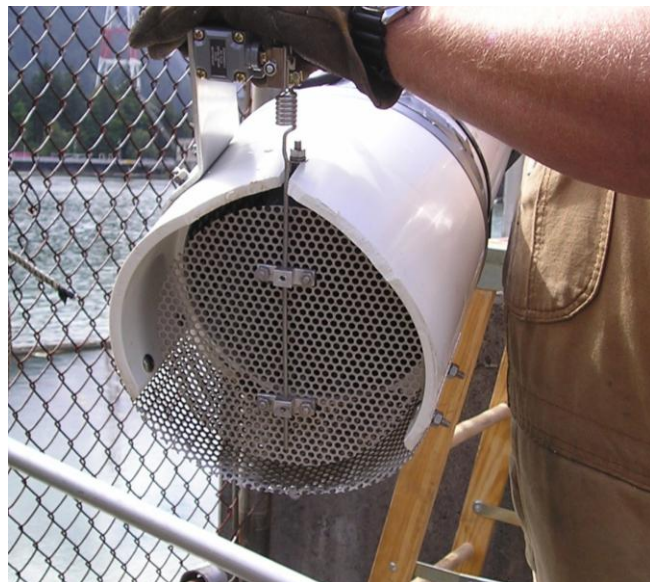
Figure 6. Lamprey activated switch at the terminus of the LPS exit slide.

Lamprey passing down through the exit slide were enumerated when they contacted a large paddle near the exit slide terminus (Figure 6).

A limit switch attached to the paddle was wired to a digital event recorder, which summed the number of lamprey that activated the switch each day. Columbia River water was supplied at the top of the LPS via a 10.2-cm-diameter, flexible corrugated pipe from two, 3-hp submersible pumps. Flow into the trap box was regulated to maintain a depth of 3 cm on the ramps and approximately 10 cm in the closed tubes. Flow regulation was achieved using an upwelling box at the top of the LPS. In this way, lamprey were stimulated to move onto the exit slide, even though water was passing down the slide.

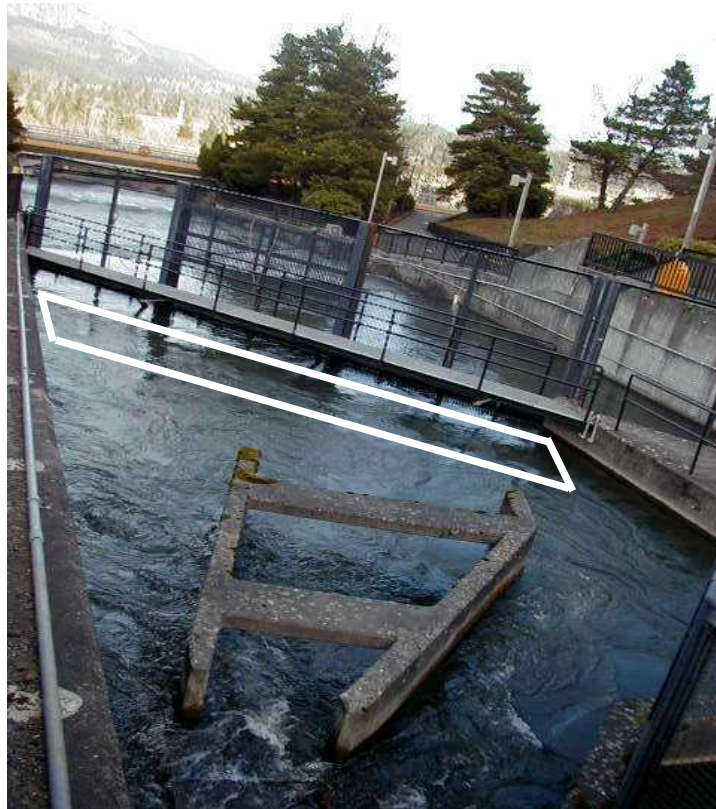
Figure 8. View looking downstream from the Bradford Island AWS. The location of the AWS channel PIT antenna (just upstream from the picketed lead) is denoted in white.

An additional PIT detector was positioned in the AWS channel immediately upstream from the picketed lead (Figure 8), which directs fish to the Bradford Island count window (Figure 3). This detection antenna was comprised of a 10-gauge multistrand wire loop positioned inside a 12.8- by 0.9-m rectangular PVC frame. The frame spanned the entire width of the AWS channel and was supported in position approximately 15 cm from the bottom by clamping it to the hand rail of the existing walkway (Figure 8). The read range of this antenna was very limited (5 cm), so only lamprey that were traveling very close to the bottom or sides of the channel could be detected.

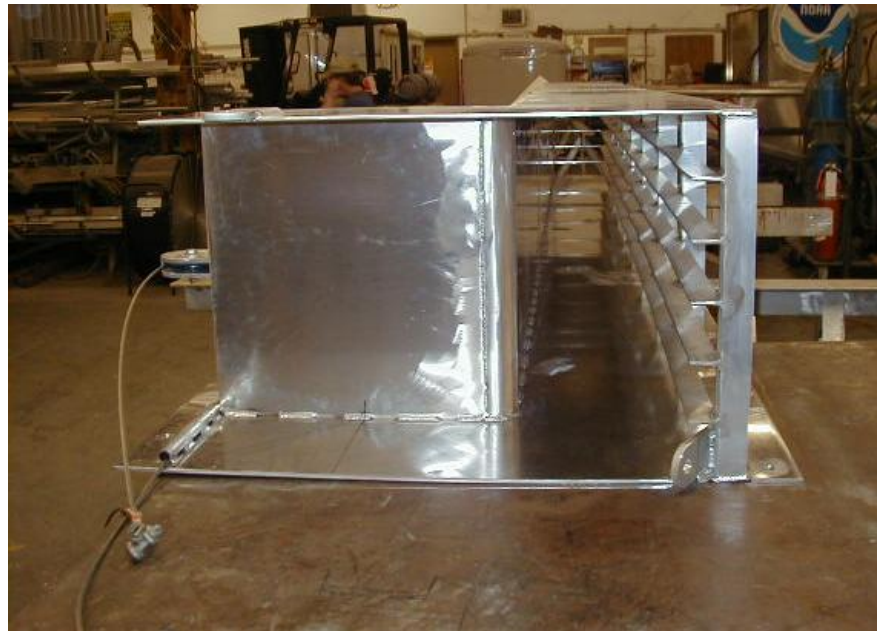
Figure 11. Transition structure (top view) to guide lamprey into the collector and provide a seat for the collector base. The structure was fabricated at the Northwest Fisheries Science Center Pasco Research Station. Bars were attached to prevent sea lions from accessing lamprey as they climb up this submerged structure.

The transition structure was a 5.2-m-long, vertical aluminum chute that terminated in a rounded crest, to aid lamprey movement into the collector (Figure 11). The structure was 0.6 m wide and fitted with a 5-cm bar grate (10 cm on center) to prevent sea lions from accessing lamprey that were climbing up this structure (Figure 11).

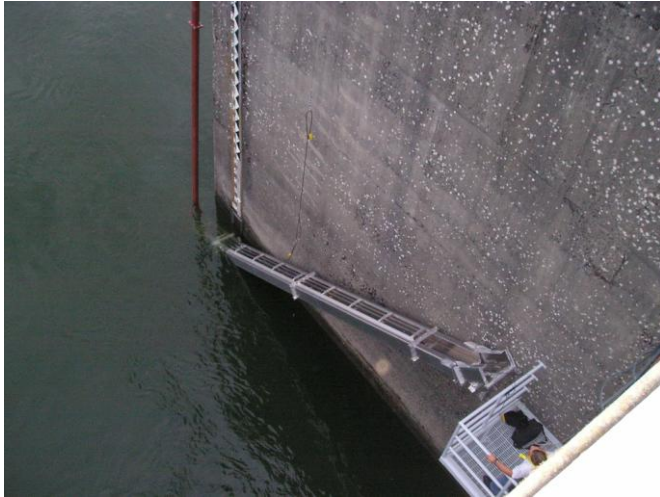
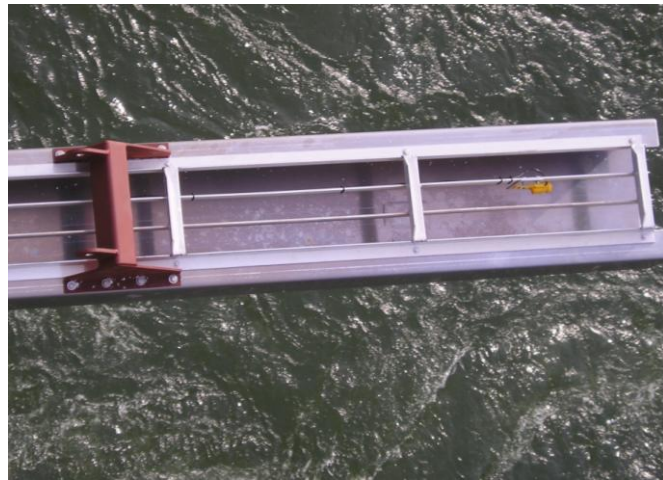
Figure 13. Top: Collector assembly being lowered into place. Note the steel beam attached to the distal end of the collector, which was used to hold the whole assembly in place. Bottom: Collector ramp prior to submersion showing the camera used to position it on the transition structure.

An underwater camera was mounted on the collector ramp to view the seal between the transition structure and the base of the connector (Figure 13). The current velocity emanating from the fishway entrance was then reduced so that the assembly could be lowered into place and seated properly onto the transition structure (Figure 13). The hold-down was then bracketed to the wall and jacked down from the top to create a seal with the transition structure. This installation was completed on the evening of 21 July.

To assess lamprey use of the Washington-shore entrance collector, the trap at the collector terminus was checked daily and lamprey in the trap were enumerated, measured, and released. At approximately weekly intervals, we also viewed the entrance to the collector with the underwater camera mounted at its distal end (Figure 13).

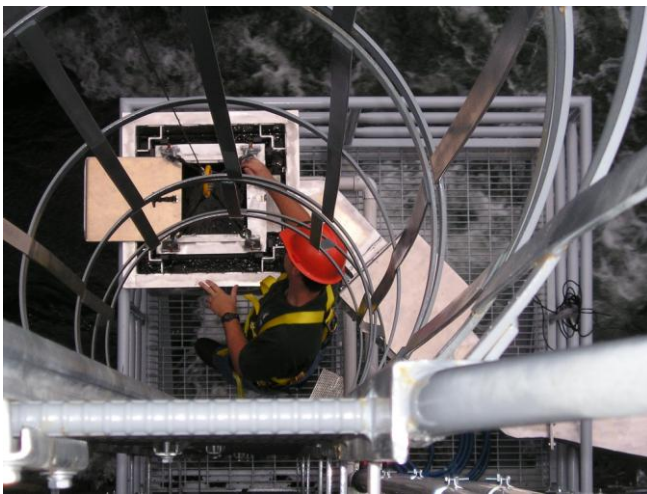
Figure 15. Top view of the trap box at the terminus of the entrance collector.

The collector ramp was constructed of 0.5-cm aluminum plate and was 51 cm wide by 12.6 m long (Figure 14). It extended upward through the water column at an angle of 45°. To prevent sea lions from accessing lamprey that were climbing the ramp, a 5-cm bar grate (10 cm on center) was installed over the ramp (Figure 13). The collector ramp terminated in a 15.2- by 20.3-cm closed tube, which passed through a PIT antenna (same construction as in the AWS LPS). The PIT antenna was connected to a detector on the deck. Lamprey passed from the tube through a plastic mesh funnel and dropped into a 0.6- by 0.6- by 0.9-m trap box (Figure 14). The trap box was accessed by a caged ladder and could be hoisted to retrieve lampreys using an electric winch and boom (Figure 15).

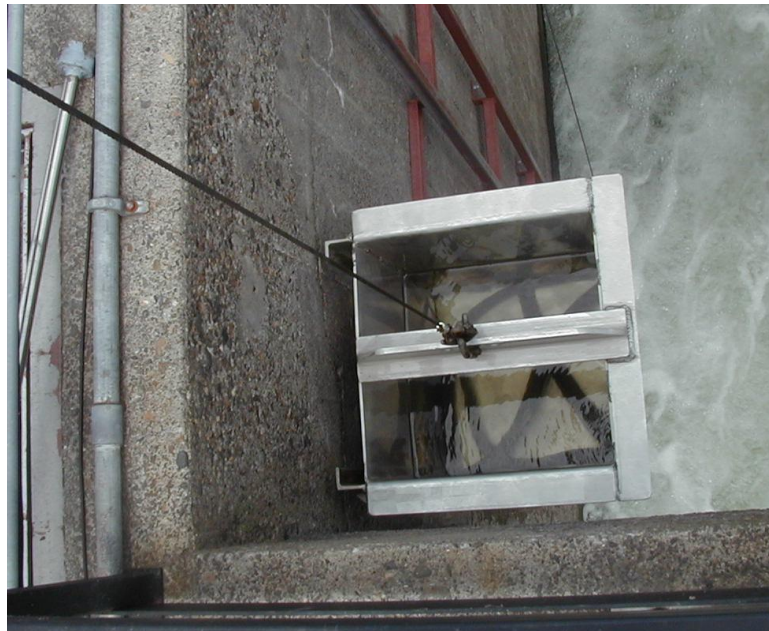
Figure 16. PIT-tagged lamprey being lowered into the Bradford Island AWS.

Most PIT-tagged lamprey were released directly into the AWS channel to obtain estimates of LPS efficiency. To help lamprey acclimate upon release, they were lowered into the AWS channel in an open aluminum release box (Figure 16). Lamprey could volitionally leave the release box at any time after it was submerged. The LPS efficiency was computed by dividing the number of AWS releases that were detected in the LPS by the total number of AWS releases. However, the study area was not closed. That is, lamprey could leave the AWS before they had investigated the LPS, resulting in a potential underestimate of LPS efficiency.

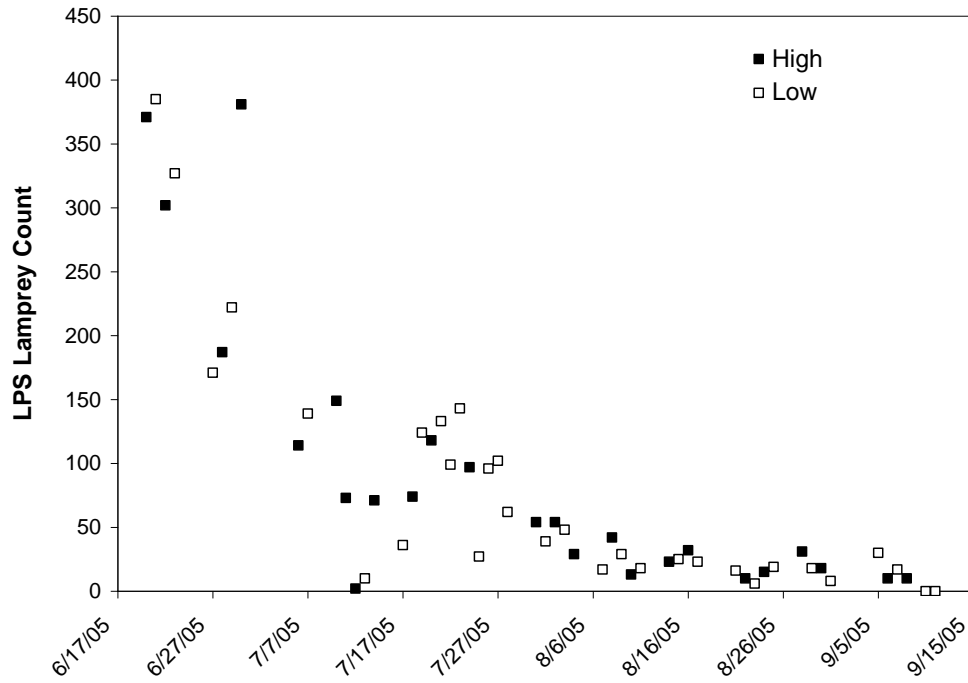
Figure 18. Number of lamprey counted exiting the LPS during low-flow (open squares) and high-flow (closed squares) treatments.

During the flow experiments (21 June-12 September), we compared LPS counts of lamprey during each treatment (Figure 18). There were 3,791 lamprey counted during the days with consecutive, alternating treatments: 1,958 (52%) during the high flow treatment and 1,833 (48%) during the low flow treatment. A paired  $t$ -test revealed no significant difference ( $P = 0.5$ ) in the number of lamprey counted during each treatment.
