## **Development of Passage Structures for Adult Pacific Lamprey at Bonneville Dam, 2006**

Report of research by

Portland District  
U.S. Army Corps of Engineers  
P.O. Box 2946, Portland OR 97020  
Contract E96950021

June 2009

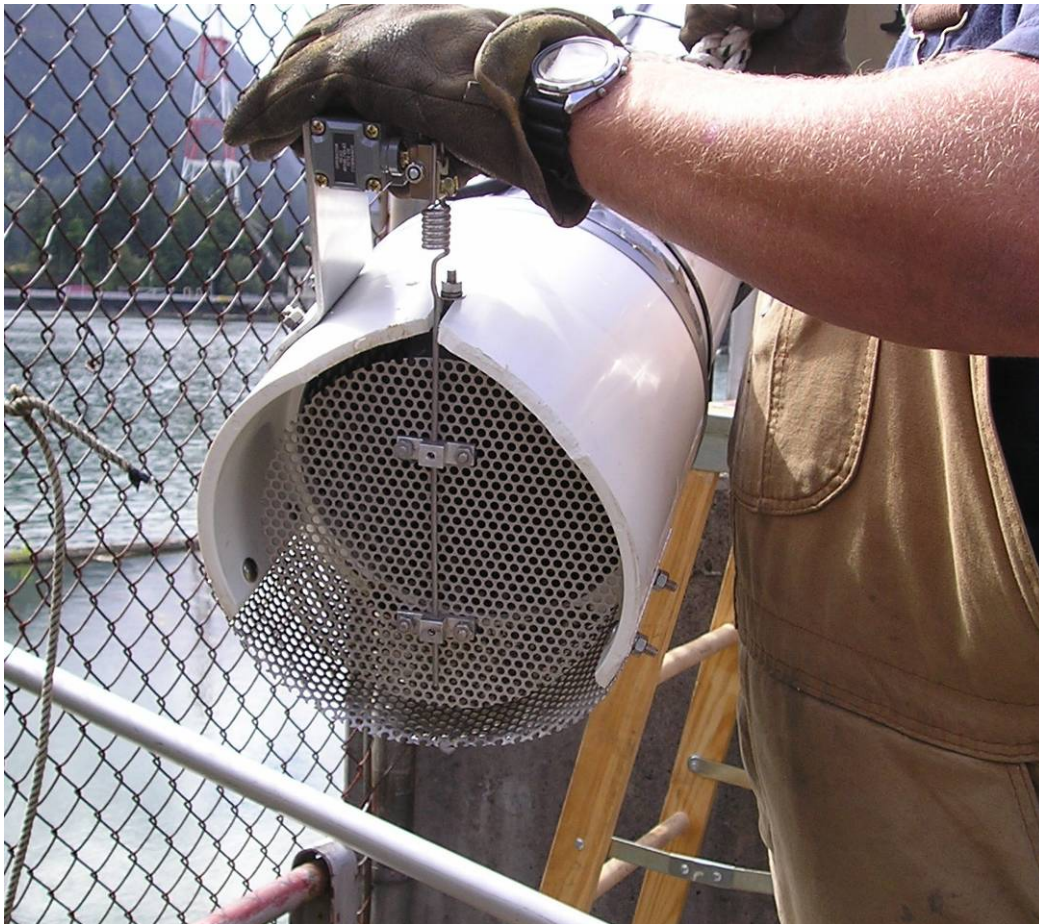
Figure 6. Lamprey-activated switch at the terminus of the LPS exit slide.

The exit slide dropped lamprey into the forebay of Powerhouse 1 at a location approximately 10 m upstream from the exit of the Bradford Island fishway (Figure 1). Lamprey passing down through the exit slide were enumerated when they contacted a large paddle near the exit slide terminus (Figure 6). A limit switch attached to the paddle was wired to a palmtop computer, which assigned date and time to each passage record.

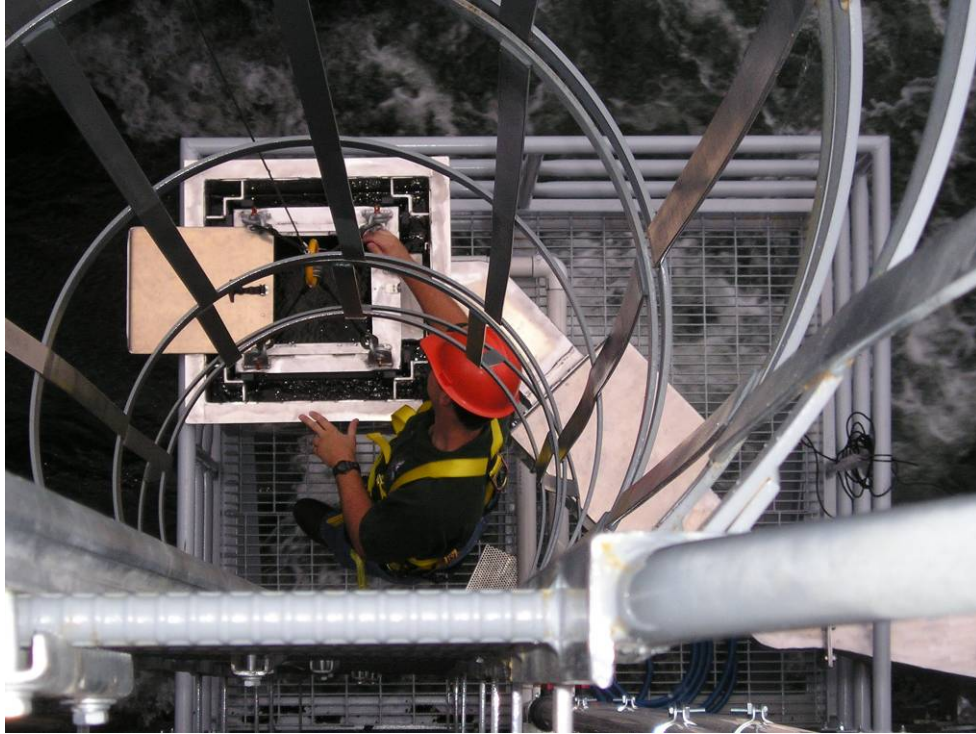
Figure 13. Top view of the trap box at the terminus of the entrance collector.

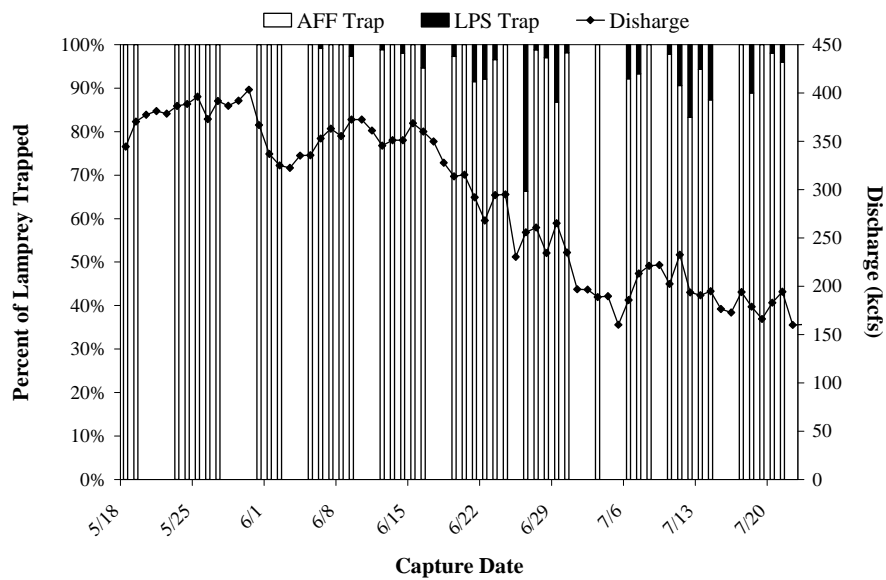
Figure 16. Percentage of lamprey trapped in the Washington-Shore fishway as a function of trap location (open bars = Adult Fish Facility, dark bars = entrance collector/LPS trap, diamonds = river discharge).

The percentage of lamprey caught in the entrance collector trap increased as river discharge (measured at the Bonneville Dam forebay) decreased (Figure 16). While it appeared that these variables were negatively correlated, the relationship between them was weak ( $r = -0.18$ ). The highest catch occurred on the night of 26 June, when 30 lamprey were collected (Figure 16).

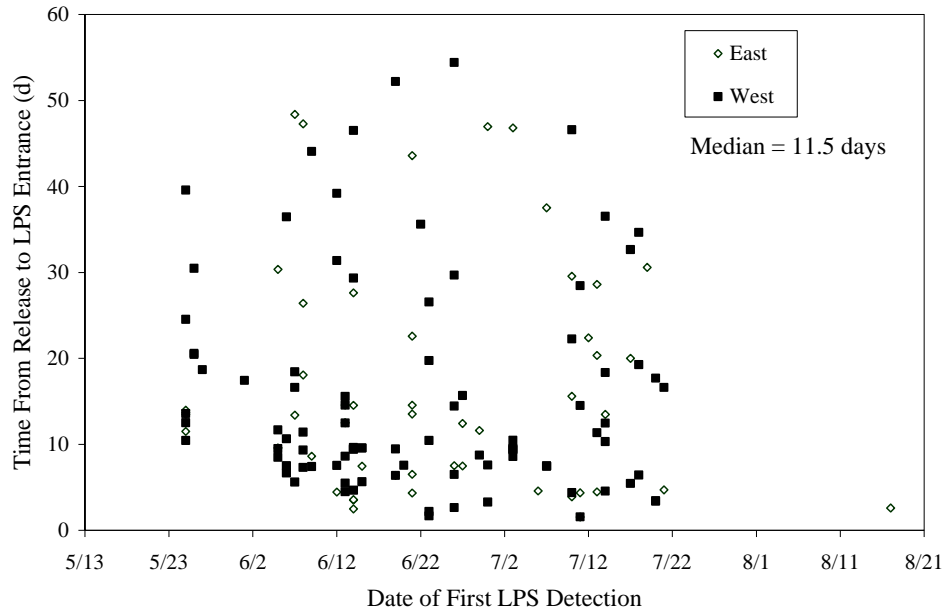
Figure 17. Time from lamprey release downstream from Bonneville Dam to first detection in the AWS LPS as a function of time of year. First detections that occurred on the east ramp are shown with open diamonds and those on the west ramp are closed squares.

The time from release to first detection in the AWS LPS was extremely variable for tagged lamprey (range 1.5–54.4 d), and there was no indication that time of year affected this metric (Figure 17). Of the 136 fish detected at the upstream end of the AWS LPS collector ramps, 65% were first detected on the west collector ramp. Moreover, the tagged lamprey took slightly less time to find the west ramp (median 10.5 d) than they did to find the east ramp (median 13.5 d; Figure 17). Only two fish were detected at the

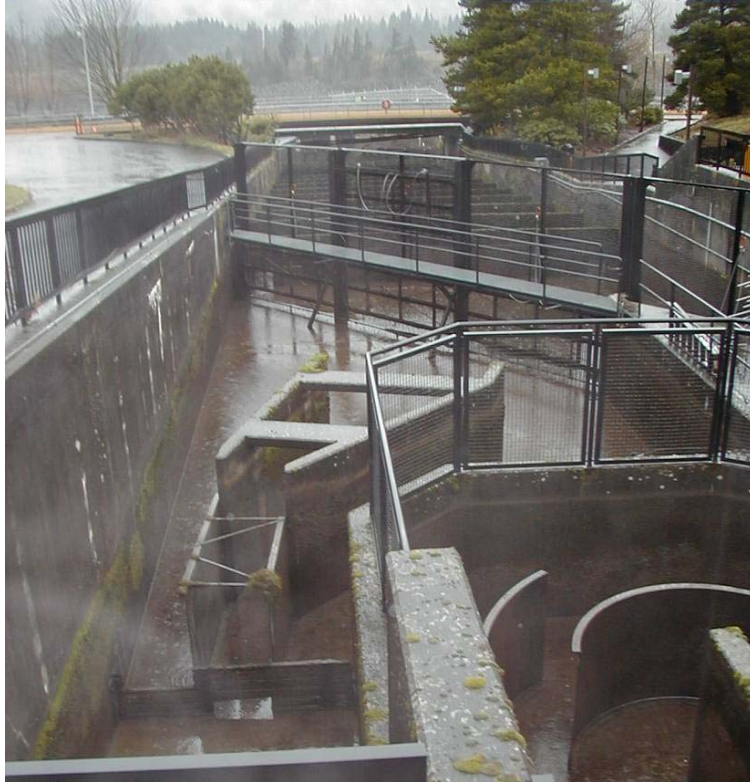
Figure 19. View looking downstream to the picket lead at the dewatered Bradford Island Auxiliary Water Supply channel. The west wall of the channel is located on the left in this photo.

The large improvement in collection efficiency observed in 2006 was probably due to the addition of a second collection ramp. PIT-tagged lamprey were detected at both collector ramps, but more fish used the west ramp than the east ramp, and they generally took less time to find the west ramp. Preference for the west ramp may be due to AWS channel configuration downstream from the LPS (Figure 19). If lamprey contact and pass through the picket lead on the west wall of the AWS channel, they can move along the wall all the way up to the LPS collector. On the east side, fish have to negotiate a more circuitous route to find the collector on the east wall. In addition, an obsolete underwater wooden weir in the AWS channel just upstream from the picket lead may direct fish towards the west side of the channel (Figure 19).
