# Development of Passage Structures for Adult Pacific Lamprey at Bonneville and John Day Dams, 2013

Report of research by

Northwest Fisheries Science Center, National Marine Fisheries Service  
National Oceanic and Atmospheric Administration  
2725 Montlake Boulevard East, Seattle, WA 98112

Portland District  
U.S. Army Corps of Engineers  
P.O. Box 2946, Portland OR 97020  
Contract E96950021

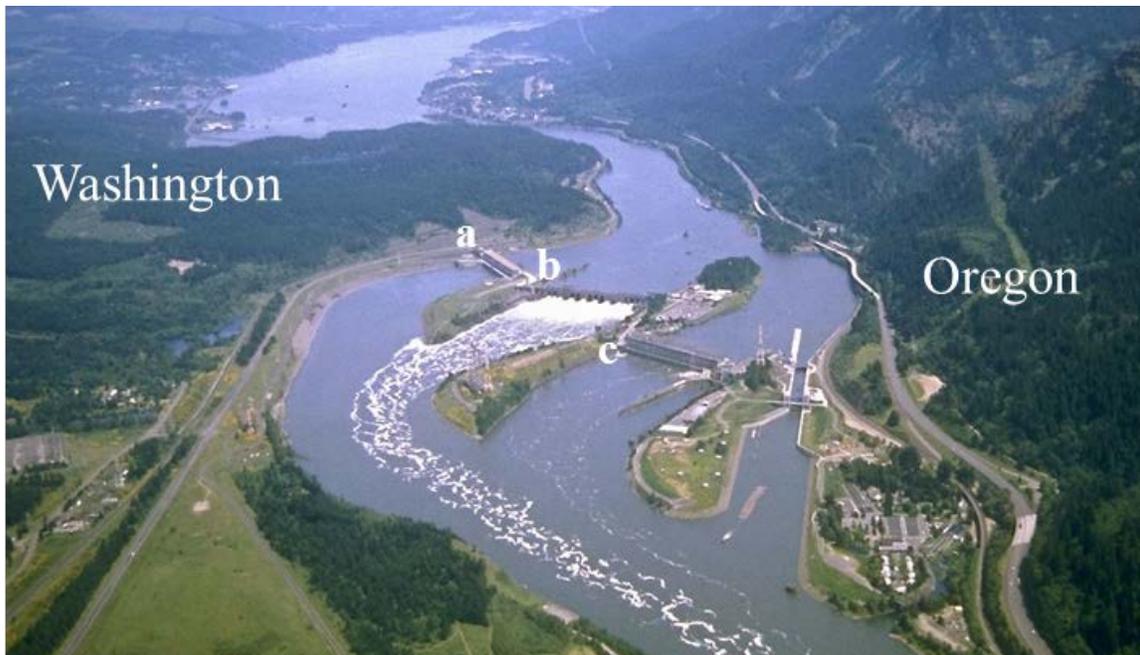
Figure 1. Aerial photo showing configuration of Bonneville Dam with approximate locations of the fishways at (a) Washington Shore, (b) Cascade Island, and (c) Bradford Island.

LPS development was initiated at Bonneville Dam, the first mainstem dam lamprey encounter when migrating up the Columbia River (rkm 235; Figure 1). Here adult lamprey have difficulty entering fishways, and those that successfully enter are often obstructed or delayed near the top (Moser et al. 2002b; Johnson et al. 2009a, 2009b; Keefer et al. 2013). In these areas, serpentine weirs present an obstacle to upstream movement. Consequently, lamprey routinely aggregate in auxiliary water supply (AWS) channels, which are adjacent to the tops of these fishways (Moser et al. 2005).

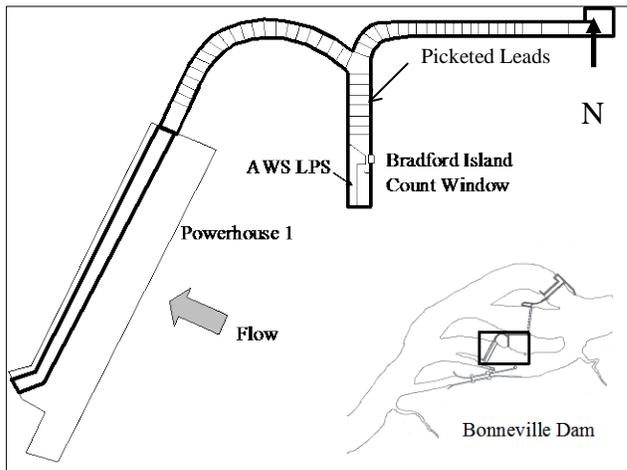
Figure 2. Schematic drawing of the Bradford Island fishway system at Bonneville Dam with locations of the auxiliary water supply LPS (AWS LPS) and count window.

The first LPS was installed in 2004 at the AWS channel near the top of the Bradford Island fishway (Figure 2). Lamprey entered the structure via one of two collector ramps and then passed through a series of wetted aluminum ramps, rest boxes and horizontal flumes that led upward and to an exit slide at elevation 7.9 m. The overall horizontal distance was 35.6 m (Figure 3). Lamprey exited from the LPS into the forebay of Powerhouse 1 immediately upstream from the Bradford Island fishway exit (Figure 2).

The greatest limitation to lamprey use of the AWS structures was relatively poor collection efficiency (Moser et al. 2011). Lamprey collection at the LPSs was limited both by lamprey access to and retention in the AWS channel. To address this, some operational and structural modifications were implemented in 2011 and 2012. Lamprey access to the AWS channels was increased by slightly raising picketed leads at the AWS channel entrances (Figures 2 and 4).

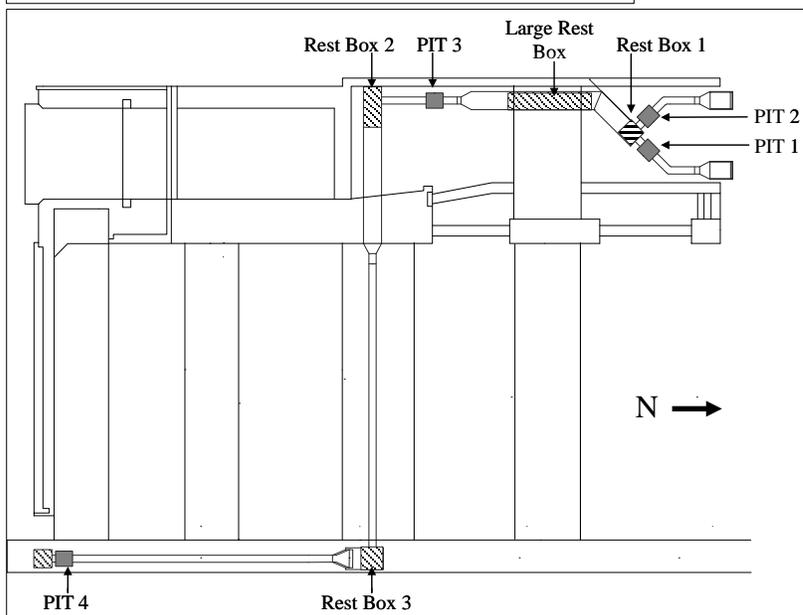
Figure 3. Top view of the Bradford Island LPS with locations of half-duplex PIT-tag detection antennas (PIT 1-4) and rest boxes indicated.

To monitor passage of PIT-tagged lamprey, the LPS was constructed with a series of four half-duplex PIT-tag detection antennas (Figure 3). Antennas were integrated into the LPS using a rectangular PVC sleeve, which was inserted seamlessly into the chutes leading to Rest Boxes 1, 2, and 4. The PVC prevented the aluminum from attenuating the PIT signal. Each reader was comprised of a loop antenna of 10-G multistrand wire wrapped around the PVC insert, and each insert had an outer aluminum housing to shield the antenna. Each antenna was connected to a transceiver, which synchronized multiple antennas and recorded and transmitted the time and date of each detection.

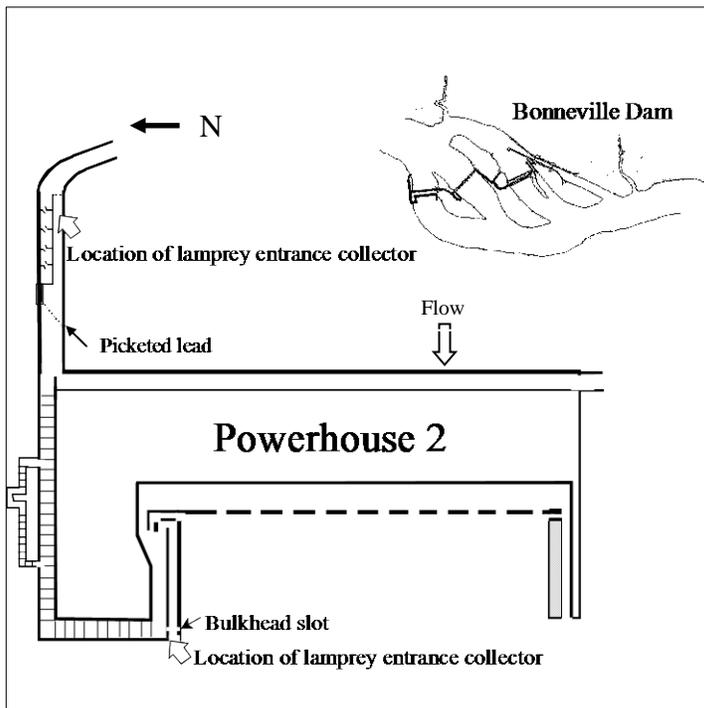
Figure 4. Locations of lamprey structures at the Washington Shore fishway.

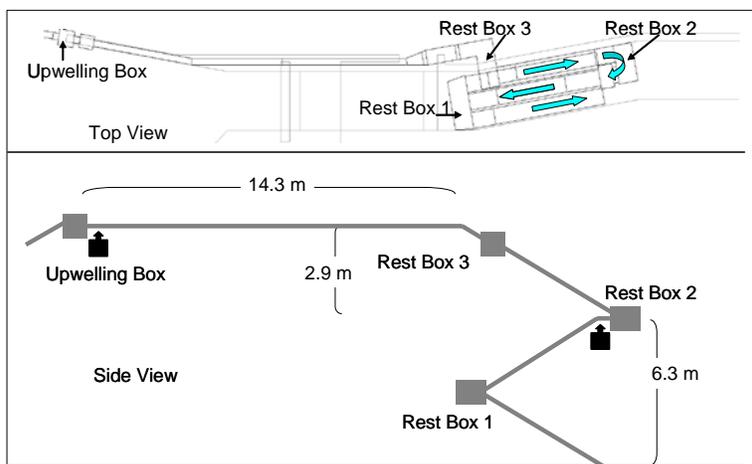
Figure 5. Top and side views of the Washington Shore AWS LPS. Shaded arrows in top view indicate the direction of water flow on the switchback ramps. Black boxes in side view indicate the position of half-duplex PIT antennas.

However, due to the width of the ramps, fykes for this structure were wider than those at the Bradford Island LPS. Ramp grades in the Washington Shore and Bradford Island AWS LPSs were similar ( $45^\circ$ ), as were the water supply systems and lamprey counters at the exit slide. The Washington Shore LPS featured a “switchback” design (Figure 5), and broad crests at the top of each ramp to facilitate lamprey progress. The overall length of the Washington Shore AWS LPS was approximately 19 m, with an elevation gain of 9.1 m (Figure 5).

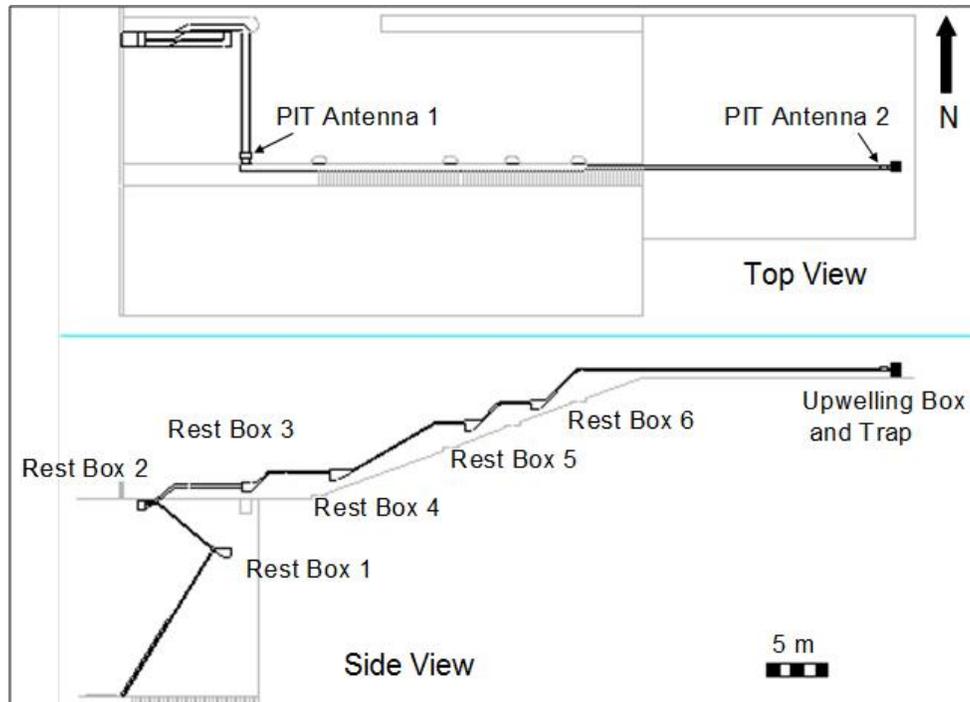
Figure 6. Top (upper panel) and side views of new Cascades Island LPS collector. Locations of PIT monitors are shown in top view and rest boxes are shown in the side view.

Due to low sample sizes of PIT-only tagged lamprey, we released some PIT-only lamprey directly into Rest Box 3 (Figure 6) of the LPS in 2013 to further evaluate the structural and operational changes to this structure. In addition, 25 double-tagged lamprey (radio and PIT) were released into Rest Box 3 and at the tip of Bradford Island (Figure 7) to assess relative rates of fallback.

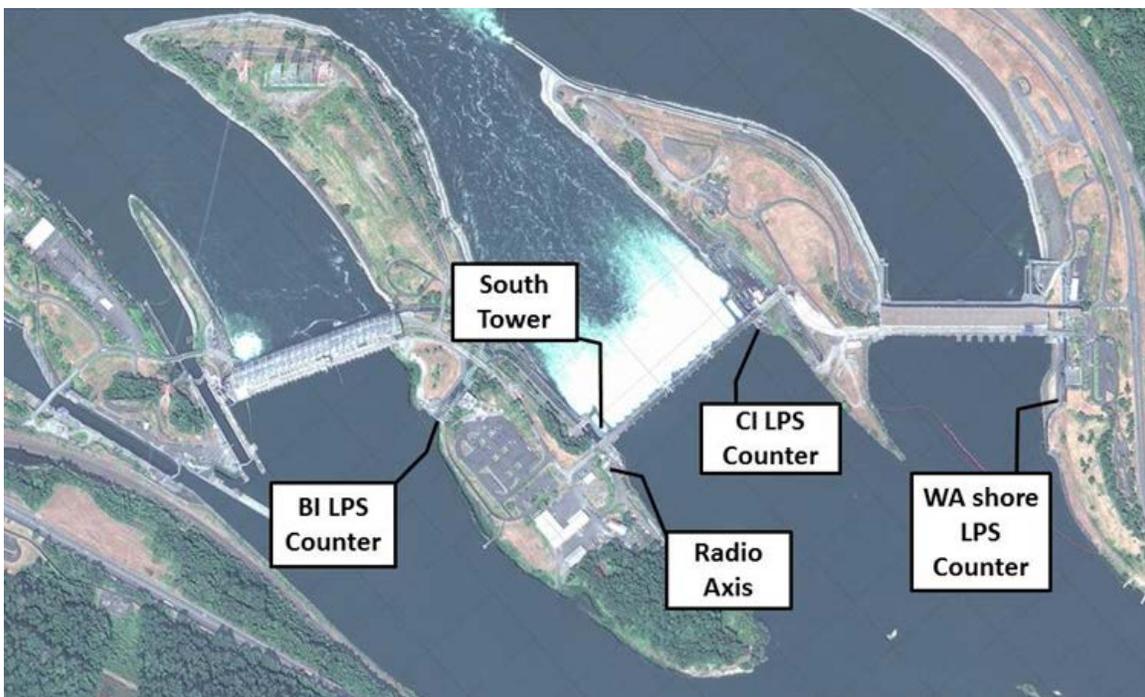
Figure 7. Aerial photo of Bonneville Dam with the locations of LPS lamprey counters and the radio uplink indicated.

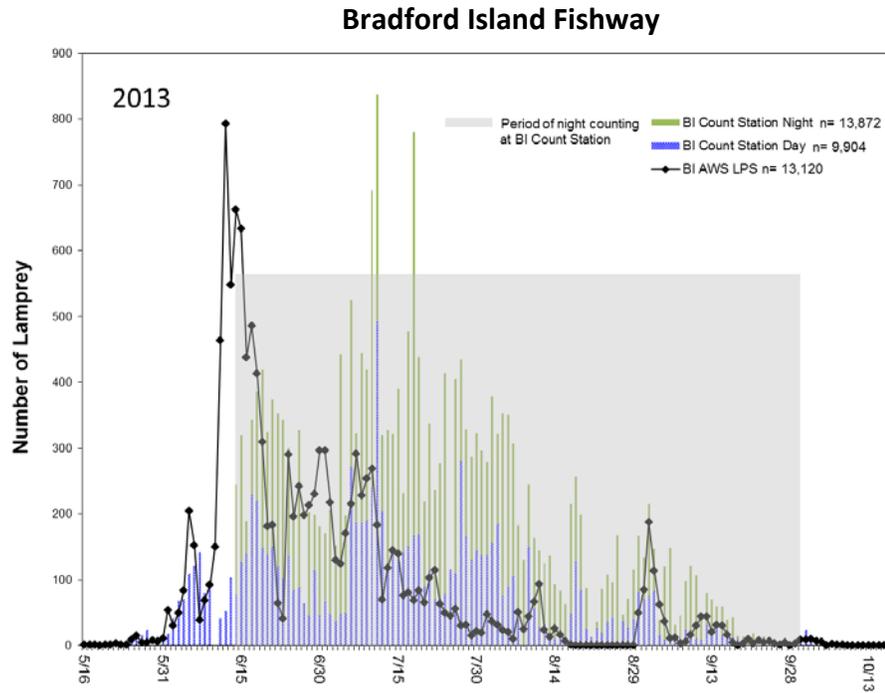
Figure 8. Number of lamprey counted at the Bradford Island count station during the day (blue) and night (green) and at the AWS LPS exit slide (closed diamonds) during the periods of LP operation in 2013. Total values reported for the count station and LPS.

In 2013, the total lamprey count at the Bradford Island LPS was 13,120 (Figure 8). The adjusted total count at the Washington Shore LPS was 18,487 and the unadjusted total count at the Washington Shore LPS was 25,316 (Figure 9).

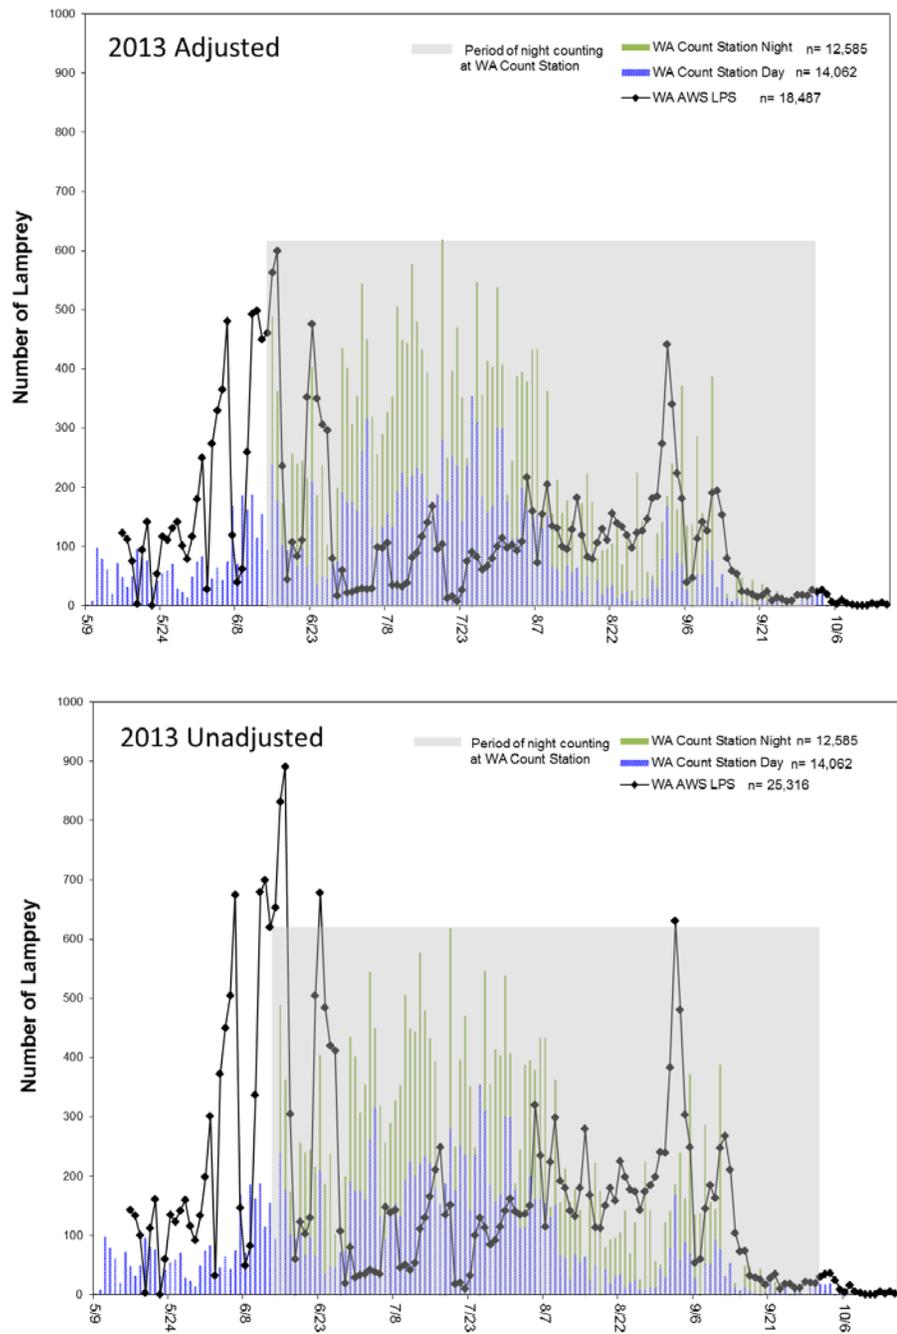
Figure 9. Number of lamprey counted at the Washington Shore count station during the day (blue) and night (green) and adjusted (top panel) and unadjusted (bottom panel) number of lamprey counted at the AWS LPS exit (closed diamonds) during periods of LPS operation in 2013. Total values reported for the count station and LPS.

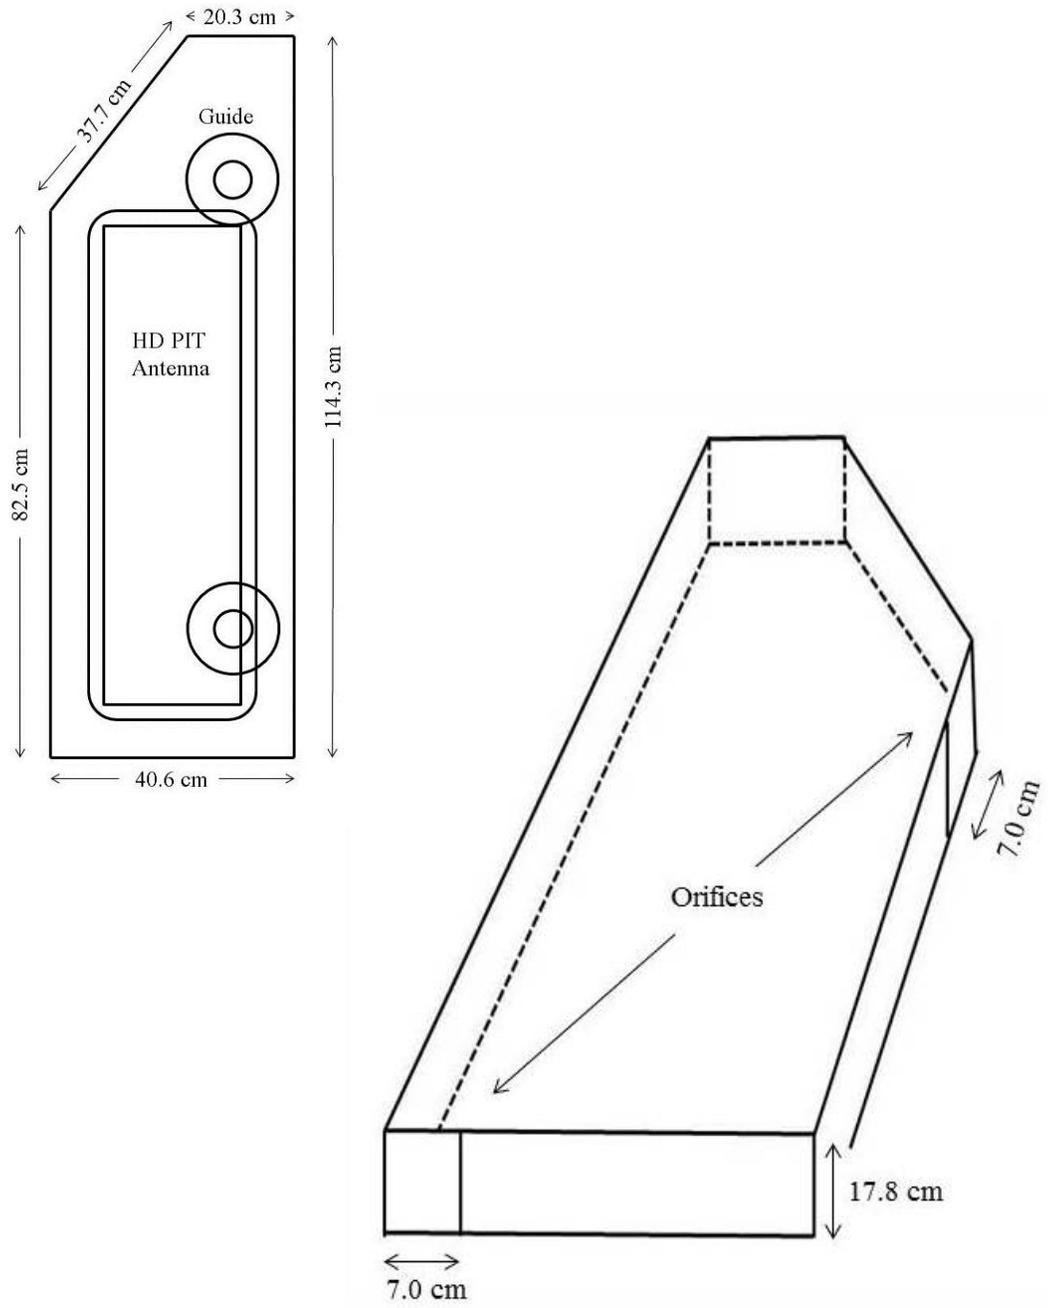
Figure 10. Plan view (upper left) and oblique view (lower right) of refuge boxes installed in the Washington Shore AWS channel and fishway.

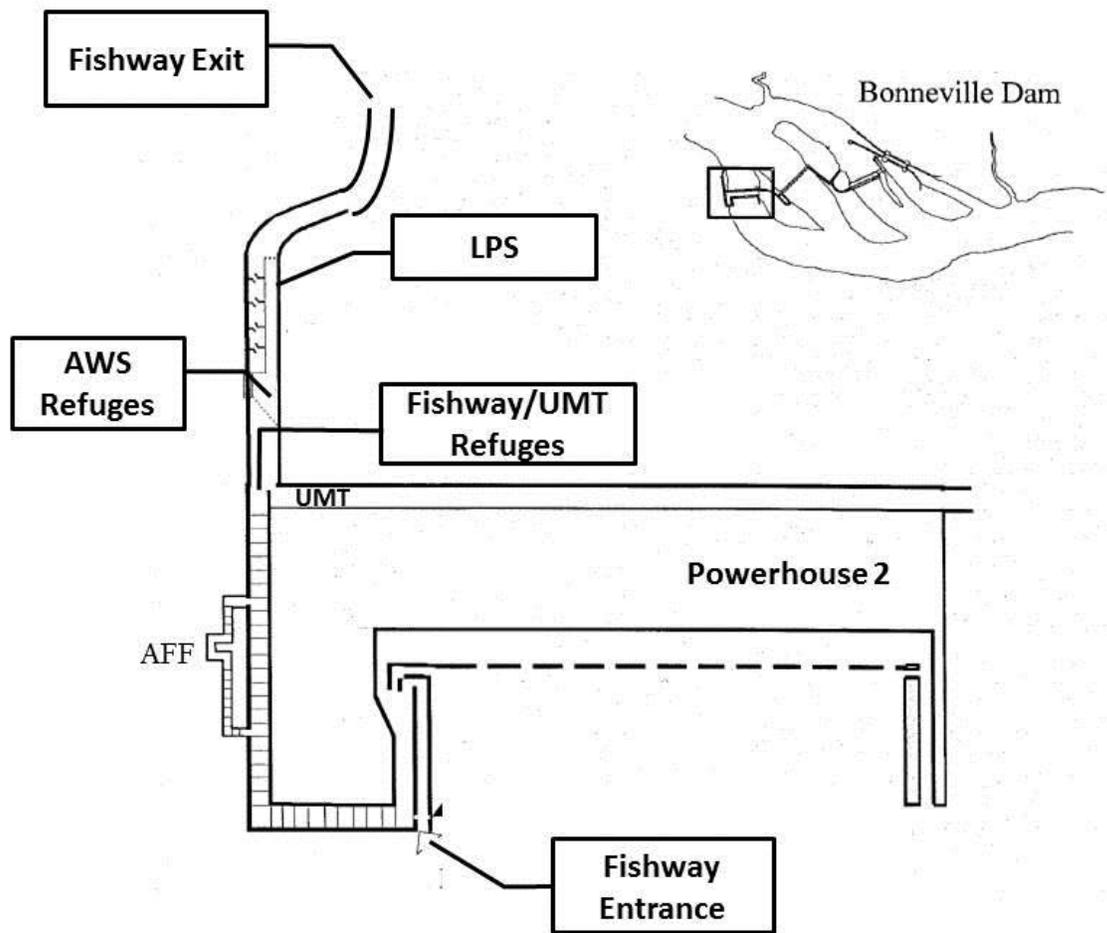
Figure 11. Location of refuge boxes in the Washington Shore AWS channel and fishway at Bonneville Dam.

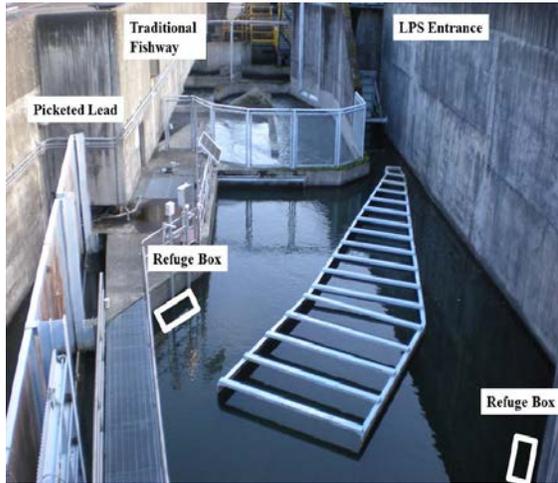
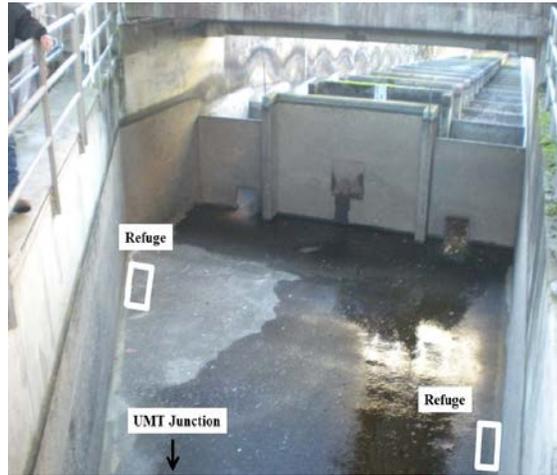
Figure 12. Location of refuge boxes in the Washington Shore AWS channel and fishway at Bonneville Dam.

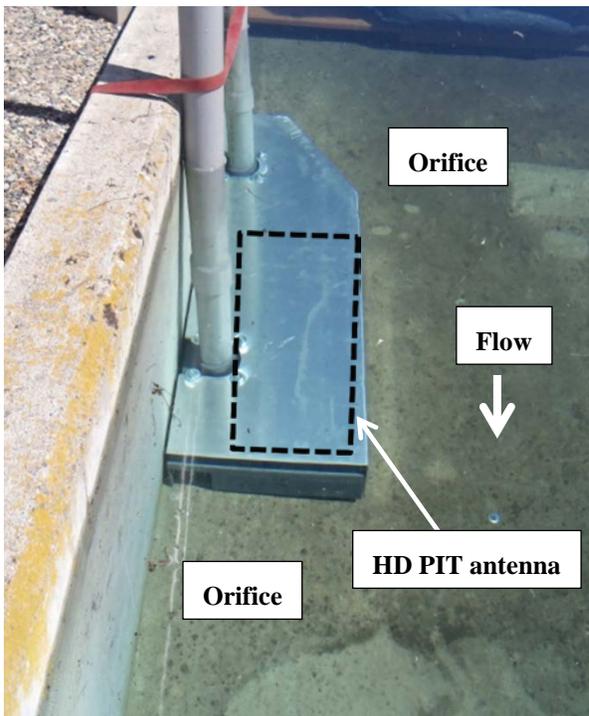
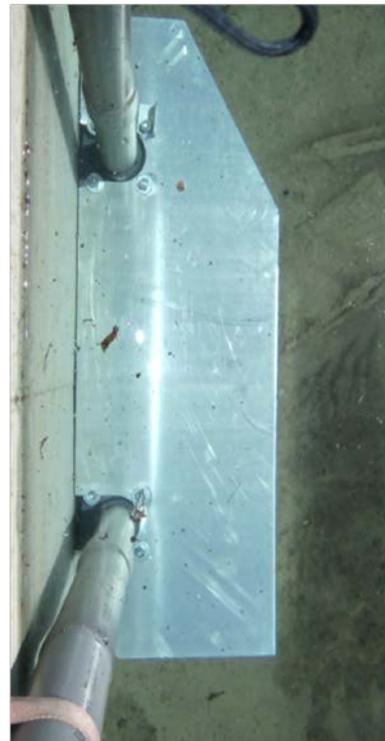
Figure 13. Photographs of refuge box design and placement.

The long axis of each box was oriented with the flow (Figure 13), and a single HD-PIT antenna was fitted to the perimeter. Antennas and transceivers for the refuge boxes were powered by AC outlets for refuge boxes in the AWS channels and by a solar panel for boxes in the fishway, where grid power was not available. Lamprey tagged with PITs as part of Objectives 1 and 3 were used to assess the lamprey use of these devices.

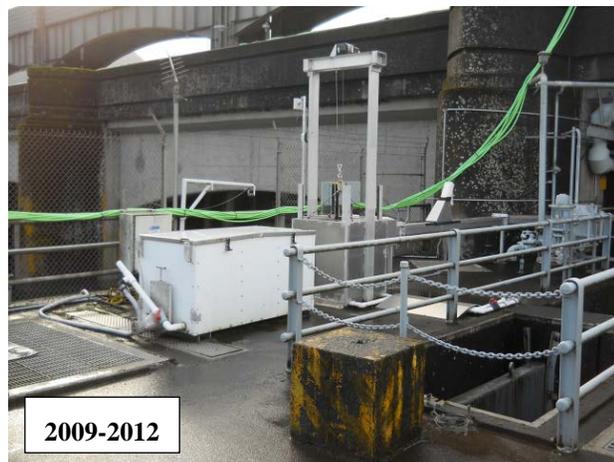
Figure 14. Photo of the Cascades Island LPS terminal trap in place 2009-2013. This trap was replaced in 2013 with a flume section that connected the lower LPS to the exit extension.

In 2013, the trap box at the former terminus of the Cascades Island LPS was removed and replaced with flume sections to allow for volitional lamprey passage upstream from tailrace to forebay. A 9-m, 8-inch rectangular flume section was added at the site of the removed terminal trap and connected the lower sections of the LPS via an upwelling box/slide to a transition “pond” (Figure 15, Panel A). A PIT antenna was incorporated into the flume 4 m downstream from the pond.

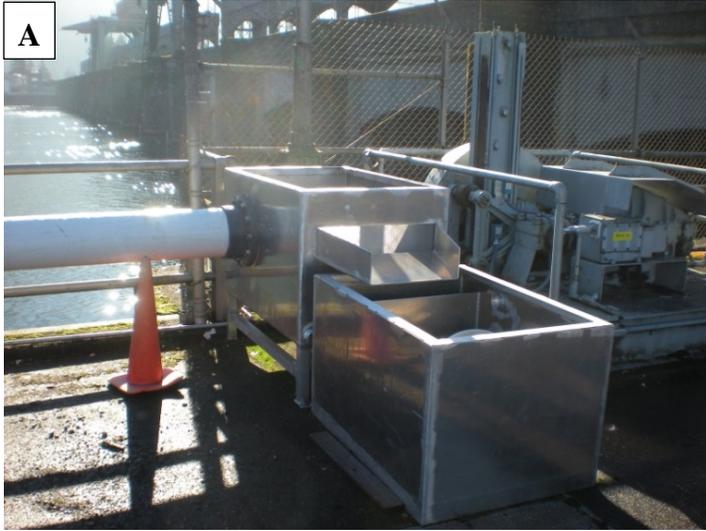
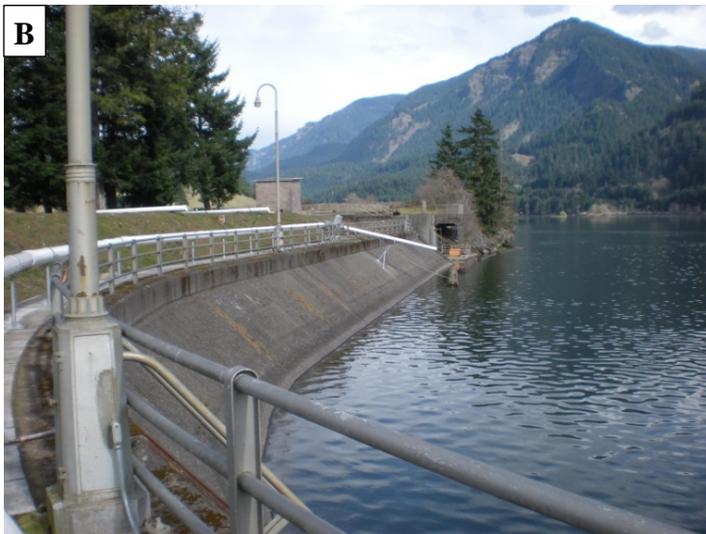
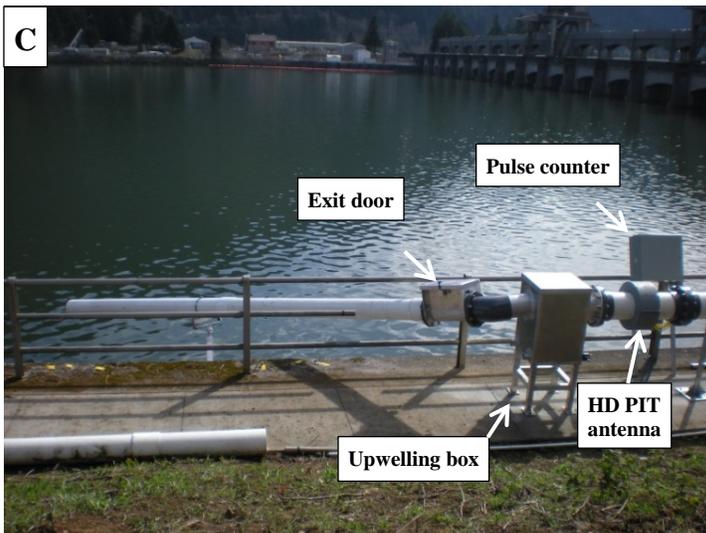
Figure 15.  
Photos of transition pond, pipe,  
and exit sections newly added to  
the Cascades Island LPS in 2013.

The transition pond is a structure that serves a dual purpose of providing a rest box to migrating lamprey as well as collecting water from the upper LPS. This water is pumped from a collection reservoir into an upwelling box that waters the lower sections of the LPS. This feature allows the LPS to be operated as a full-elevation, volitional passage structure or as a terminal trap for lamprey collection. Upstream from the pond, a 70-m, 10-inch-diameter pipe and 10-m, 10-inch-diameter exit slide were added (Figure 15, Panel B), connecting the lower structure and pond to the forebay.

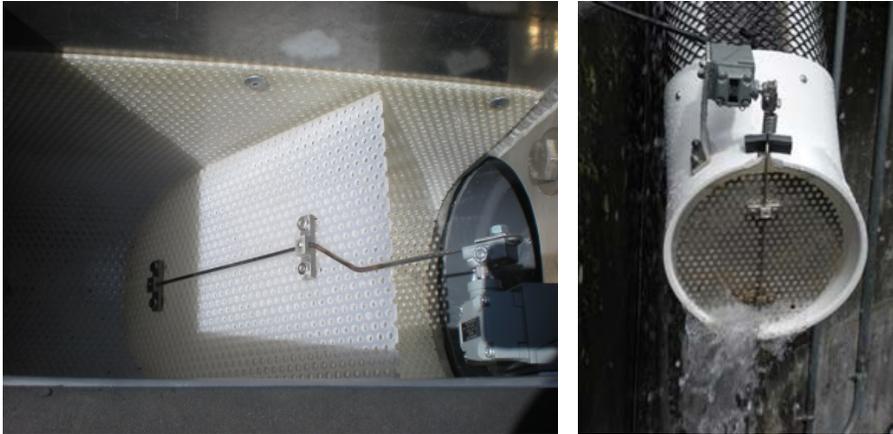
Figure 16. Prototypical and traditional door paddle and limit switch configurations at Cascades Island (left) and Washington Shore LPS (right).

Columbia River water was supplied to the top of the LPS and into the trap box by two 3-hp submersible pumps via a 10.2-cm-diameter PVC pipe. A PIT antenna was installed between the pipe terminus and the upwelling box (Figure 15, Panel C). The exit door (activated for lamprey counting) was located at the highest portion of the exit slide so that it could be easily accessed for maintenance from the forebay deck. A prototype design for the exit door was incorporated to the passage count system (Figure 16).

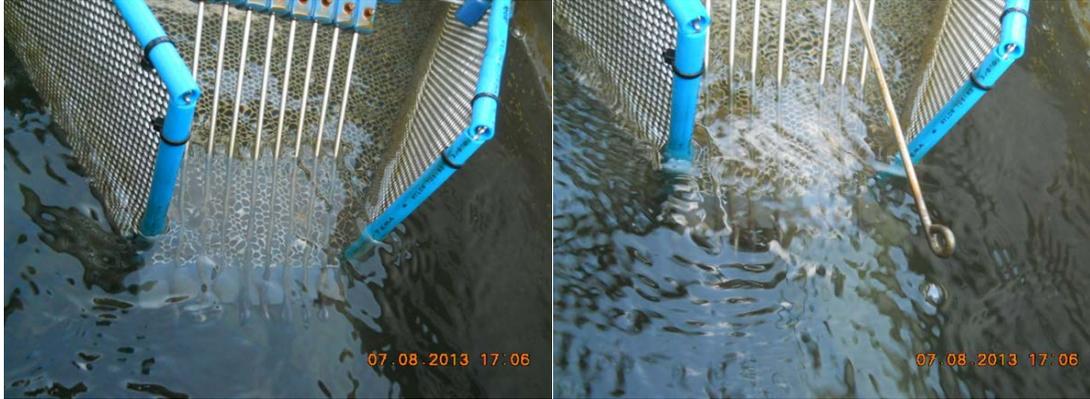
Figure 17. Photos of the 2013 experimental one-way gate entrance (closed at left and open at right) to Rest Box 4 of the Cascades Island LPS.

In 2013, the nylon mesh, conical fyke at the entrance to Rest Box 4 (Corbett et al. 2013) was replaced with an experimental one-way gate entrance (Figure 17).

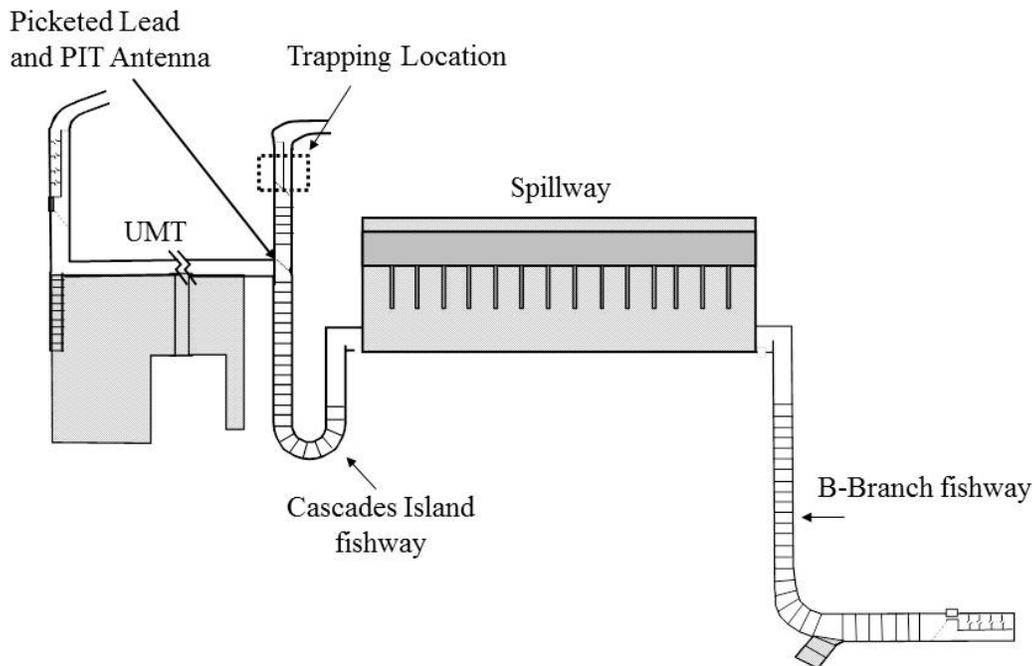
Figure 18. Locations of the HD-PIT antenna at picketed lead and trap deployments at the Cascades Island AWS channel.

In 2013, portable traps similar to those deployed at the adult fish facility were deployed at the Cascades Island AWS channel upstream from the picketed lead near the fishway exit (Figure 18). Lamprey had been observed accumulating in this area, where PIT-tagged lamprey were detected in 2012 and prior years. Trapping sites were selected both to evaluate lamprey use of the channel and to provide information for future siting of an LPS collector (Figure 19). Traps were attached to a weighted standing wire to allow ease of deployment while ensuring that they remained firmly in place. Collected lamprey were enumerated and either used for Cascades Island LPS experiments or transported and released upstream from Bonneville Dam

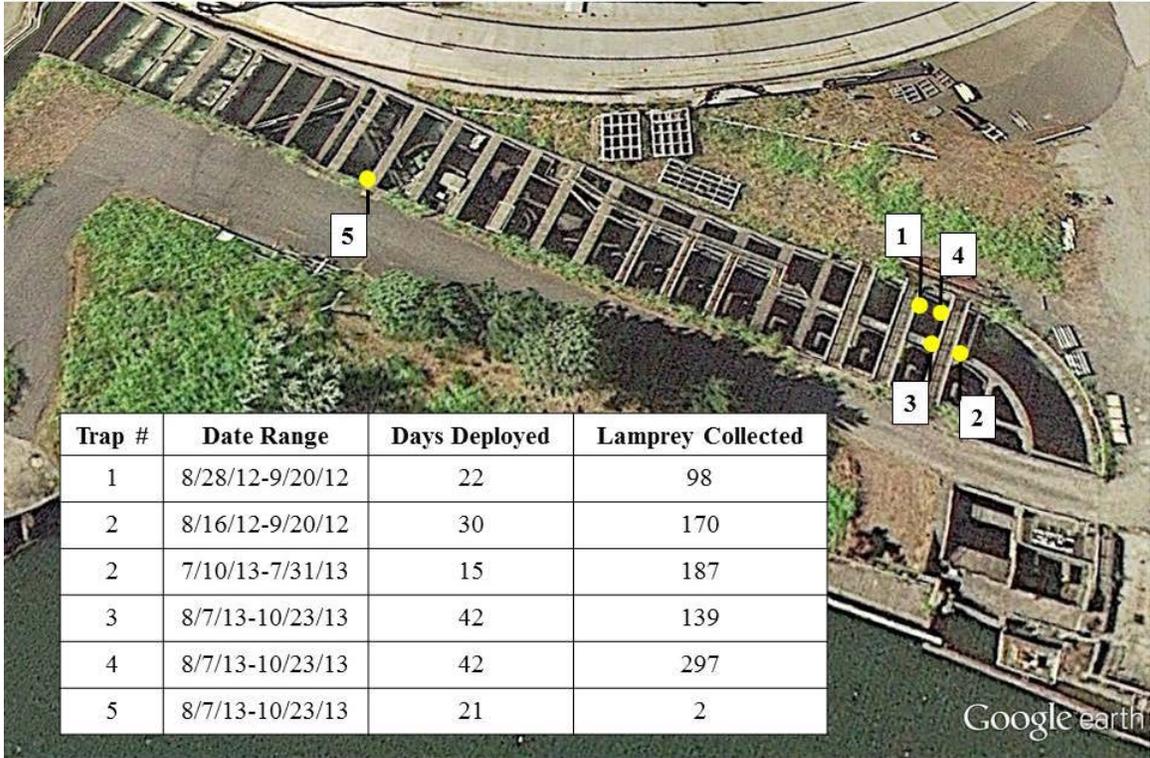
Figure 19. Locations of 2012 and 2013 trap deployments and associated lamprey captures at the Cascades Island AWS channel.

In addition to the two original trap locations established in 2012, we added two trap locations on 7 August 2013 to determine areas where lamprey accumulate and to help inform the optimal location for placement of an LPS entrance collector (Figure 19).

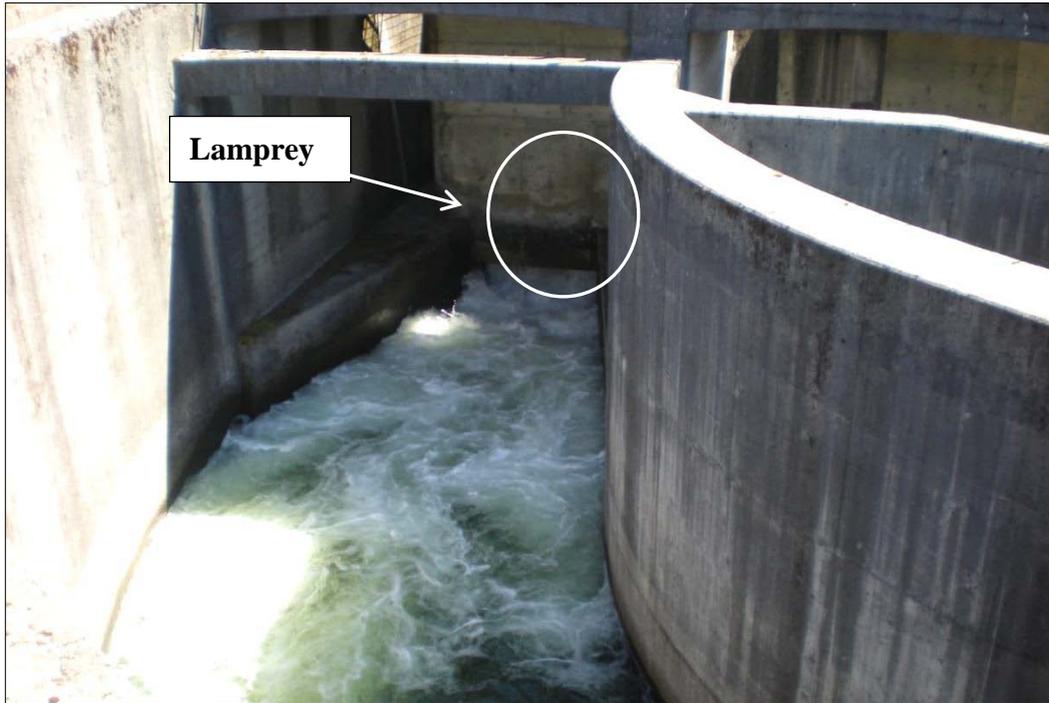
Figure 20. Lamprey ascending headgate of fishway exit at Cascades Island AWS channel.

Further evidence of lamprey accumulation in this area was provided by the observation of both live and dead lamprey in the serpentine weir section of the ladder. Additionally, live lamprey were observed climbing the headgate at the fishway exit to the forebay (Figure 20).

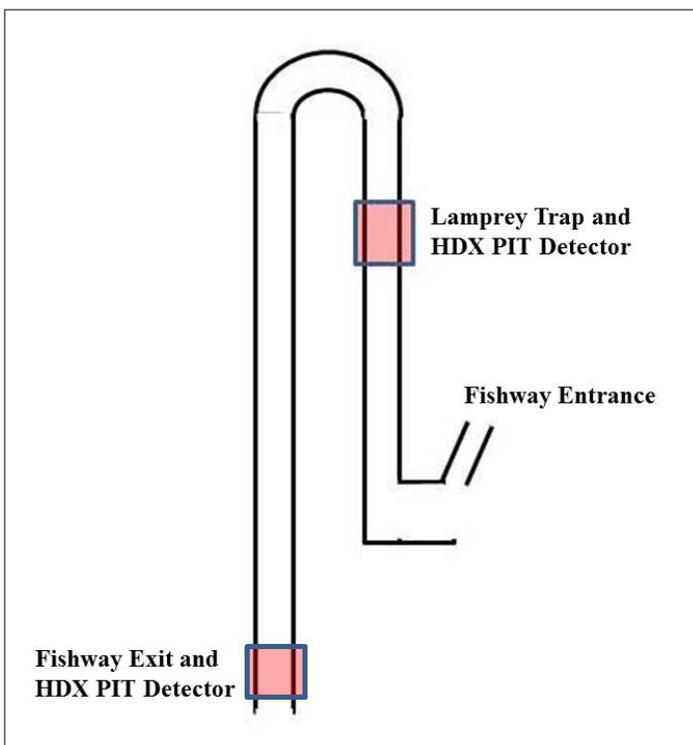
Figure 21. Locations of the HD-PIT antennas and trap deployment at the John Day South Fishway.

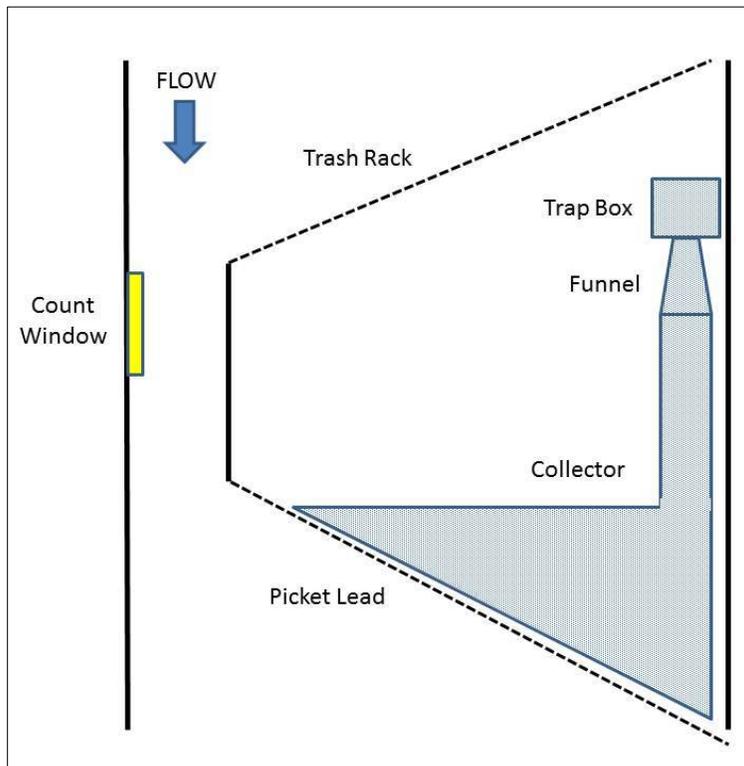
Figure 22. Plan view showing location of trap in relation to other structures within the John Day South Fishway.

Data from PIT detections indicated that lamprey were occupying the collector for extended periods and not quickly passing through to the trap box (Figure 22). The collector is similar in shape and design to that of the refuges installed at the AWS channel and fishway at Bonneville Dam. Periods of occupation at the trap collector (time at first detection to time of last detection) were similar to those observed at the refuges at Bonneville Dam, suggesting that the trap collector was functioning as a refuge.

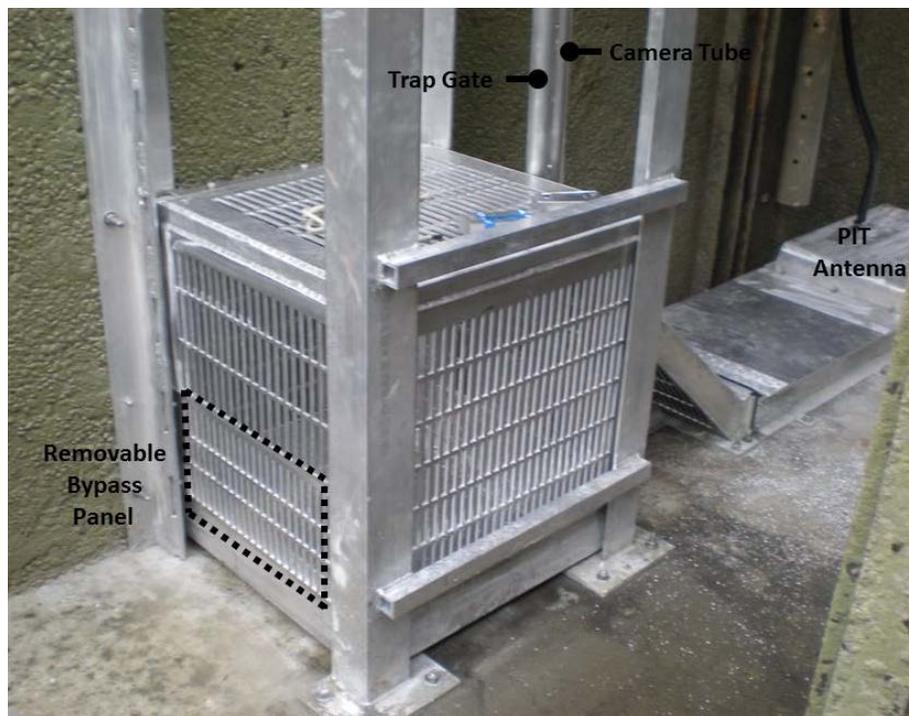
Figure 23. Photo of trap and associated features.

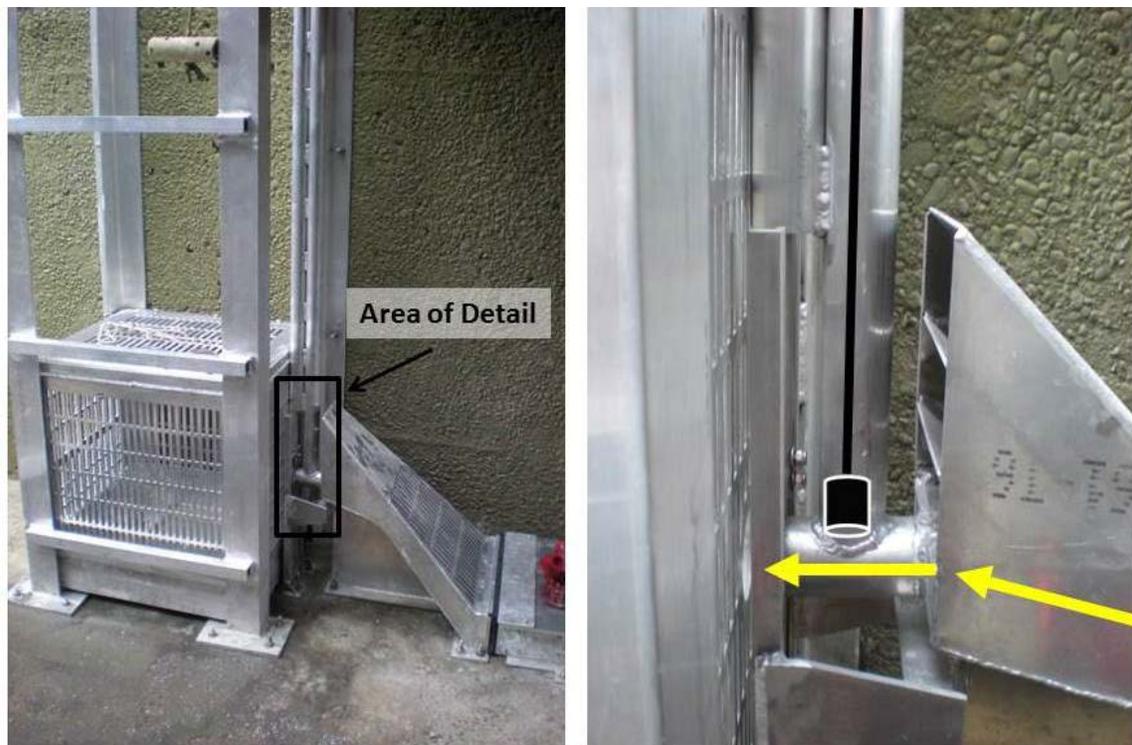
Figure 24. Photo of vertical camera orientation as designed for trap.

Tests of the vertical camera position deployment were conducted between 10 May and 2 July. No imagery of lamprey entering the trap was recorded during the 605 h of underwater horizontal camera deployment. For the vertical camera (Figure 24), the quality of recorded video degraded within 1 h of deployment due to the accumulation of bubbles at the lens surface (Figure 25). We attempted several different techniques to deflect bubbles from the camera lens but were unsuccessful due to the design of the camera tube.

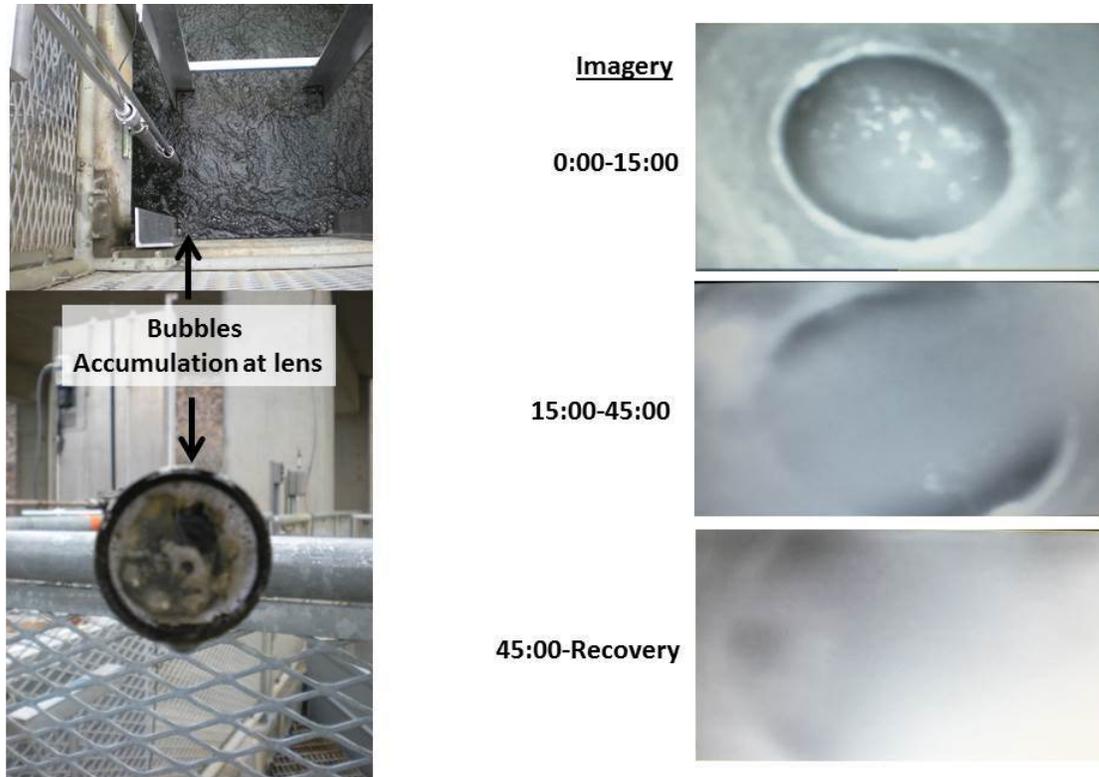
Figure 25. Photos of accumulation of bubbles at camera lens and resulting image degradation over time.

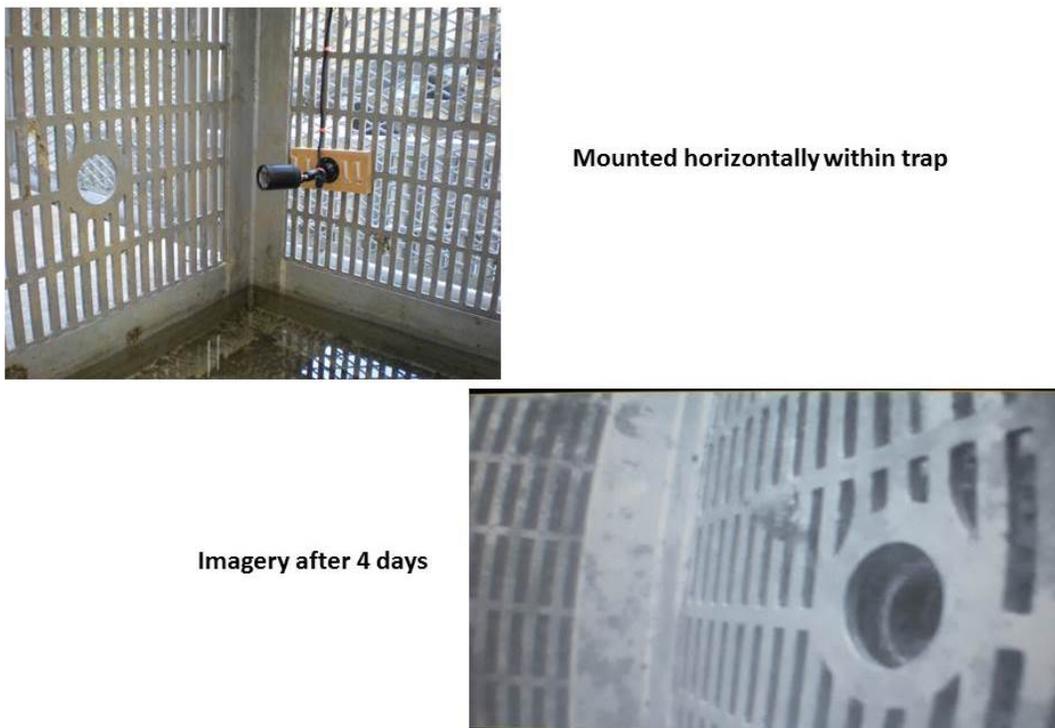
Figure 26. Photos of camera mounted in horizontal orientation and obtained imagery.

Tests of the horizontal camera deployment were conducted between 3 and 8 September. No imagery was recorded of lamprey entering the trap during the 144 h of underwater horizontal camera deployment. Recorded imagery was of consistently good quality throughout the test, and it is assumed that had lamprey entered the trap, the entrance events would have been able to be enumerated.
