# **Adult Pacific Lamprey Passage Structures: Use and Development at Bonneville Dam and John Day Dam South Fishway, 2014**

Portland District, U.S. Army Corps of Engineers  
P.O. Box 2946, Portland OR 97020  
Contract E96950021

September 2015

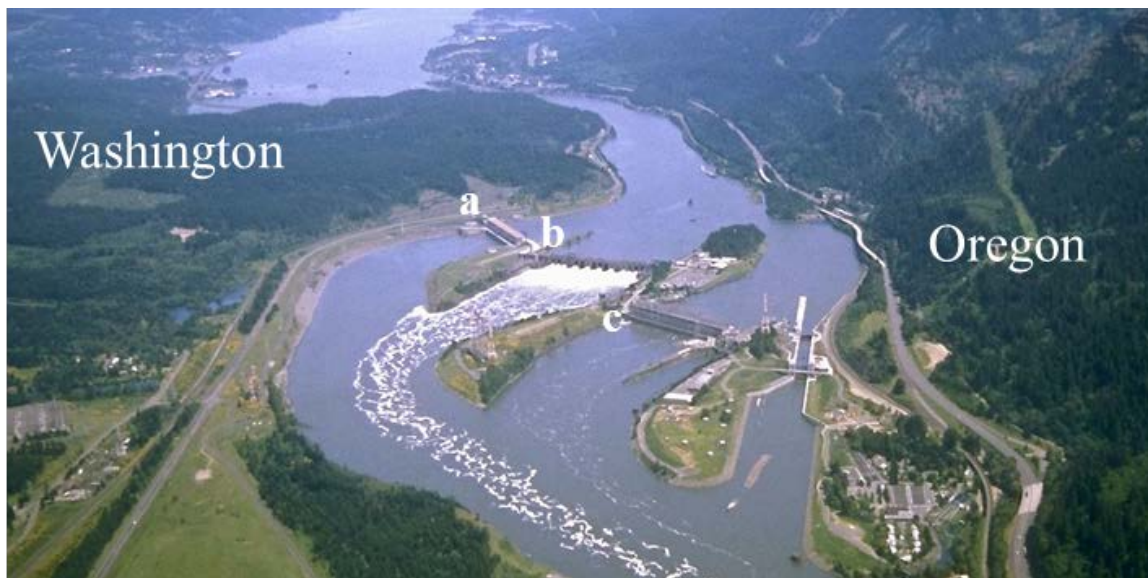
Figure 1. Aerial photo showing configuration of Bonneville Dam with approximate location of fishways at: (a) Washington Shore, (b) Cascades Island, and (c) Bradford Island.

We initially developed the LPS at Bonneville Dam, the first mainstem dam that lamprey encounter when migrating up the Columbia River (rkm 235; Figure 1). Here adult lamprey have difficulty entering fishways, and those that successfully enter are often obstructed or delayed near the top of the fishway (Moser et al. 2002b; Johnson et al. 2009a, 2009b; Keefer et al. 2013). In these areas, vertical slot weirs (‘serpentine’ weirs) present an obstacle to upstream movement. Consequently, lamprey routinely aggregate in auxiliary water supply (AWS) channels, which are adjacent to the tops of these fishways (Moser et al. 2005).

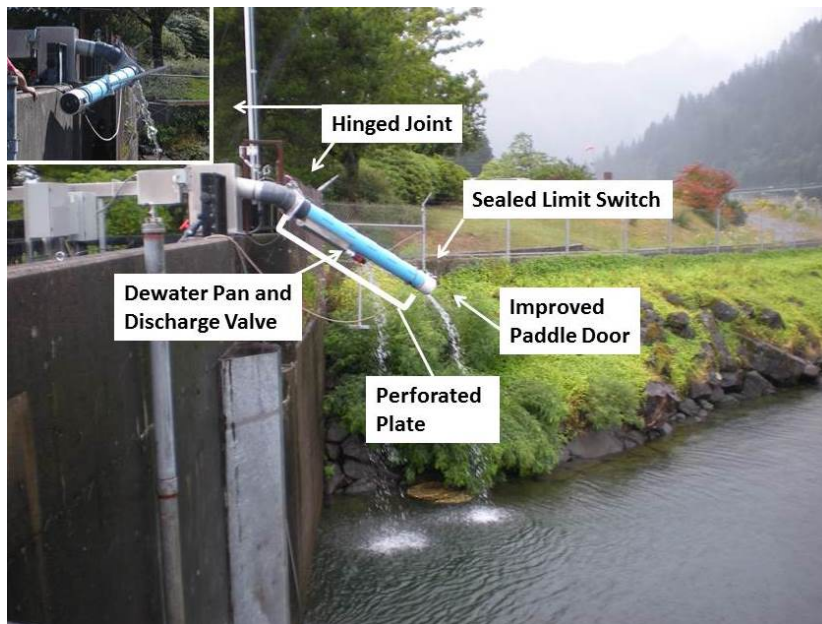
Figure 7. Photograph of redesigned exit slide at Bradford Island AWS LPS with features labeled.

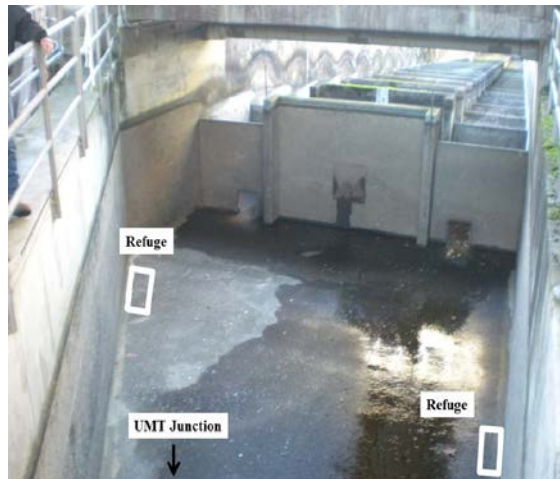
Figure 16. Location of refuges in the Washington Shore AWS channel and fishway at Bonneville Dam.

Prior to the 2013 migration period, two additional refuges were installed in the Washington Shore fishway downstream from the AWS channel. These refuges were positioned along the north and south walls of the fishway below its junction with the upstream migrant tunnel (Figure 16; Corbett et al. 2014). A PIT antenna was integrated into each refuge to allow detection of tagged lamprey (Figure 17).

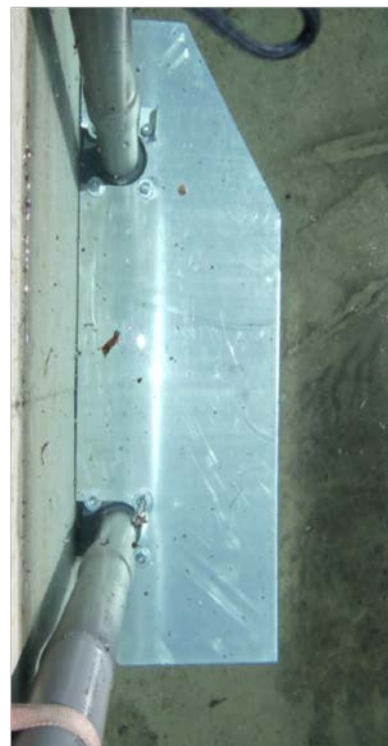
Figure17. Photographs of refuge design and placement.

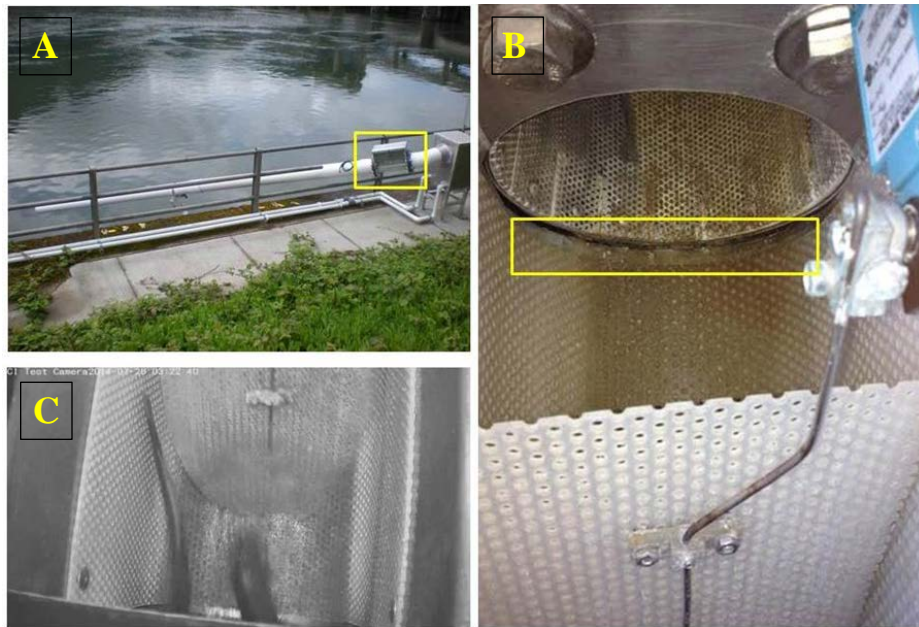
Figure 25. Photos of the Cascades Island LPS exit (A, yellow outline), the gap in perforated plate (B, yellow outline), and lamprey passing under the counter paddle (C).

For lamprey that attempt, but fail to attach at this location, passage can be slowed by the attempt, and these fish can pass under the count paddle in a tail-first, horseshoe orientation. Video validation showed that most lamprey passed under the count paddle in this orientation, indicating that these fish frequently attempt to attach but are not always able. For lamprey that passed under the count paddle in a head-first orientation, the result was an accurate passage event record reported by the pulse counter.

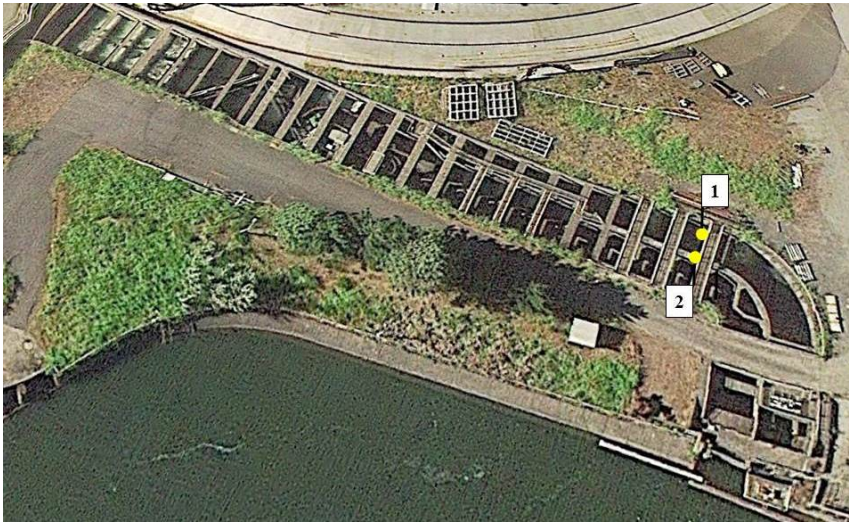
Figure 27. Locations of the two traps (yellow dots) deployed in the Cascades Island makeup water supply channel in 2014.

PIT-tagged lamprey have been detected in this channel during all previous years of monitoring. Trapping sites (Figure 27) were selected both to evaluate lamprey use of the channel and to provide information for future siting of an LPS collector. Traps were attached to a weighted, standing wire to allow ease of deployment while ensuring that they remained firmly in place. Collected lamprey were enumerated and then transported and released upstream from Bonneville Dam.

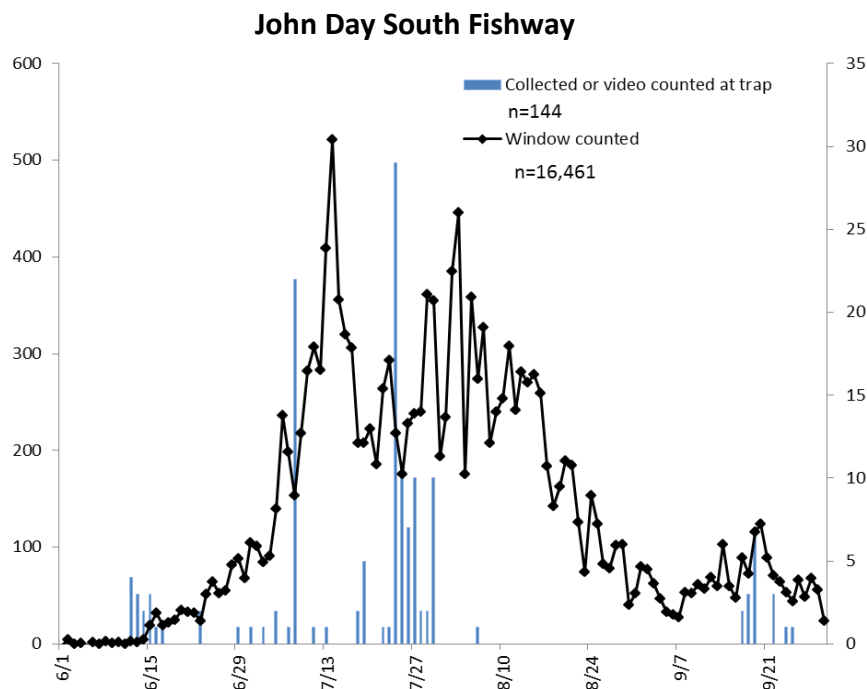
Figure 32. Number of lamprey counted at the John Day south count station (closed diamonds, primary axis) and either collected from the trap or video counted entering the trap (bars, secondary axis) during dates it was operated in pass-through mode in 2014. Total values reported for the count station and trap.

From the 288 h of video footage recorded during 16-30 July, when the trap was operated in pass-through mode, we observed an additional 66 lamprey swimming through the structure. An additional 432 h of digital video was recorded when the trap was operated in pass-through mode (18 trapping periods from 31 July to 19 August). This imagery will be reviewed and the results reported. By comparison, a total of 16,461 lamprey were counted during day and night visual counts at the John Day south count window between 1 June and 30 September (Figure 32).

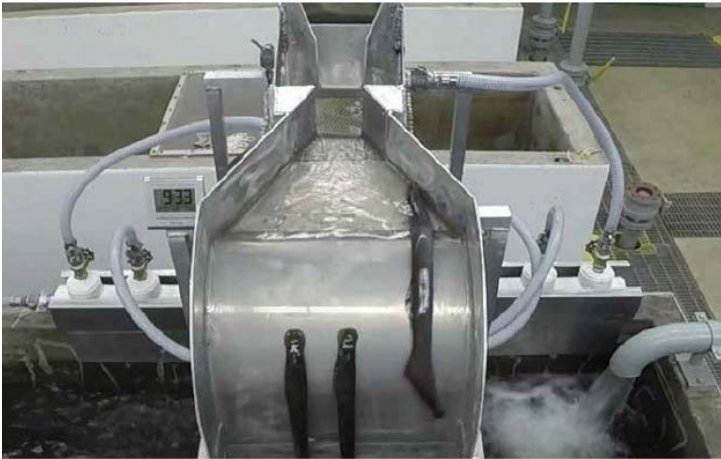
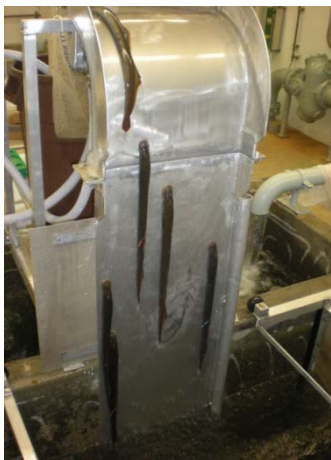
Figure 35. Photos of experimental wetted wall collector show lamprey ascending during a trial.

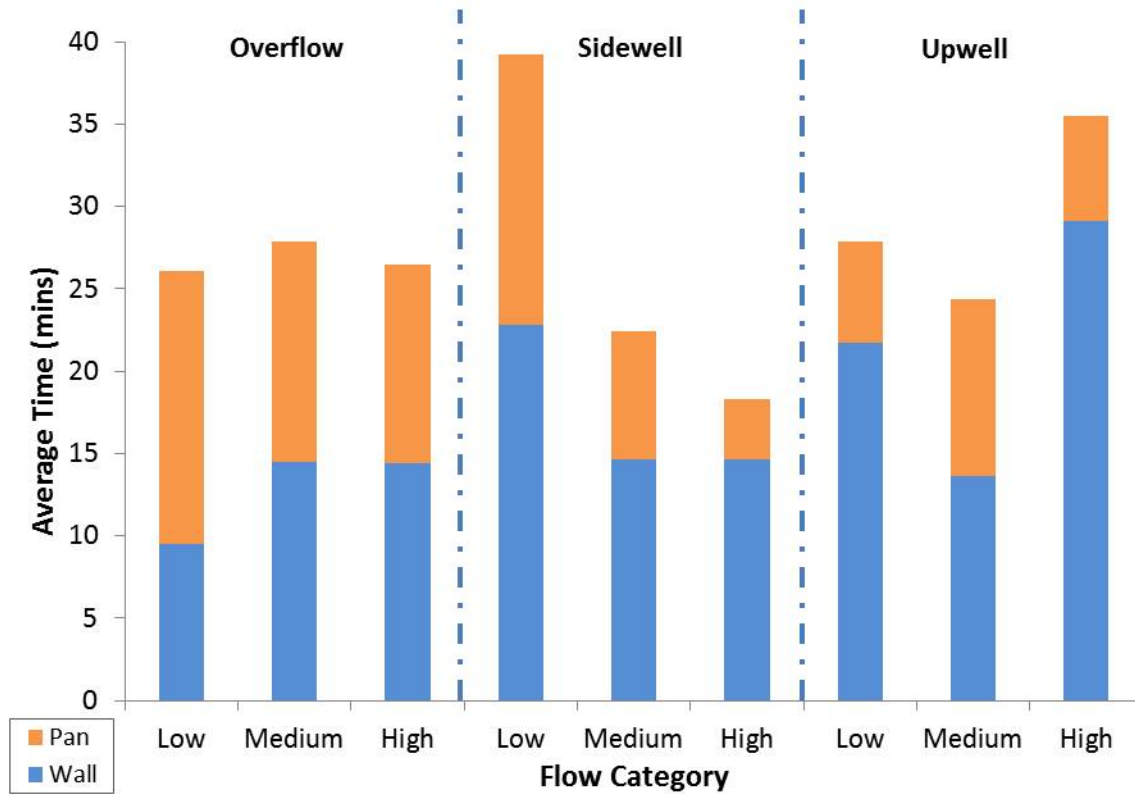
Figure 37. Average time lamprey spent on the vertical wall portion (blue) and upper pan section (orange) of the experimental wetted wall for each water supply type.

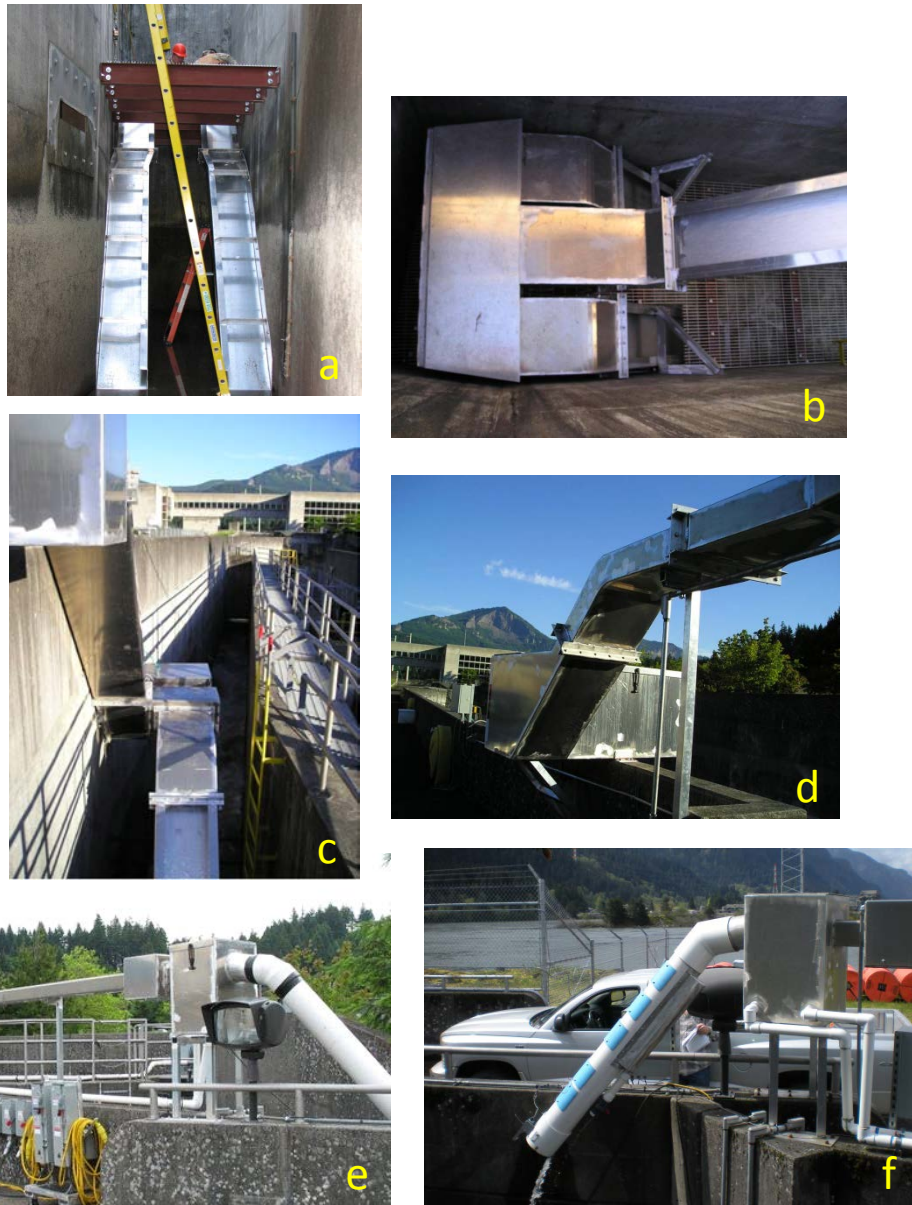
Figure A3. Photos of Washington Shore lamprey passage structure showing ramps converging at Rest Box 1 (a), Rest Box 1 (b), switchback at Rest Box 2 (c), Rest Box 3 (d), upwelling box (e), and exit slide (f).

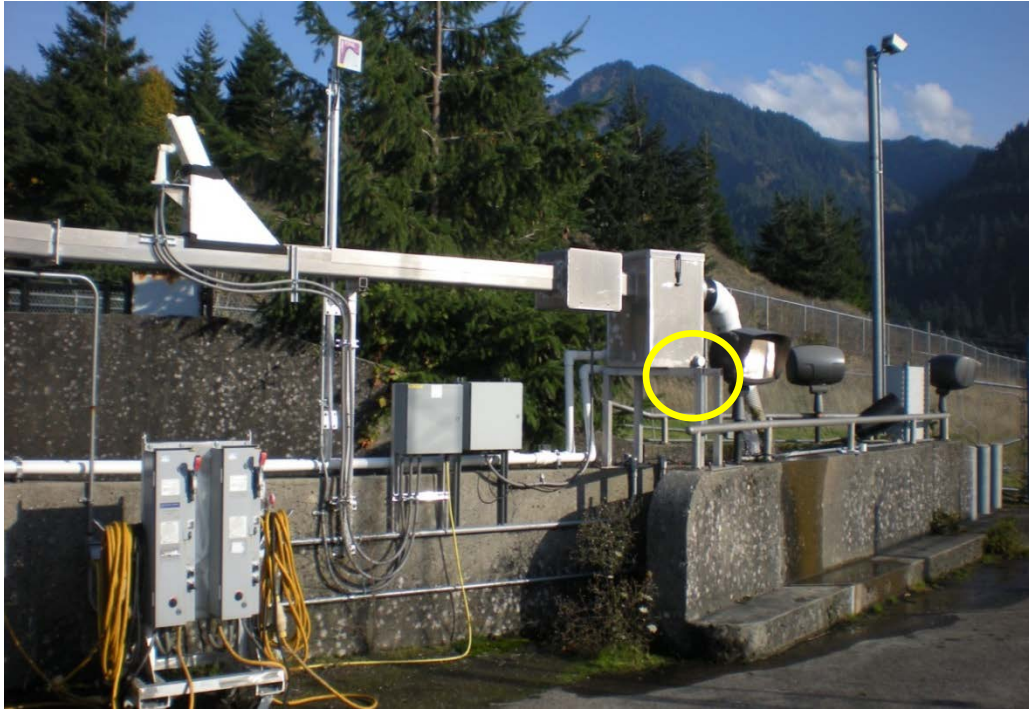
Figure A4. Discharge valve at Washington Shore AWS LPS upwelling box.

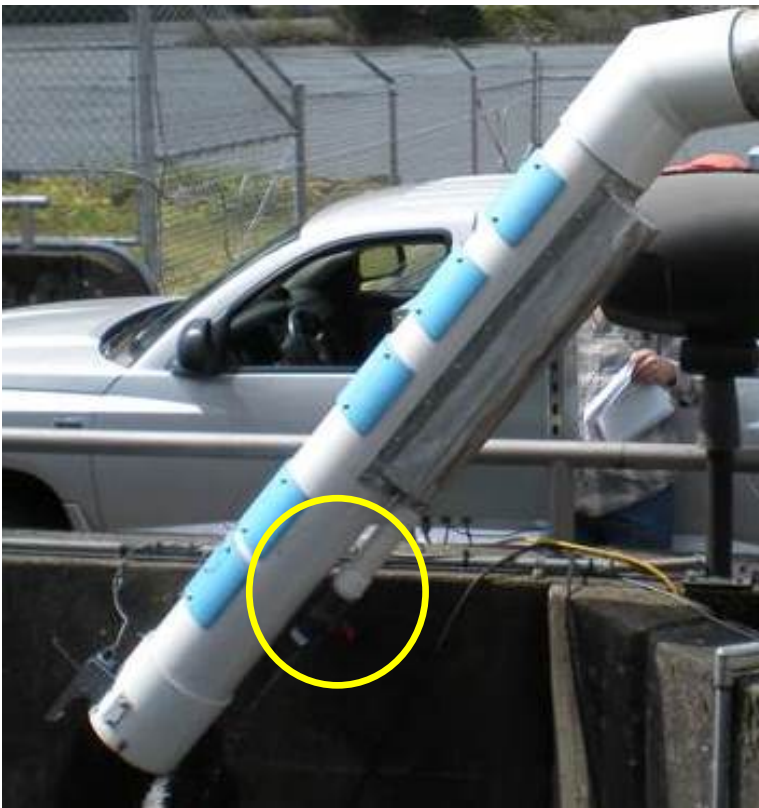
Figure A5. Discharge valve at exit slide of Washington Shore AWS LPS.

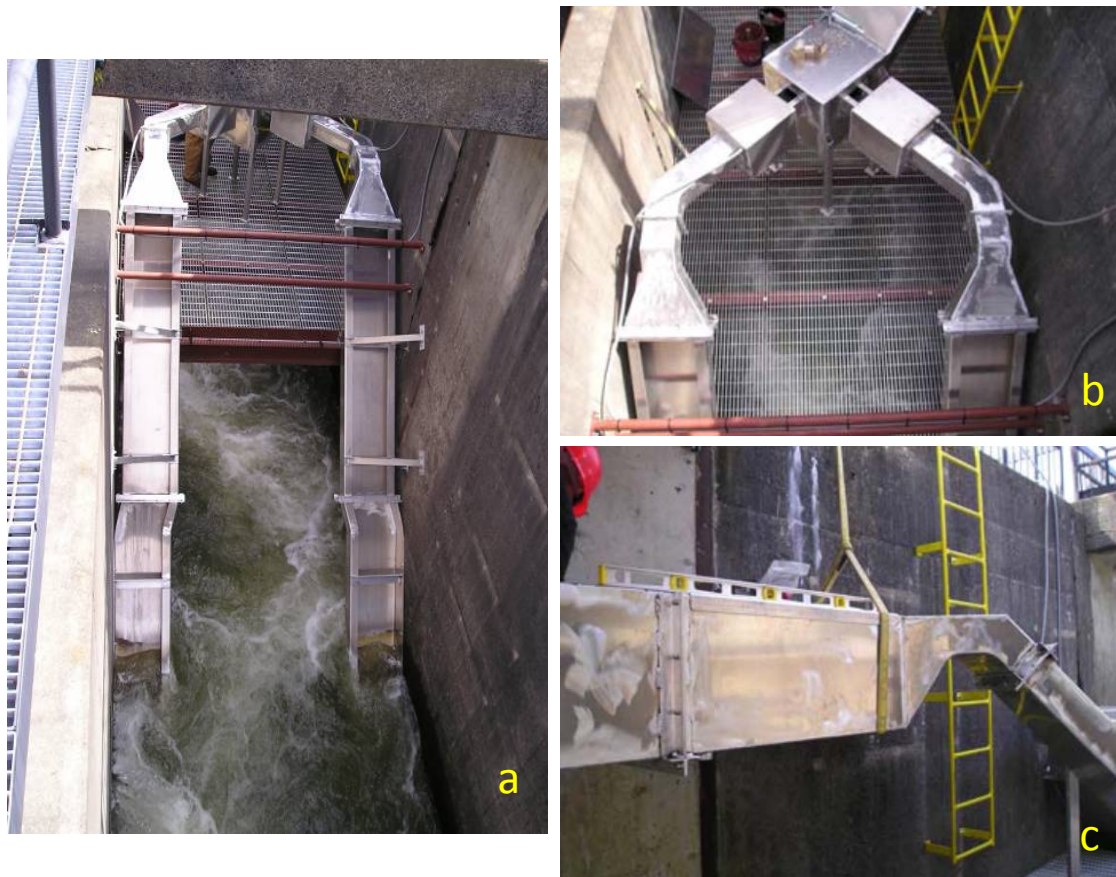
Figure B3. Photos of LPS installation in the Bradford Island AWS channel: a) dual collection ramps, b) access platform, and c) short ramp leading to large second rest box.

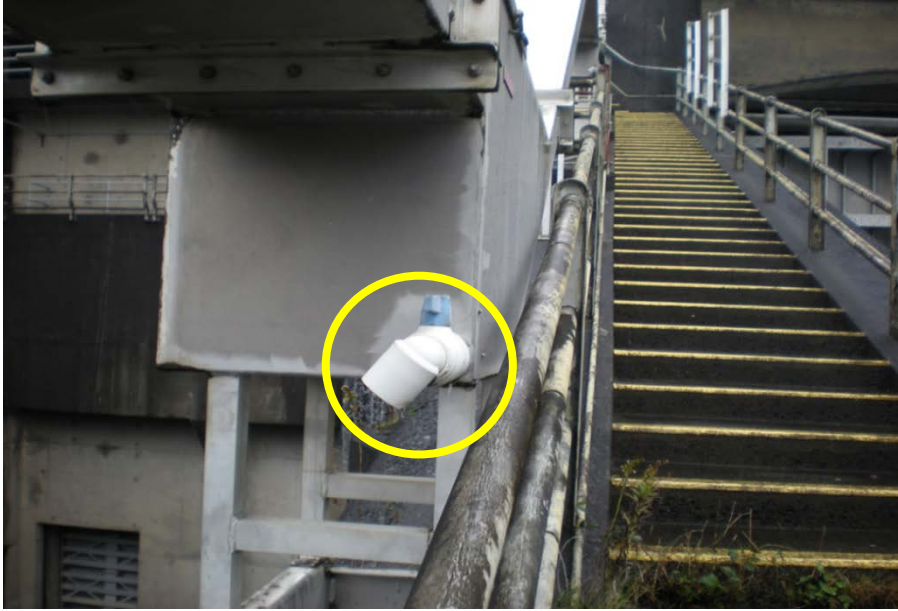
Figure B6. Example of a discharge valve at a rest box.

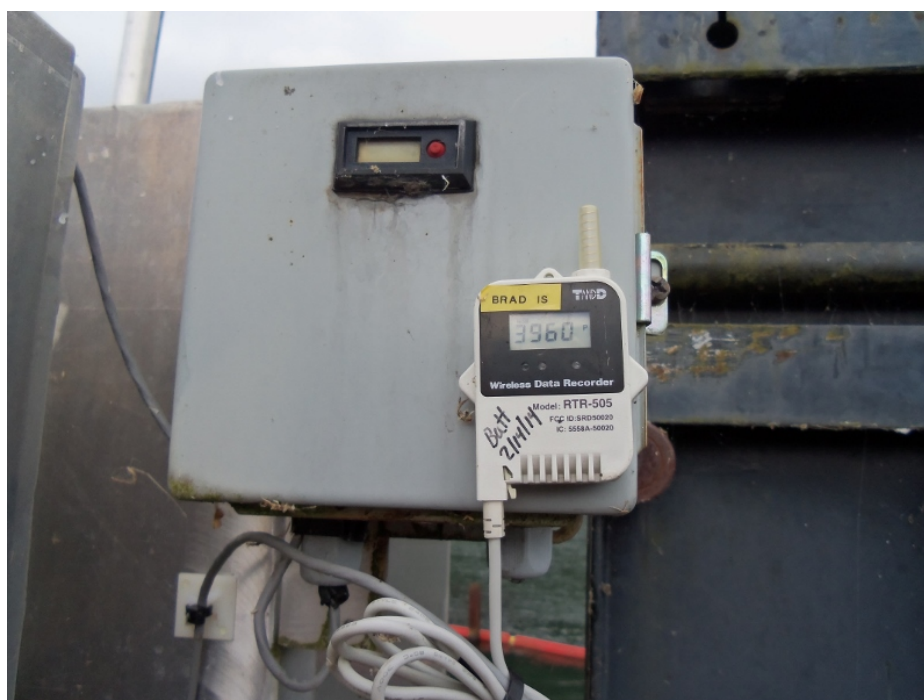
Figure B9. Wireless data recorder, RTR-500.

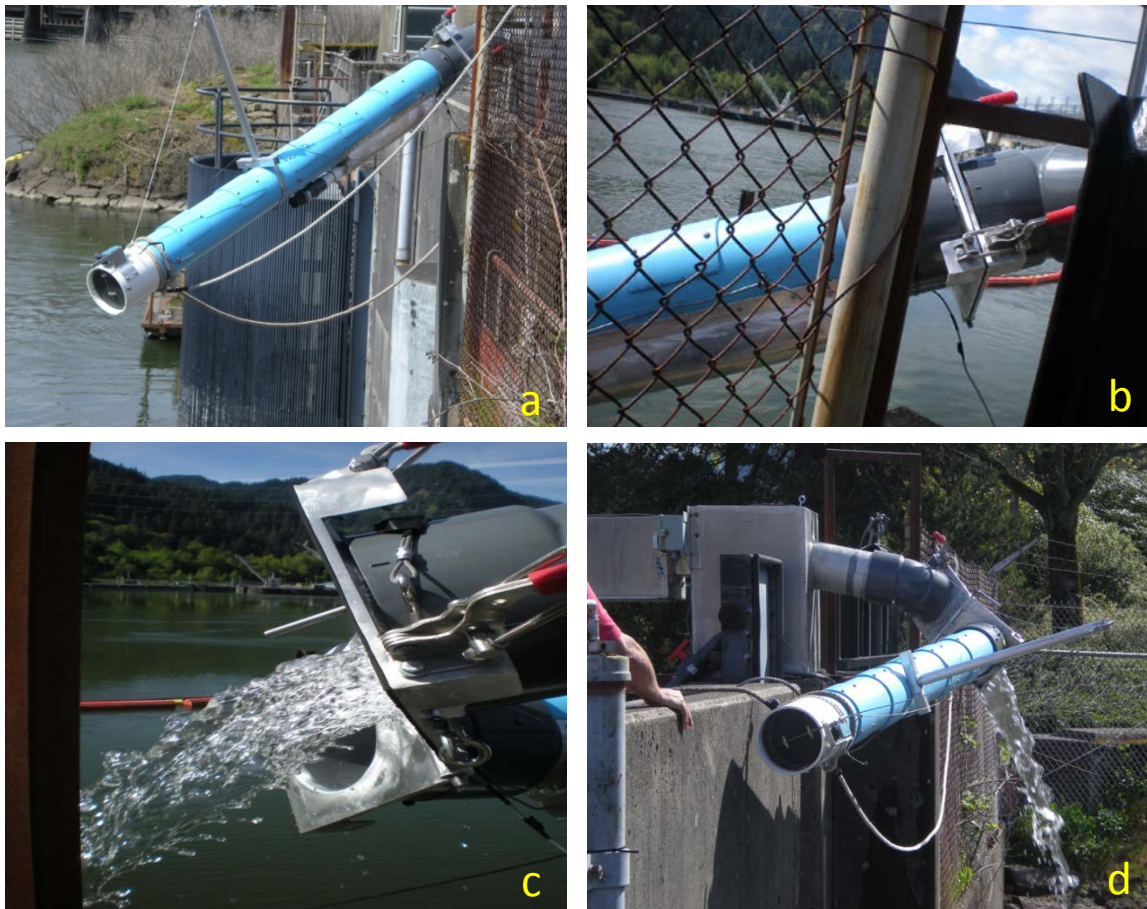
Figure B10. Retractable exit slide of Bradford Island LPS showing slide deployed (a), hinge closed (b), hinge open (c), and slide retracted (d).

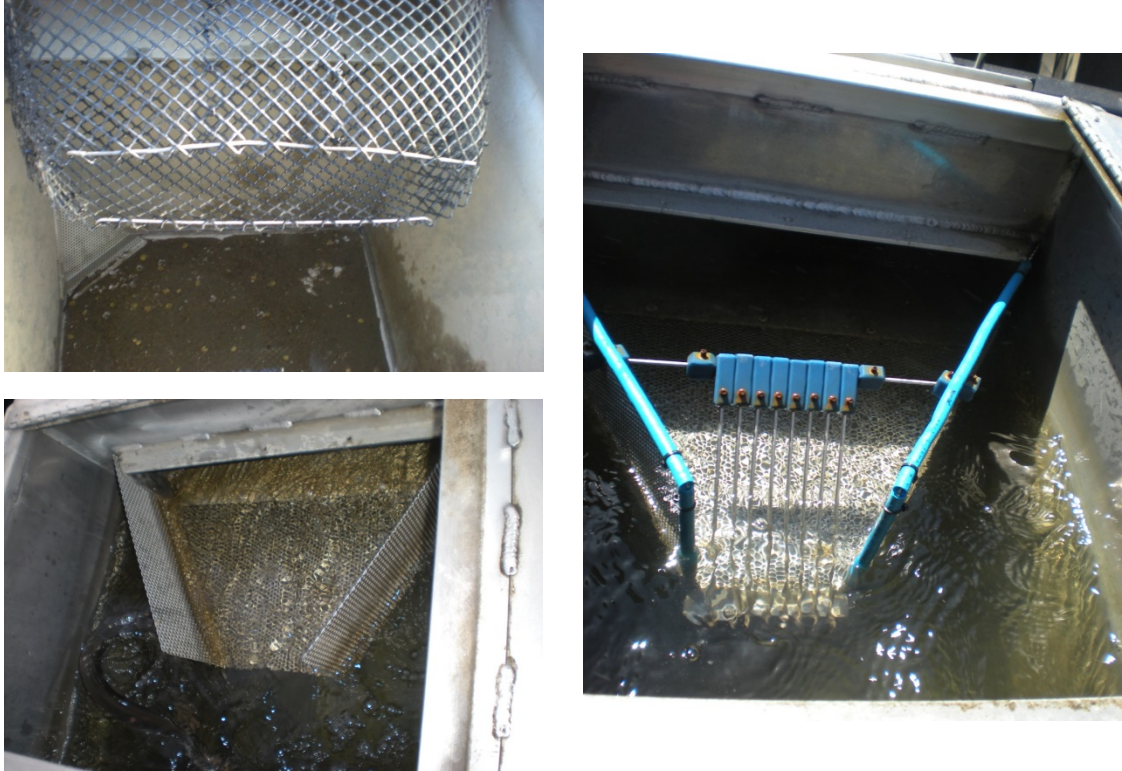
Figure C4. Examples of different fyke entry designs for rest boxes in the Cascades Island LPS.

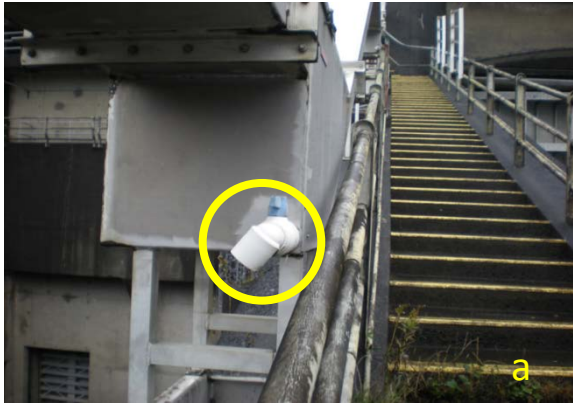
Figure C6. Discharge valves at rest boxes are mostly PVC ball valves at accessible boxes (a). Remote hydraulic purge valves for Rest Boxes 1 and 2 have controls at the deck (b).
