SURVEY OF FISH PROTECTIVE FACILITIES AT WATER WITHDRAWALS ON THE SNAKE AND COLUMBIA RIVERS PHASE II

Fiscal Year 1980 Report of Research
Financed by
Bonneville Power Administration
(Contract DE-A179-80BP18490)

June 1981

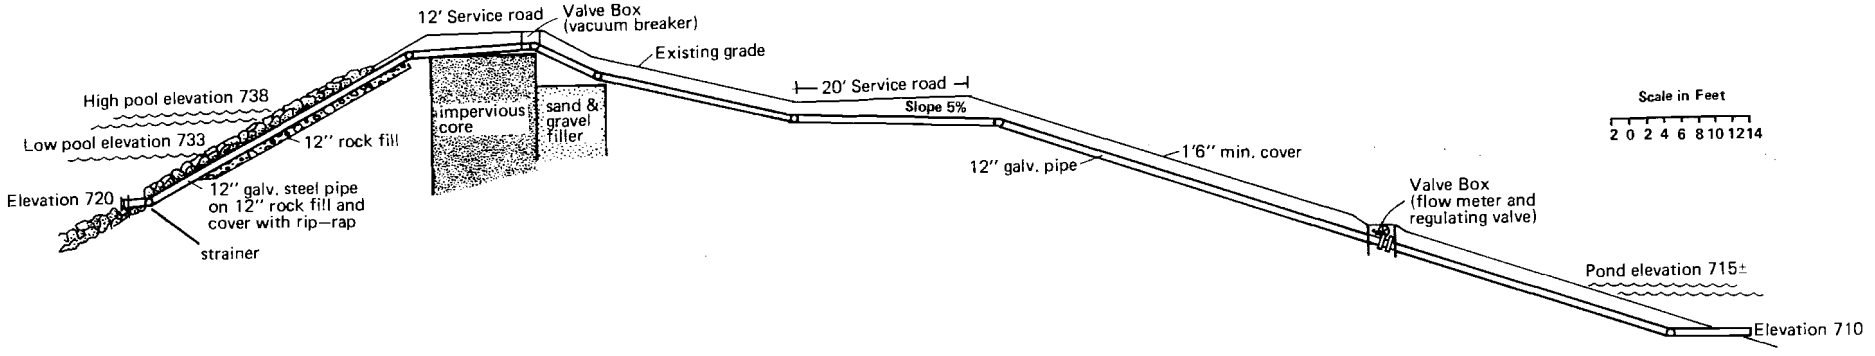
Four withdrawals operated by the CofE as part of the levee at Lewiston, Idaho, were of interest because they are siphons in use the year around (Figure 3). One is located on the Snake River, and three are on the Clearwater River. The purpose of these siphons is to introduce more water into a ground-water drainage ditch running parallel to the levee to create higher flow in the ditch and avoid water stagnation. NMFS divers inspected them on 3 and 18 September 80 and found intake velocities, measured with an electromagnetic flow meter, to be greater (3.3 fps) than the acceptable fish protective criteria (0.5 fps). As soon as the deficiencies were made known to the CofE, corrective action was taken.

Figure 3.--Siphon No. 1 located on West Lewiston Levee, Snake River (longer and greater head loss, but typical of 3 other siphons on East Lewiston Levee, Clearwater River).
