SURVEY OF FISH PROTECTIVE FACILITIES AT WATER WITHDRAWAL SITES ON THE SNAKE AND COLUMBIA RIVERS

July 1985

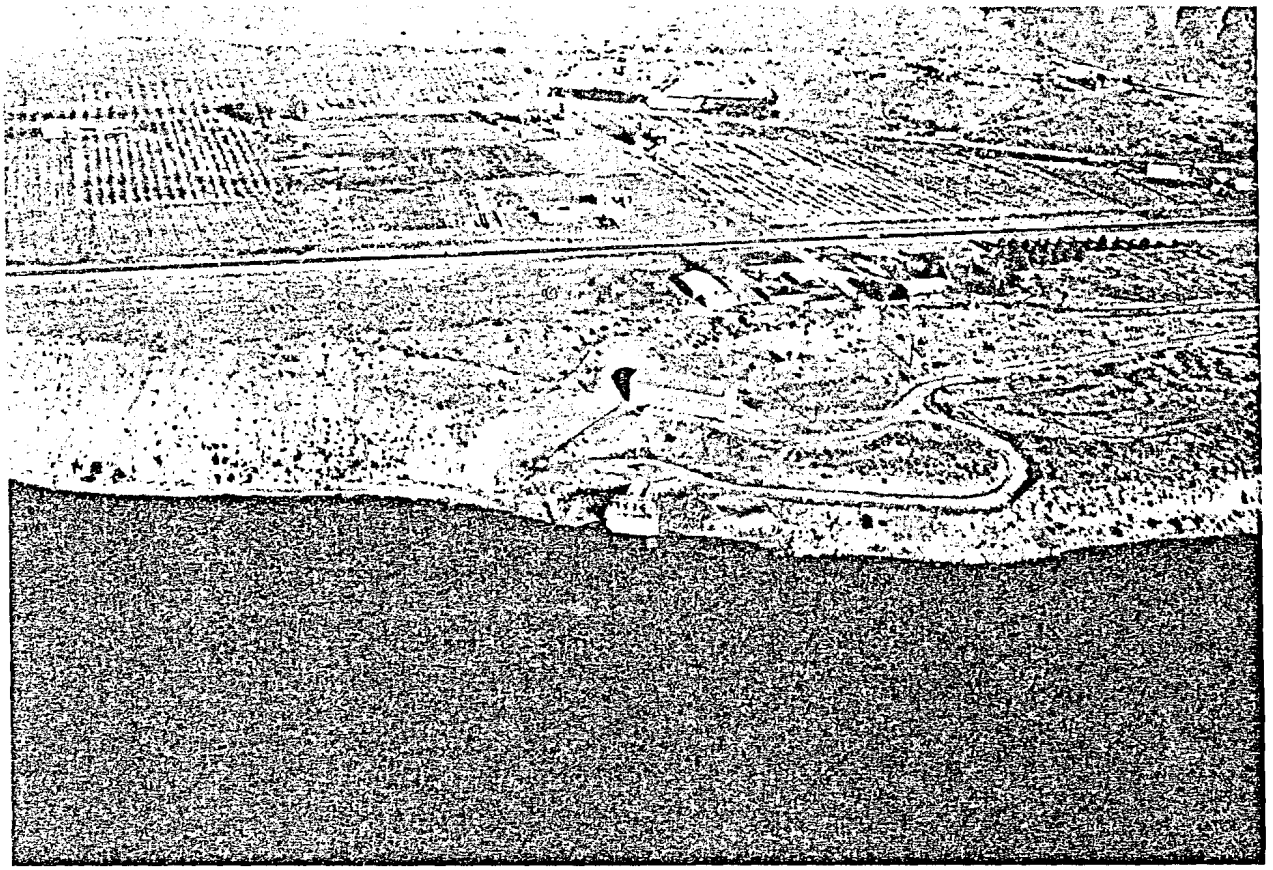
Col460.5L—Greater Wenatchee Irrigation District

Figure 3.--

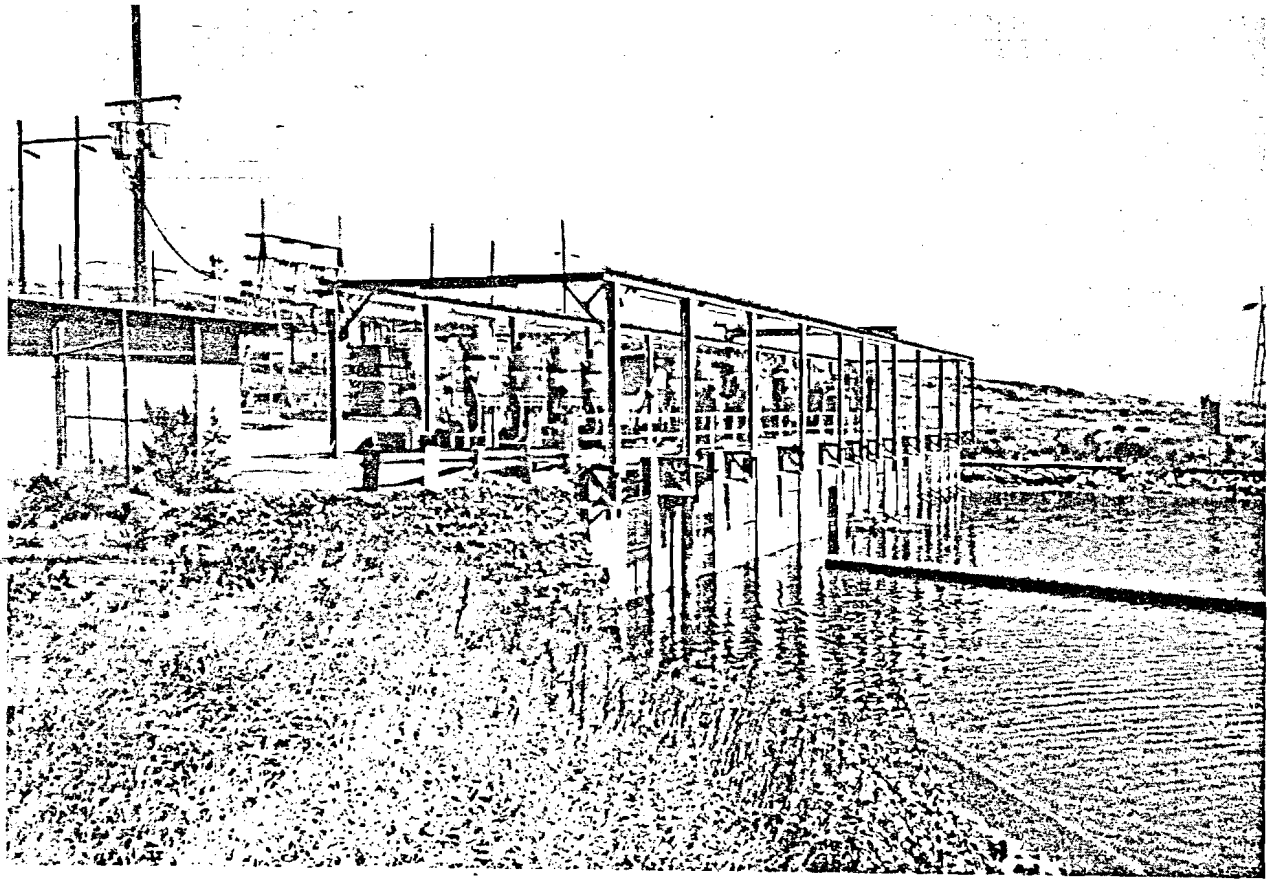
Figure 5.--

Col275.5R—Paterson Irrigation Project Landowners

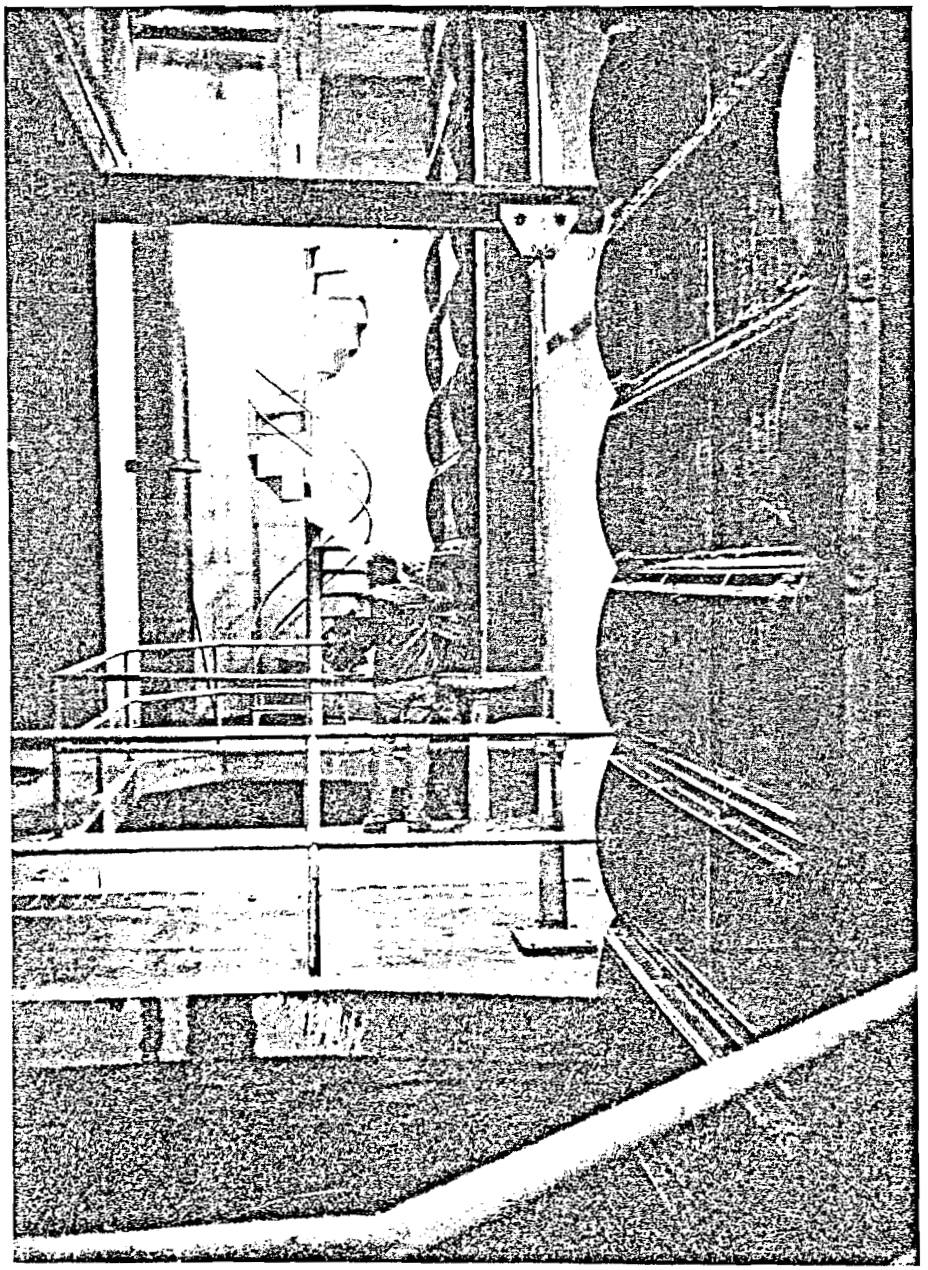
Figure 16.-- Vertical traveling screens used by the City of Richland, Washington to screen their municipal water supply (Col340.8R).

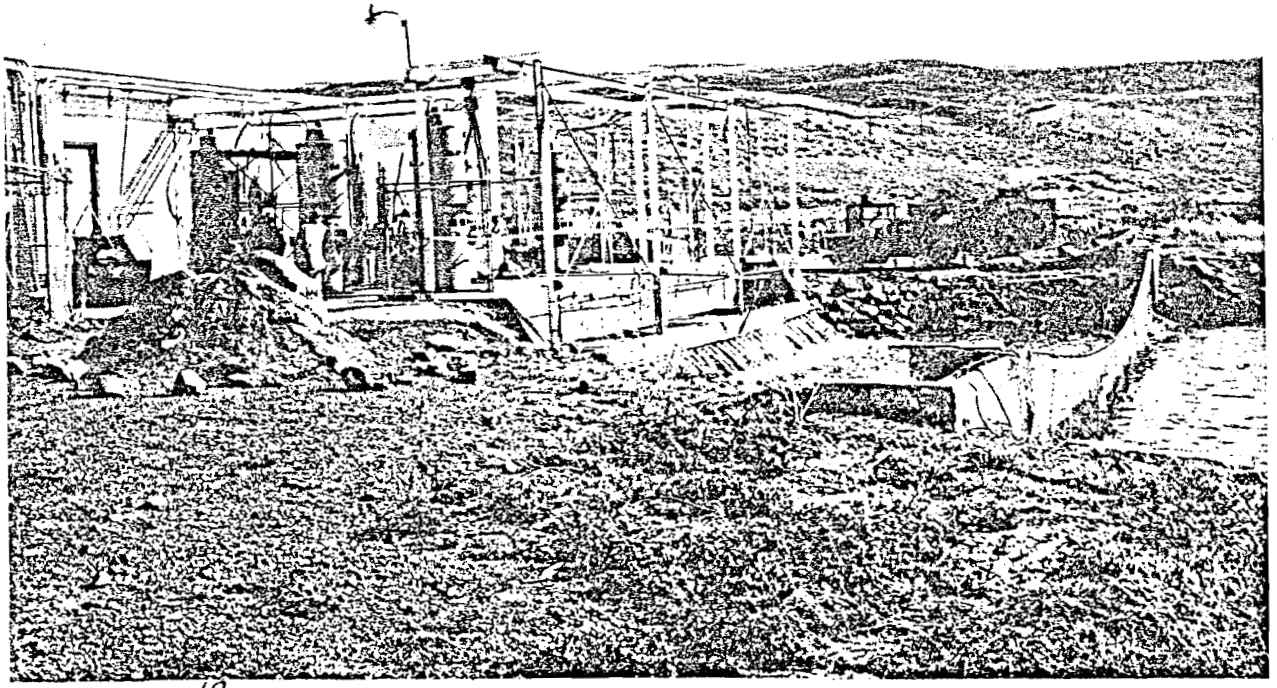
Figure ~~20~~ 18.--

Snk017.0L—K2H Farms, Inc.

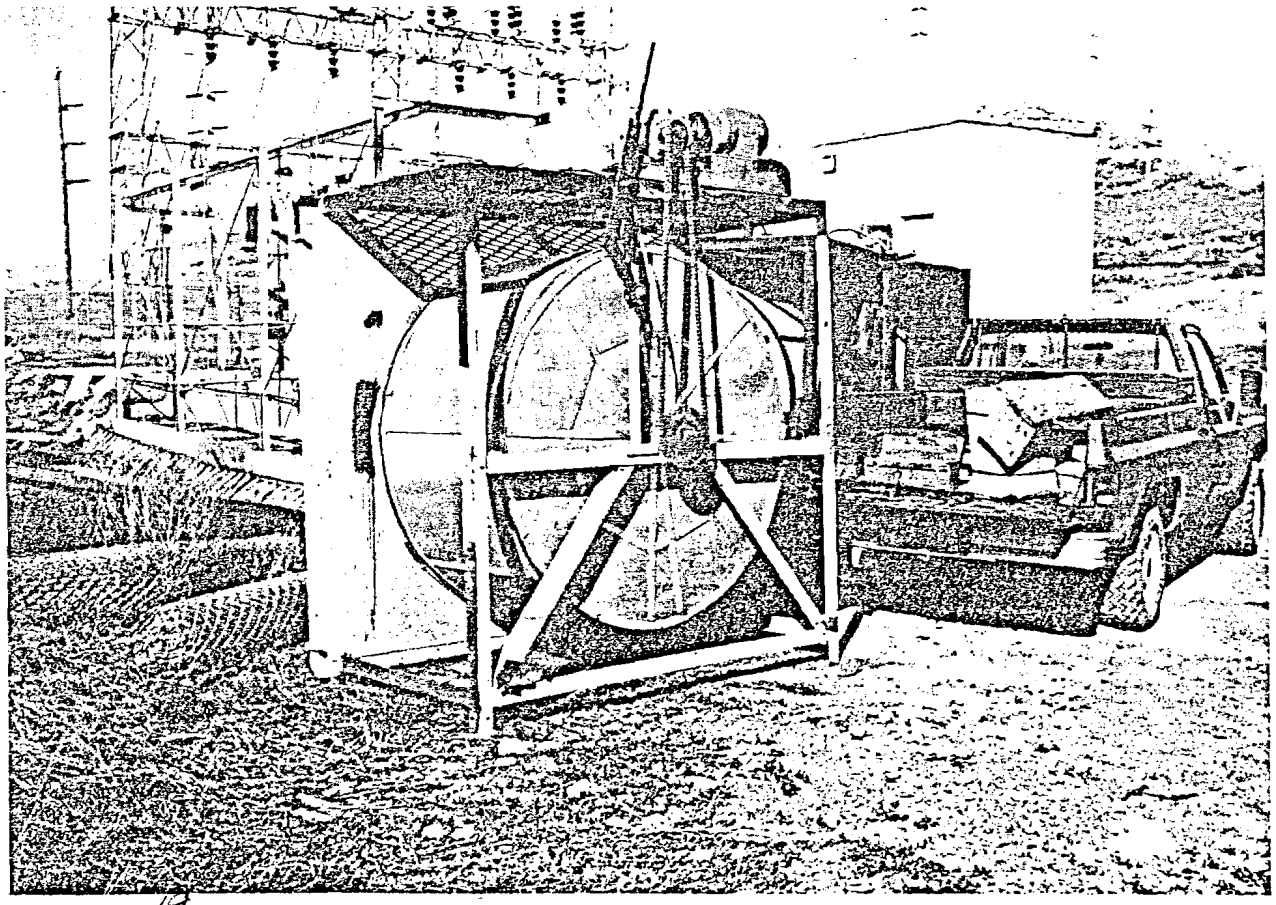
Figure 19.

Fine mesh revolving drum screen used at a water withdrawal site (Snk017.0L) to remove water borne weed seeds from irrigation water. Small fish may also benefit from such a screen.
