SUMMARY REPORT  
MECHANICAL OPERATION OF HORIZONTAL  
TRAVELING SCREEN MODEL VII

By  
Winston E. Farr  
and  
Earl F. Prentice

Research performed under contract between  
Eugene Water and Electric Board, Bureau of  
Reclamation and the National Marine Fisheries  
Service

September 1973

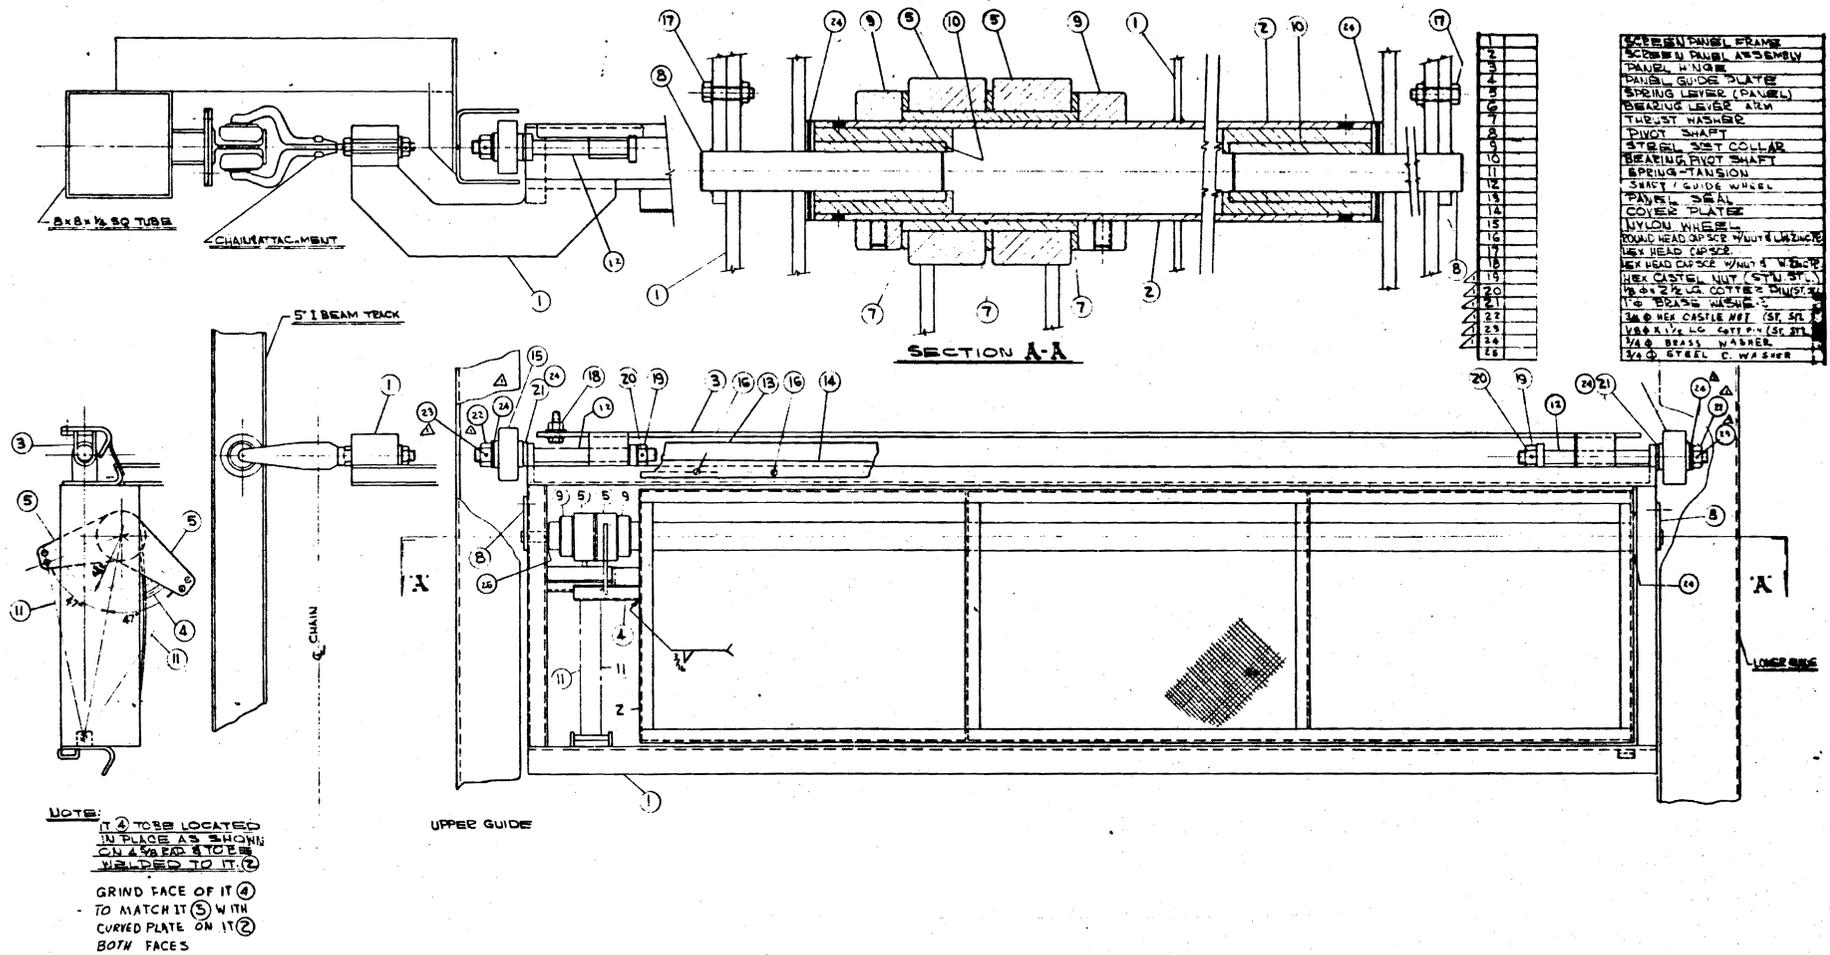
Figure 5. -- Details of screen panel and frame.

The screen panels (Figure 5) were set in a frame and were hinged on the trailing edge in a manner that allowed the panels to open when the water pressure was sufficient to overcome tension on the springs. The tension springs (Figures 4 and 6) were attached at the top of each screen

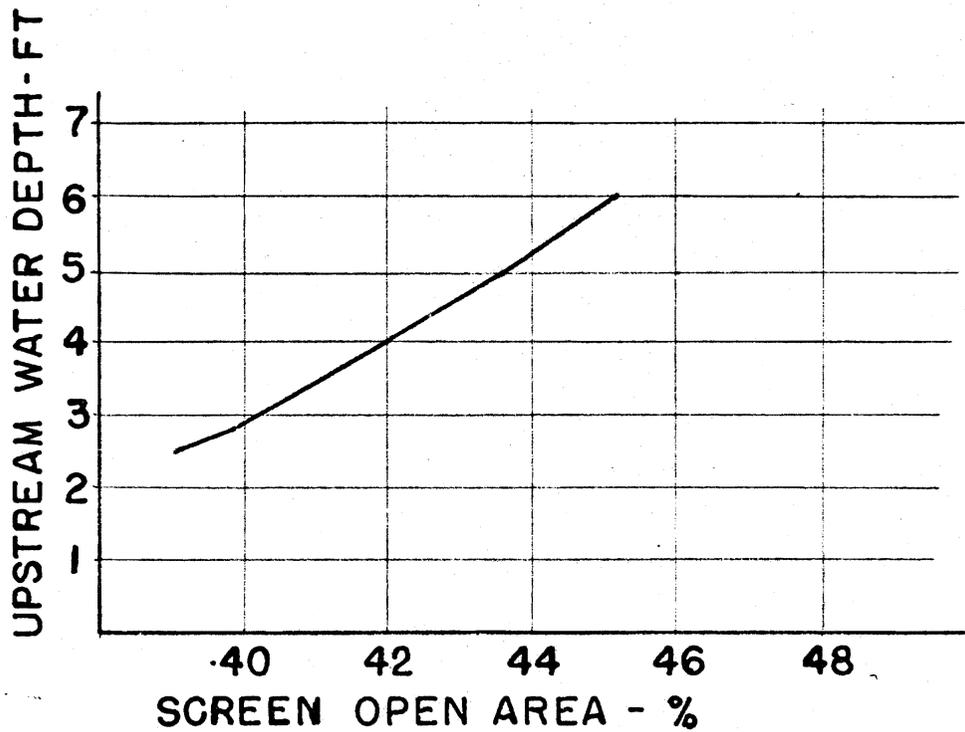
Figure 7.--Percentage of open area on the upstream leg of traveling screen in relation to water depth at screen.

The screen on the panels was 8- x 8-inch mesh and made of 0.028-inch diameter galvanized wire which provided 0.097-inch clear opening per mesh and 60.2% net open area for the screen. Figure 7 shows the net open area for water passage on the upstream leg of the facility at different depths of water. Nylon wheels (Figure 8), attached to the top and bottom of the panel frame and traveling in "U"-shaped guides, carried the horizontal load on the structure. The upper guide was supported by the main beam and the bottom guide was anchored to the concrete floor of the flume. The screen panels were supported by two steel carriage wheels (one on each side of "I" beam track) for each of 48 frames; each wheel had a zerk fitting for lubrication.

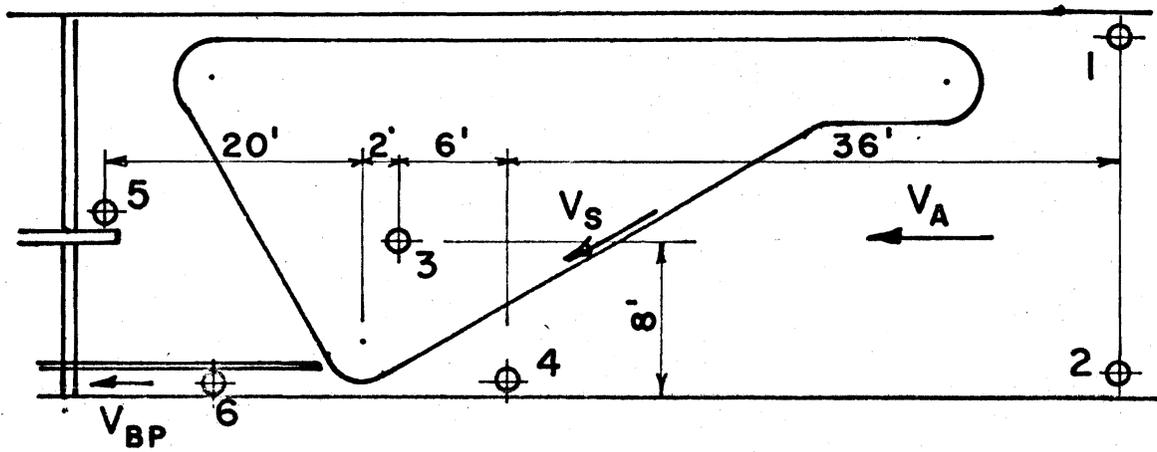
Figure 10.--Location of the six point gages used to measure head loss or gain.

Head loss or gain is the difference in water surface elevation from a point upstream to a point downstream in the flume. Head differences were determined from point gages placed at six locations in the vicinity of HTS VII. Table 1 lists the gage readings for water approach velocities up to 2 fps, and Figure 10 shows the location of the point gages.

2/ A reading of 1.500 on a gage indicates 6-foot water depth in the flume; 0.000 indicates a 4.5-foot water depth. Location of each gage is shown in Figure 10.

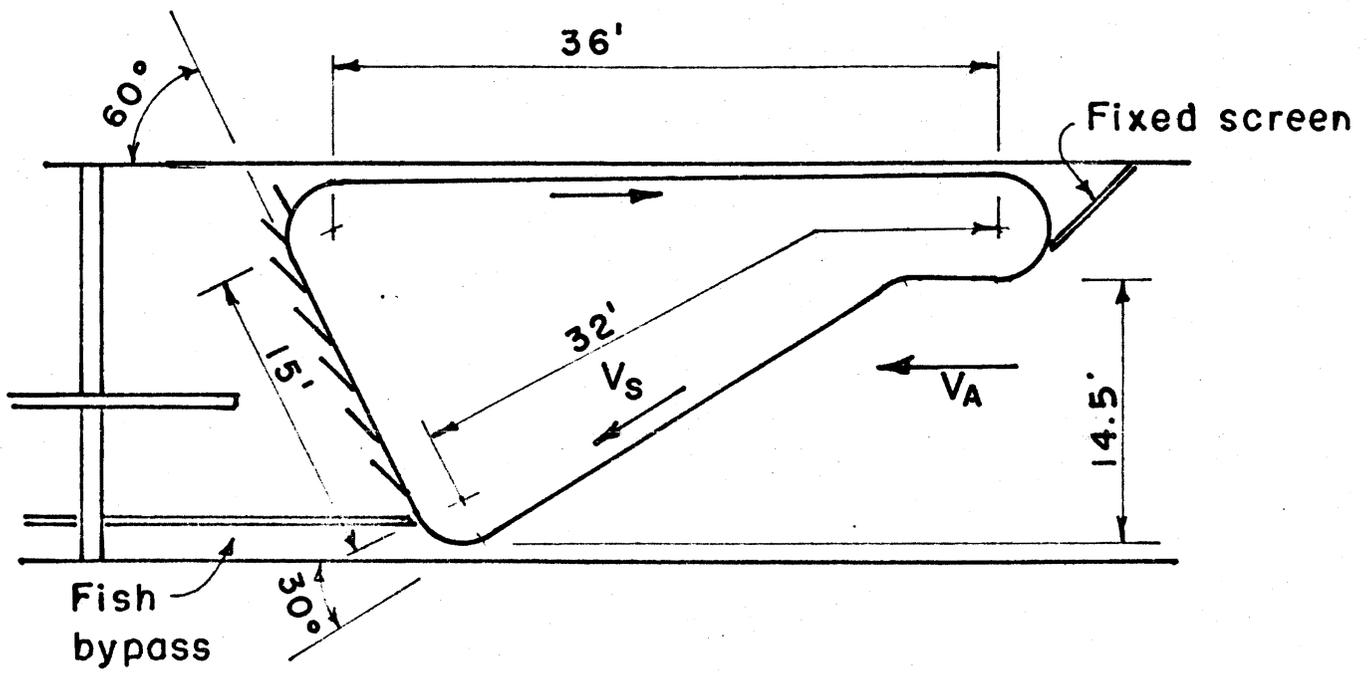
Figure 13.--Plan view of traveling screen installation on Grande Ronde River near Troy, Oregon.

The following description of water flow in the flume and through the upstream and downstream legs of the screening facility will suffice to explain the origin of excessive head loss. Assume the depth of the water in the channel is 5 feet and refer to Figure 13 for dimension orientation.

- (a) The cross-sectional area of the water approaching the facility is  $14.5 \times 5 \text{ ft} = 72.5 \text{ sq ft}$
- (b) Applying the percentage open area in the screen structure (Figure 7), the net opening for water passage in the upstream leg would be  $32 \text{ ft} \times 5 \text{ ft} \times 0.437 = 69.9 \text{ sq ft}$
- (c) Applying the same percentage for the downstream leg, the net opening would be  $15 \text{ ft} \times 5 \text{ ft} \times 0.437 = 32.8 \text{ sq ft}$

With the screen panels hinged on the trailing edge (Figures 13 and 15), panels opening in the downstream leg pushed water while the screen was moving. Although tension springs were designed to close the screen panels before the panels negotiated the downstream turn, water approach velocities in excess of 2 fps prevented rapid closure of the panels and they subsequently jammed against the adjoining wall.

Head loss on the downstream leg can be reduced by hinging the panels on the leading edge and additionally by enlarging the channel on the downstream right bank as shown in Figure 16.
