NOAA Technical Memorandum NMFS-NWFSC-120

Working with Beaver to Restore Salmon Habitat in the Bridge Creek Intensively Monitored Watershed

Design Rationale and Hypotheses

October 2012

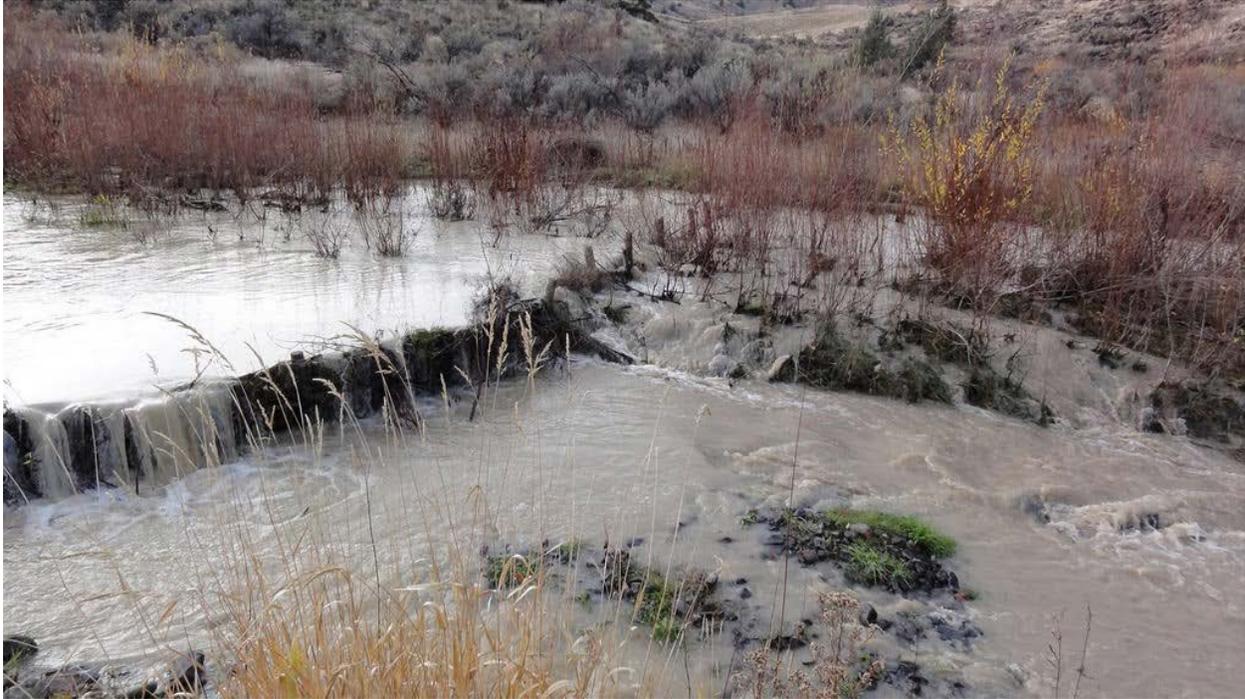
Figure 10. A typical SD (SF-17 at Sunflower) with willow branches woven between vertical posts and the back side sealed with rock and clay. Note that the dam height is sufficient to divert flow onto the river left terrace, mimicking a stable beaver dam.

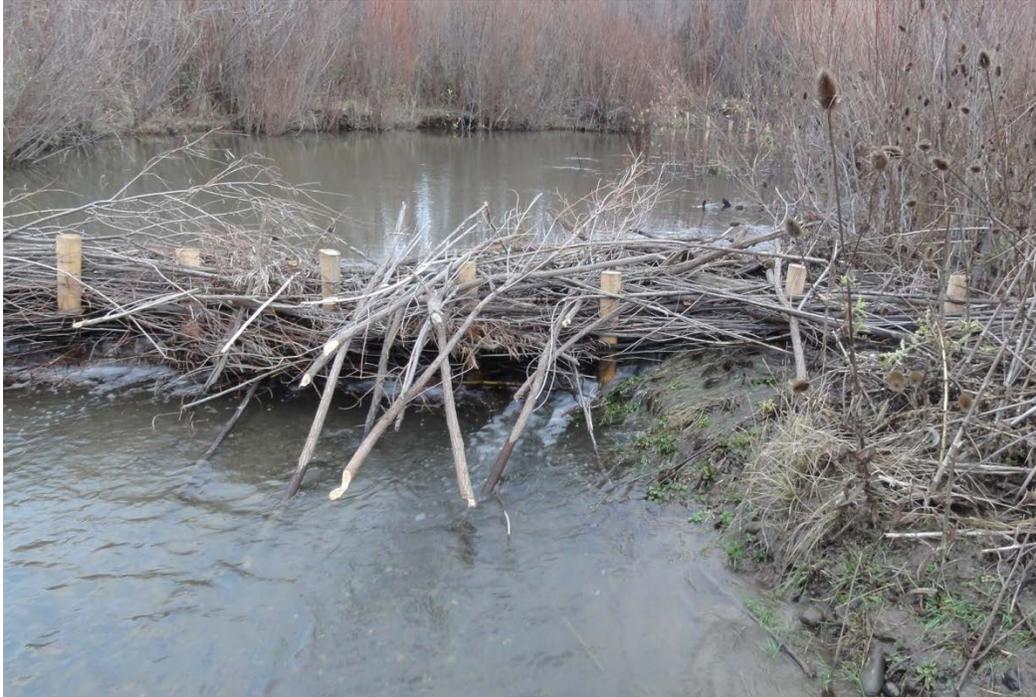
Figure 11. A PLWW is similar to an SD, but acts more like a weir in that water is allowed to flow through the willow branches such that low flows are not overtopping the structure and the woven branches may not extend to the top of the posts. These may naturally seal up by trapping sediment and organic material moving downstream or they may be utilized by beaver. Note that beaver have started to colonize this PLWW, as evidenced by the chewed stems aligned parallel to the flow in the middle of the photograph.

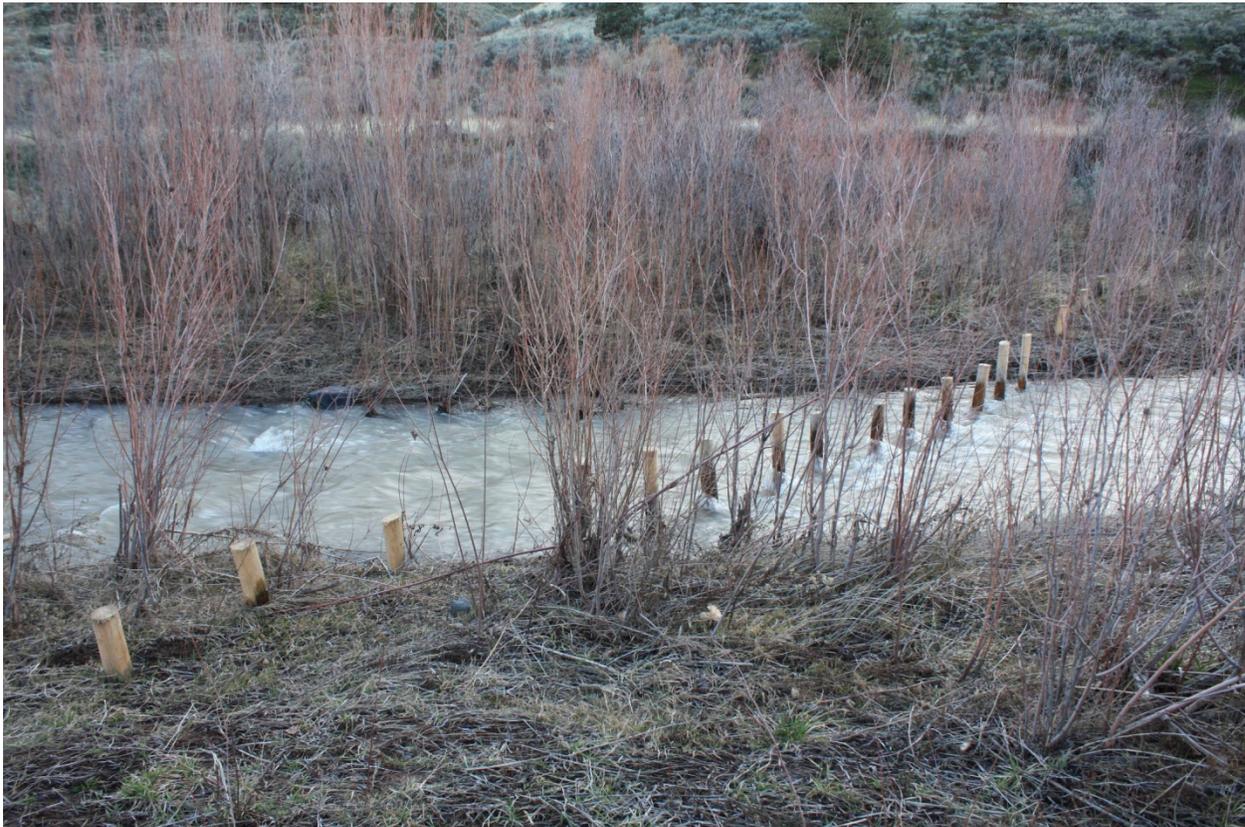
Figure 12. The purpose of a PL is to provide a site where beaver can build a stable dam. They generally create little or no geomorphic changes unless utilized by beaver.

PLs (Figure 12) were placed in sites where a future beaver dam was desired and where geomorphic conditions were suitable for a dam. In contrast to PLWWs, PLs by themselves were limited to sites where there was minimal risk if no aggradation occurred because beaver did not use them to build a dam. These structures were not intended to be functional unless beaver utilized them to build a dam.

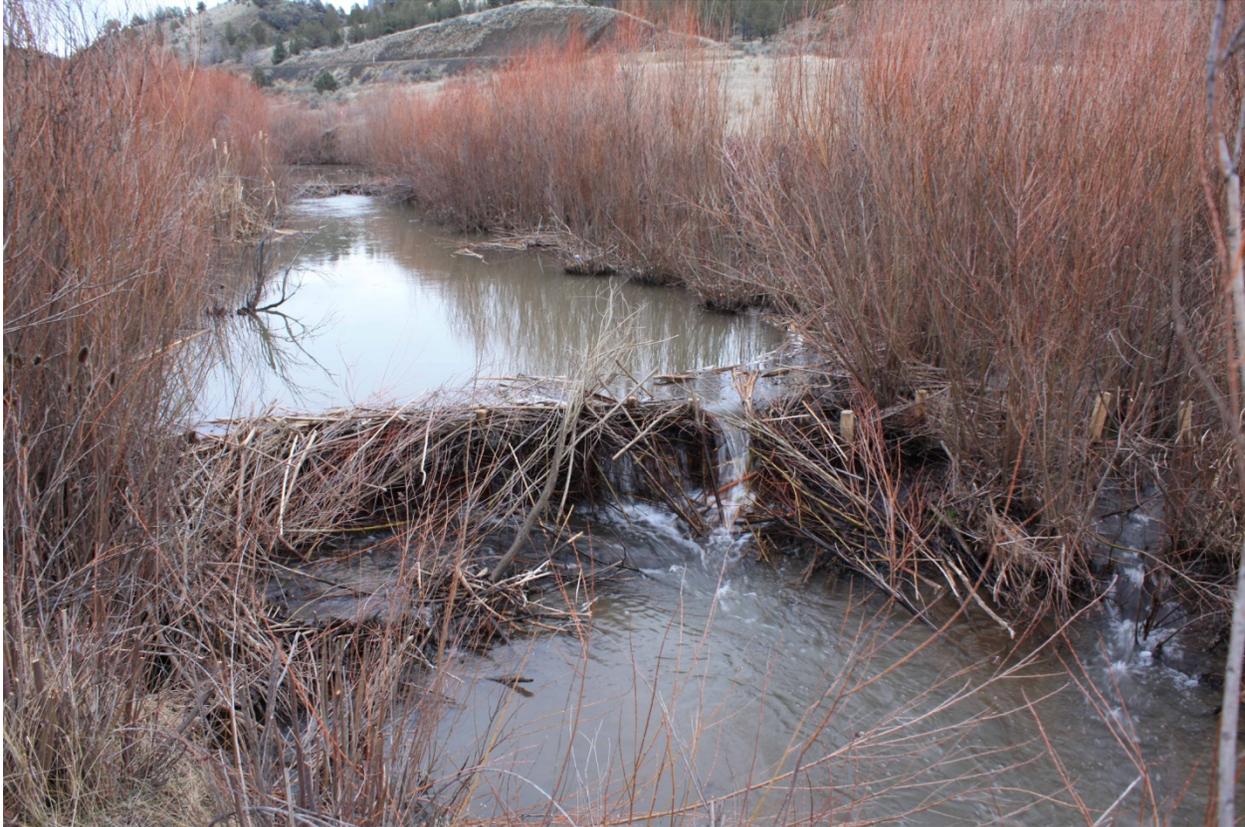
Figure 13. Any active dams within the treatment areas were strengthened with posts to lengthen their functional life, since most dams along the incised Bridge Creek have been shown to last less than a year (Demmer and Beschta 2008). This structure was one of four dams built in sequence in Lower Owens to form a new colony. Within 1 year, all four dams had backfilled with sediment, which improved floodplain connectivity and habitat complexity, but made the site unsuitable for beaver. However, because we had installed additional PLs just downstream, the beaver were able to use them to build new dams, which allowed the colony to persist.

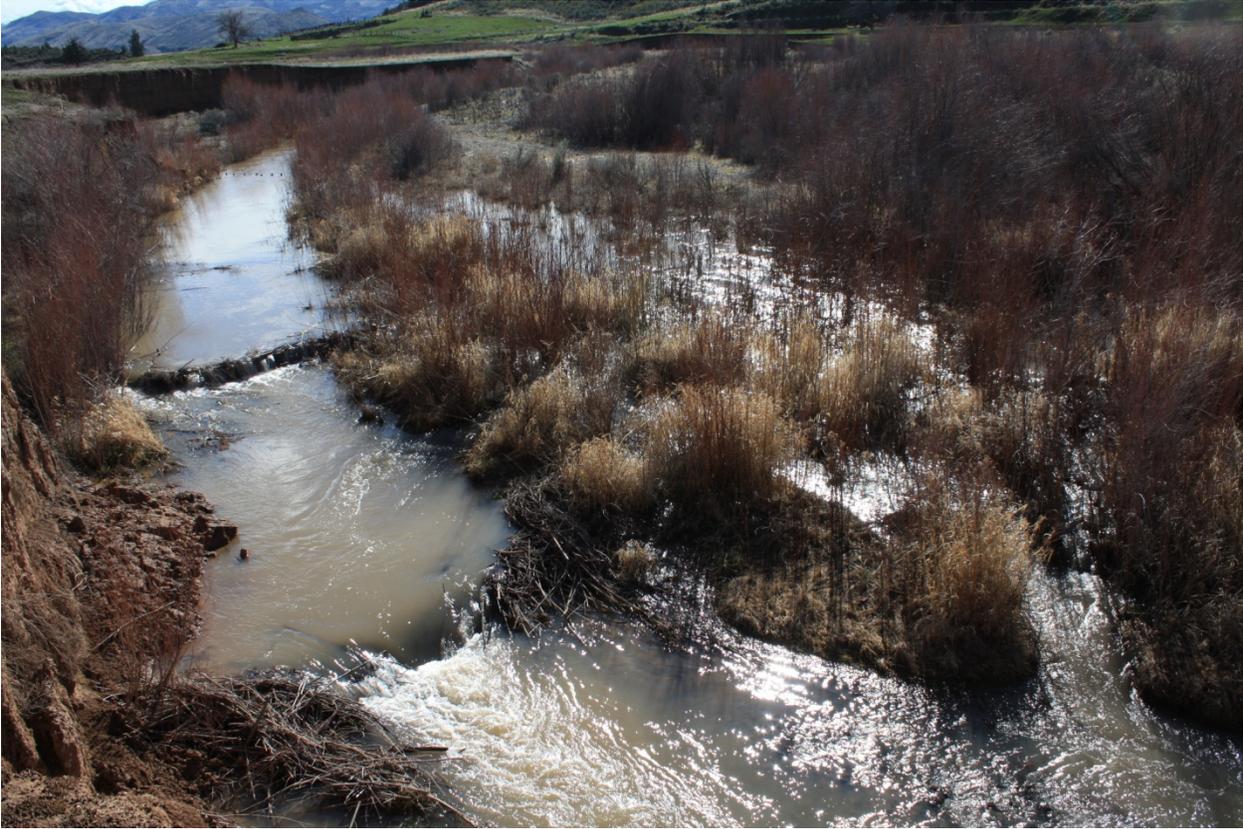
Figure 14. Any abandoned dams with significant structure remaining were reinforced with posts, since these were sites where beaver had previously built dams and with additional structure available might do so again. Beaver abandoned this dam (PC-15 in foreground) and one immediately downstream (not in photograph) after they were breached by high flows. Within a year following reinforcement by posts, beaver rebuilt this dam and built two more dams on PLs (one visible immediately upstream of PC-15, the other farther upstream), resulting in a flooded terrace and complex, multichannel habitat forming on river left and diverting flow away from a high exposed bank on river right.
